Inspection Report

Property Address:
74 County Road 624
Oak Grove Arkansas 72638

Abba Home Inspections, LLC

Date: 1/17/2023	Time: 08:58 AM	Report ID: F-Fairweather8425
Property: 74 County Road 624 Oak Grove Arkansas 72638	Customer: Rob Fairweather	Real Estate Professional:

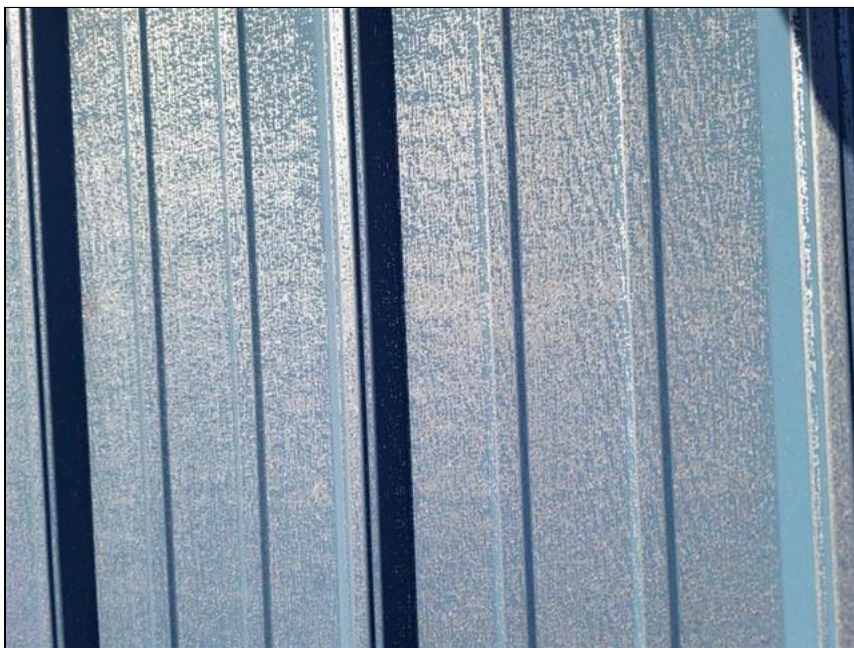
1.0 (1) The paint is coming off and the panels may begin to rust in the future.

1.0 Item 1(Picture) Paint-coming off

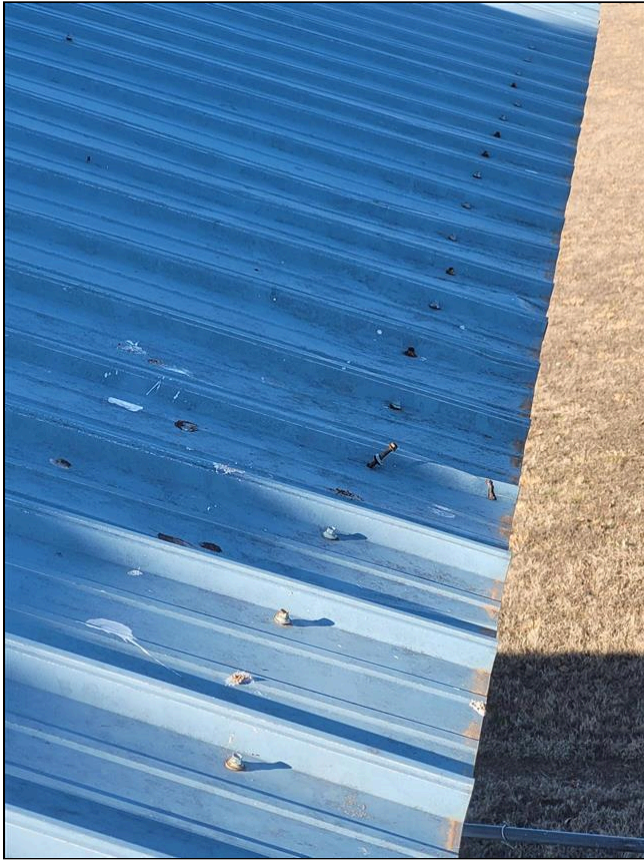
1.0 Item 2(Picture) Secure loose screws

Install and secure all loose/missing screws, where needed.

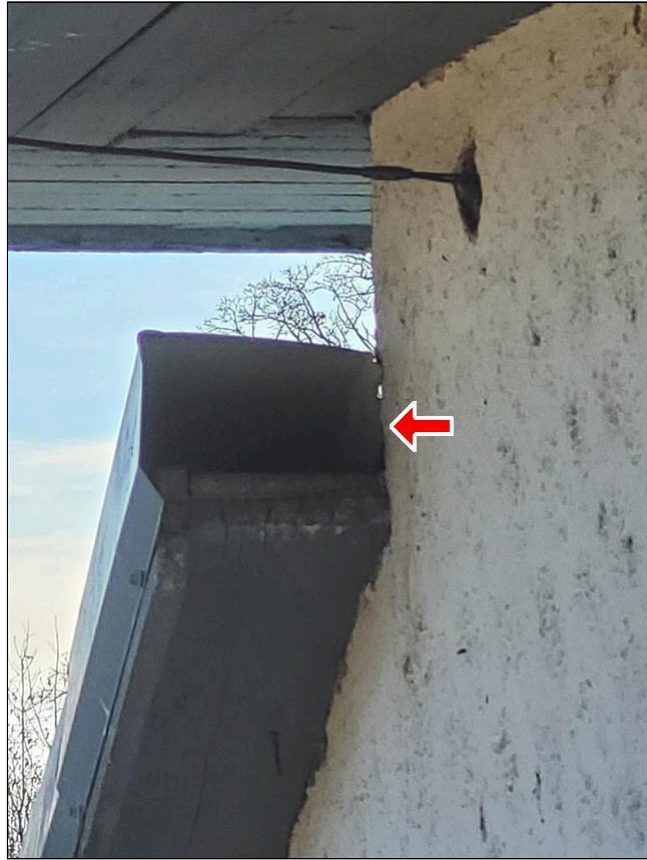
1.0 Item 3(Picture) Open area

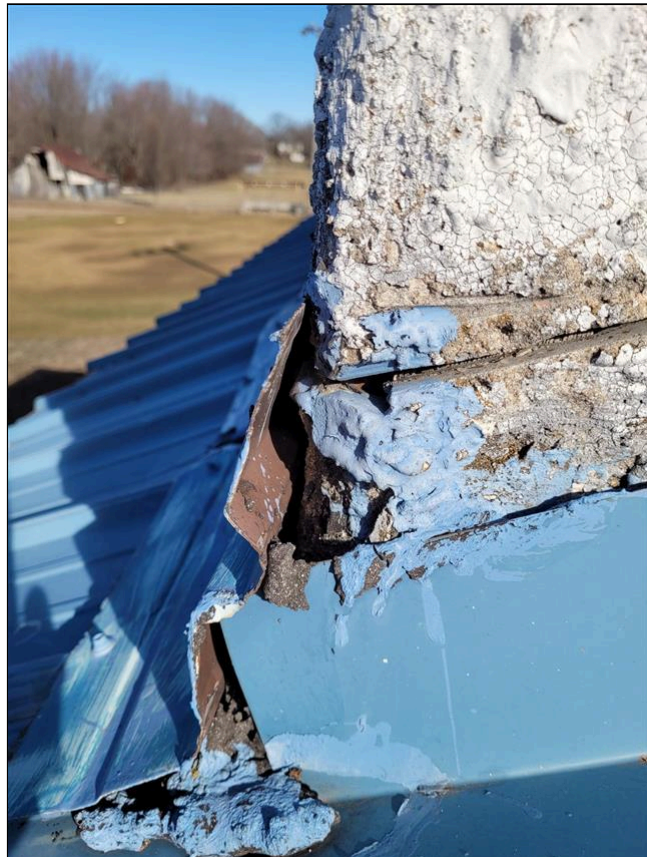
1.1 Item 6(Picture) Flash/seal all areas properly

1.1 All areas should be flashed/sealed properly to prevent water intrusion and framing damage.

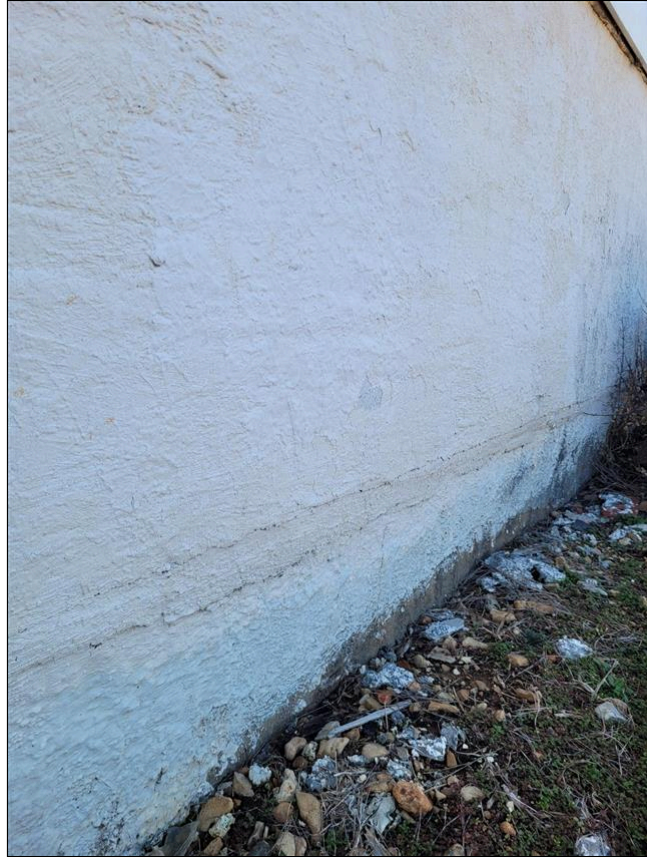
2.0 (1) There are numerous areas on the exterior with cracks. Some areas appear to be bulging.

2.0 Item 2(Picture) Possible bulging

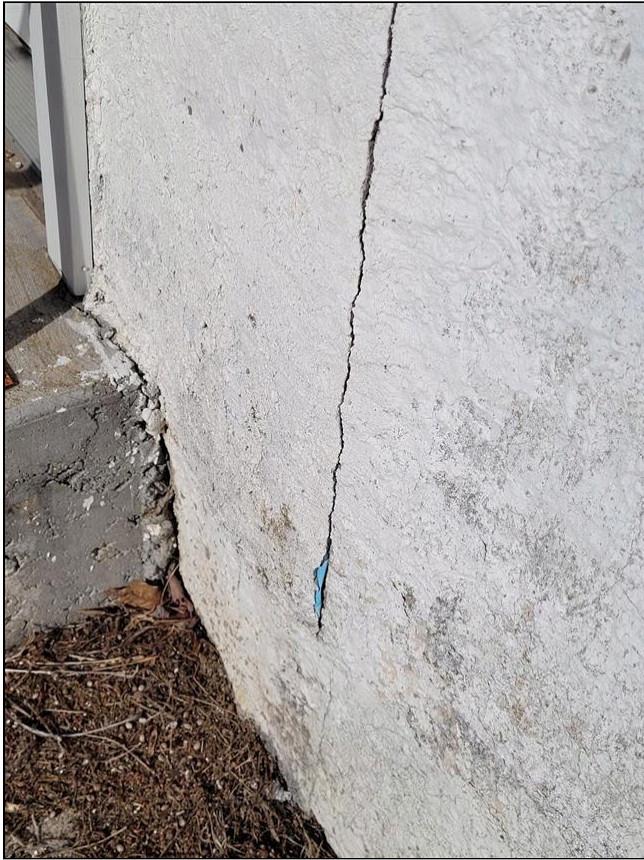
Water could enter and cause framing damage.

2.0 Item 5(Picture) Cracked exterior

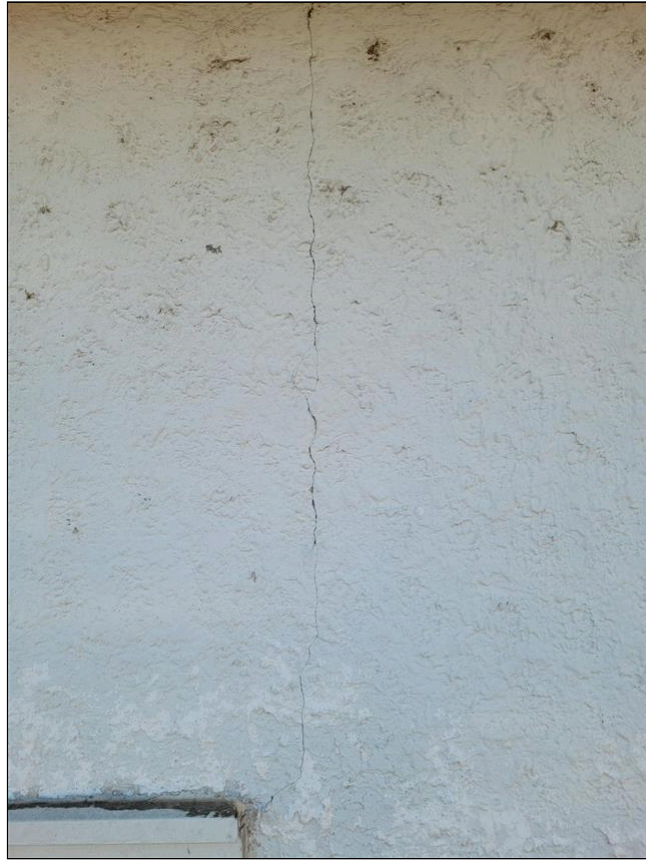
2.0 Item 6(Picture) Cracked exterior

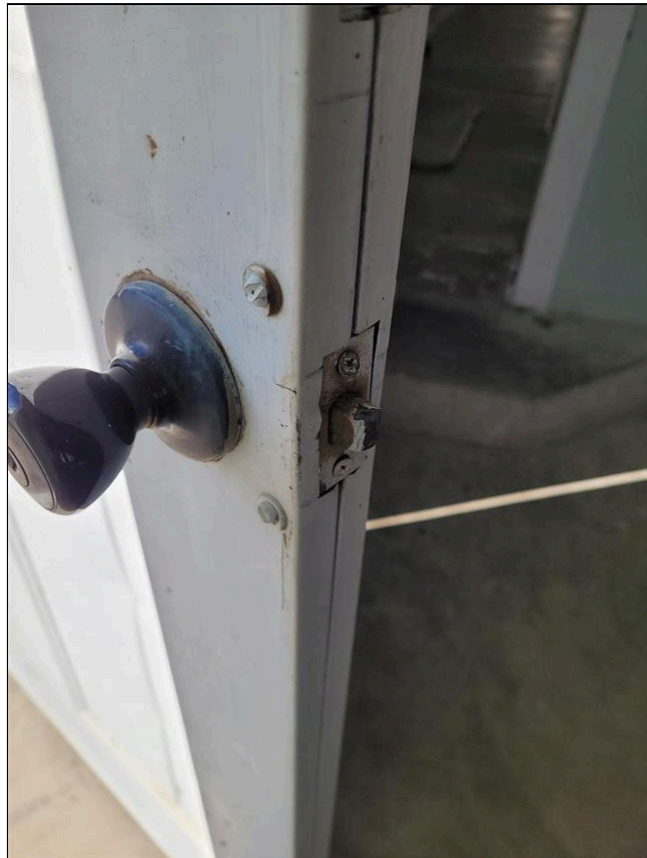
2.1 Item 4(Picture) Repaired door-Southwest side

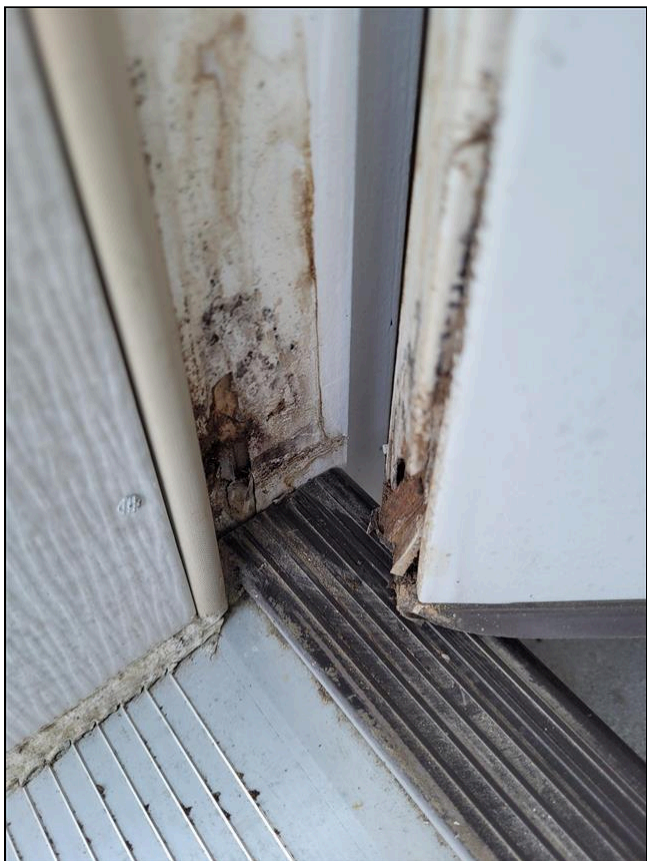
2.1 (1) *There are door and jambs with damage.*

2.1 Item 5(Picture) Rotten jamb, rotten door-North door

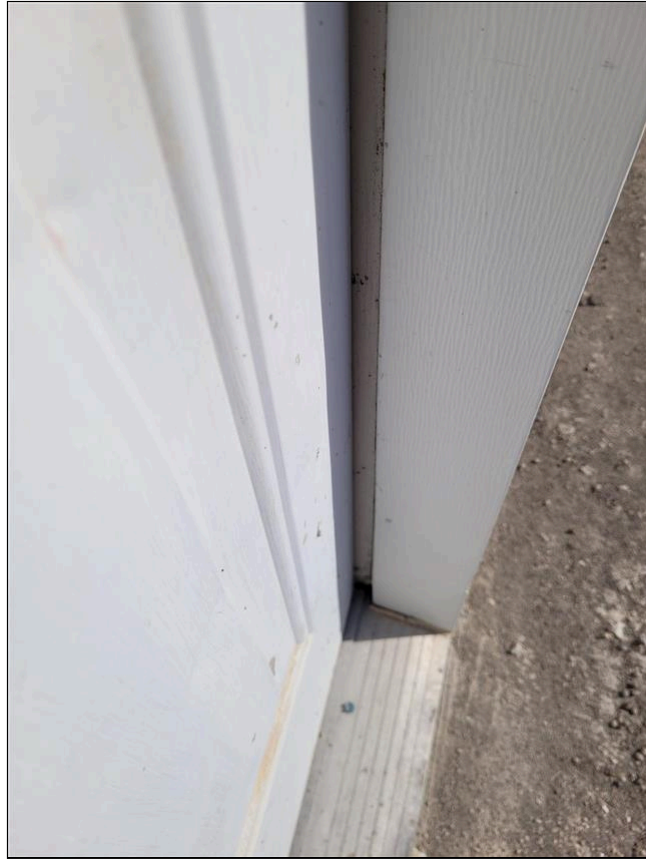
2.1 Item 8(Picture) Unsealed door-Southeast door

(2) Replace all damaged threshold seals and weather stripping to prevent any water intrusion into the home and possible damage.

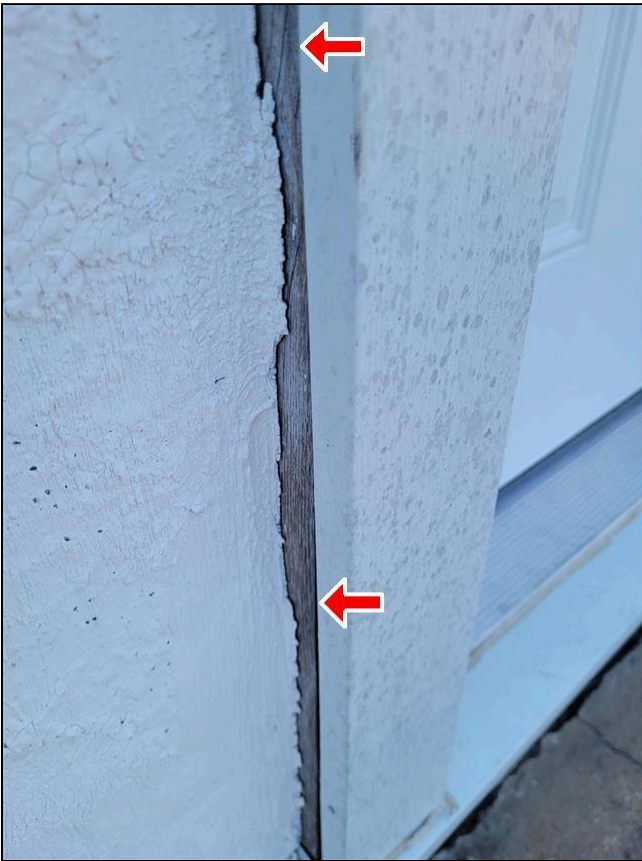
2.1 Item 10(Picture) Exposed wood

(4) *I recommend sealing around all doors to help prevent possible water intrusion and framing damage.*

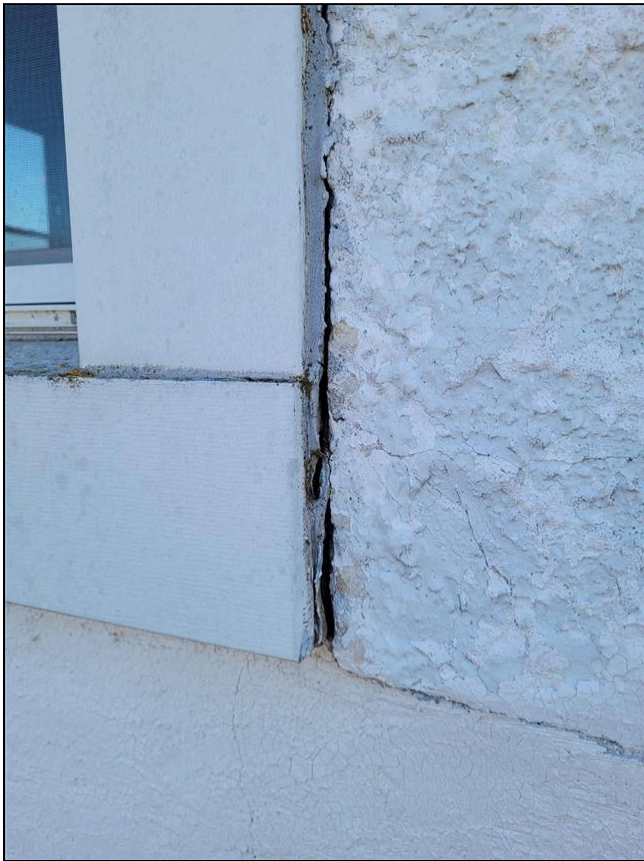
2.2 Item 1(Picture) Sealant needed-windows

2.2 (1) ***I recommend sealing around all windows to help prevent possible water intrusion and framing damage.***

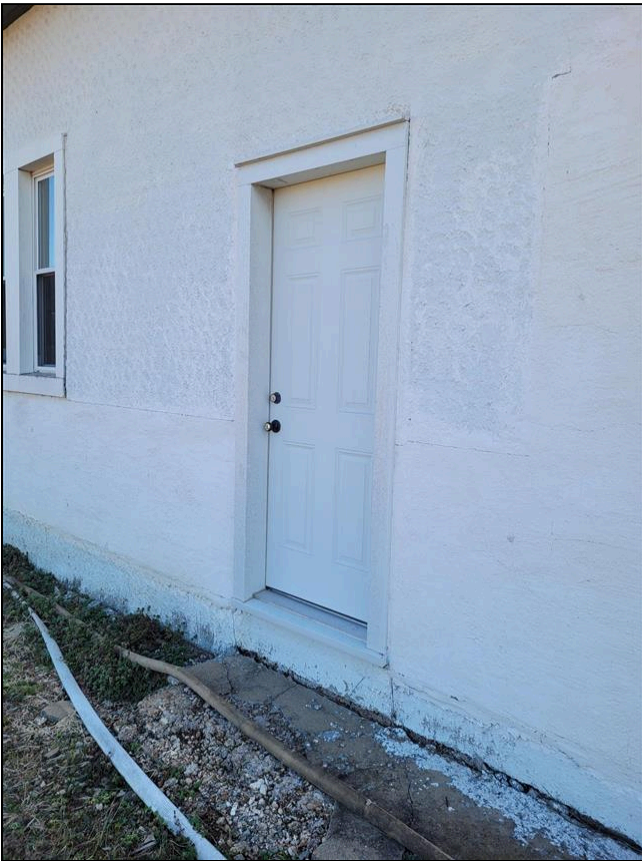
2.3 Item 1(Picture) Step and handrail needed-West side

2.3 I recommend installing a step and handrail system on the West side.

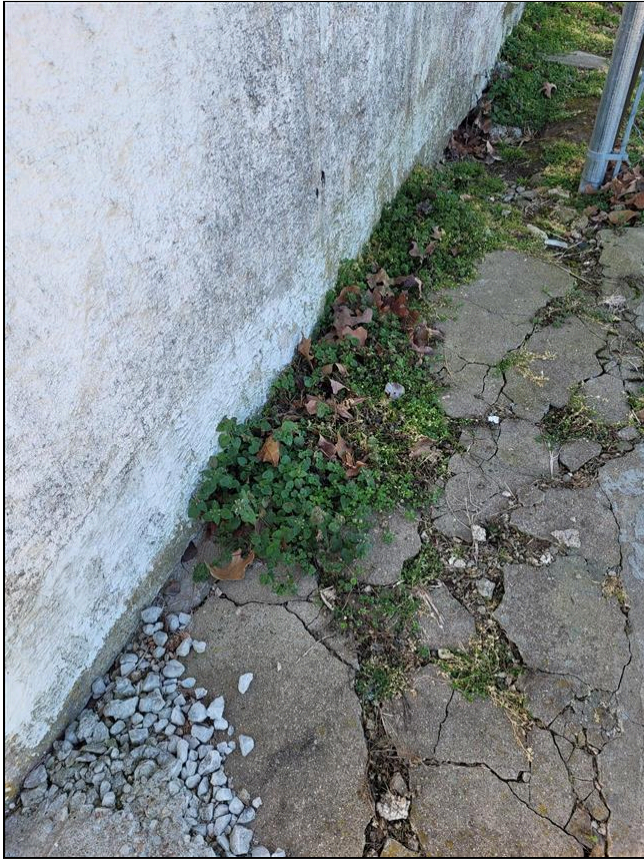
2.5 Item 1(Picture) Improper grading method

2.5 (1) All areas of grading on the exterior should cause the water to drain away from the foundation to prevent water intrusion.

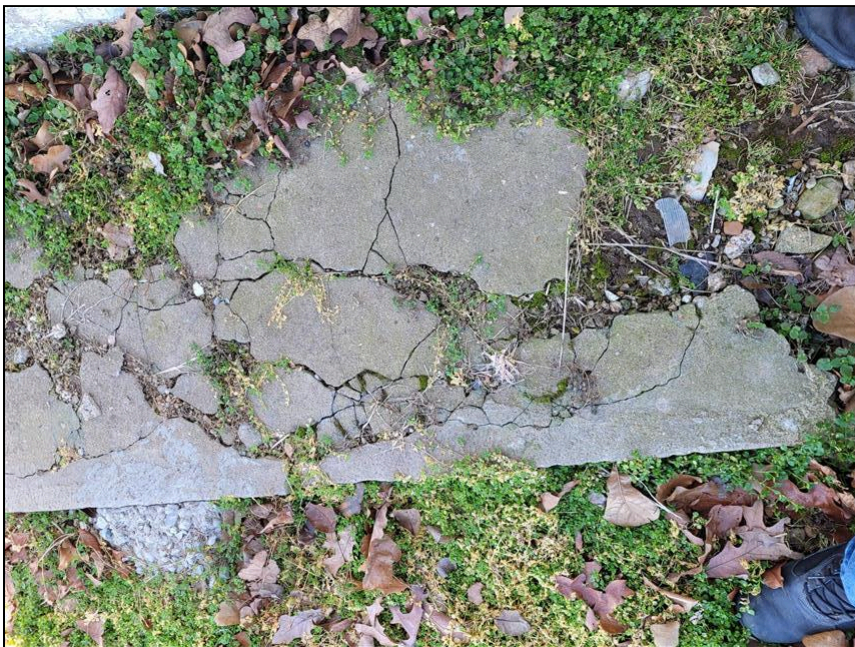
(2) **Damaged concrete**

2.5 Item 5(Picture) Damaged concrete

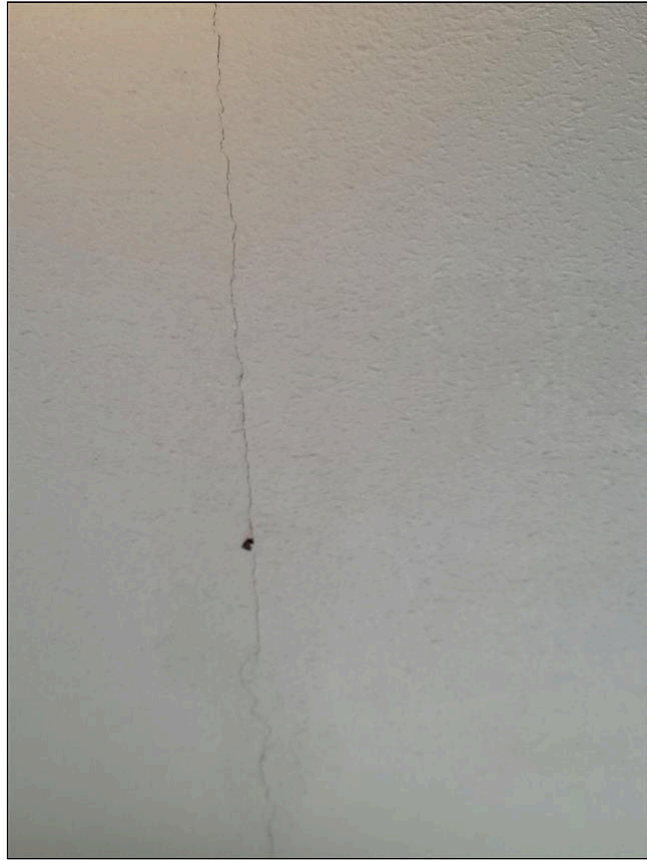
3.0 Item 4(Picture) School room ceiling-settling crack

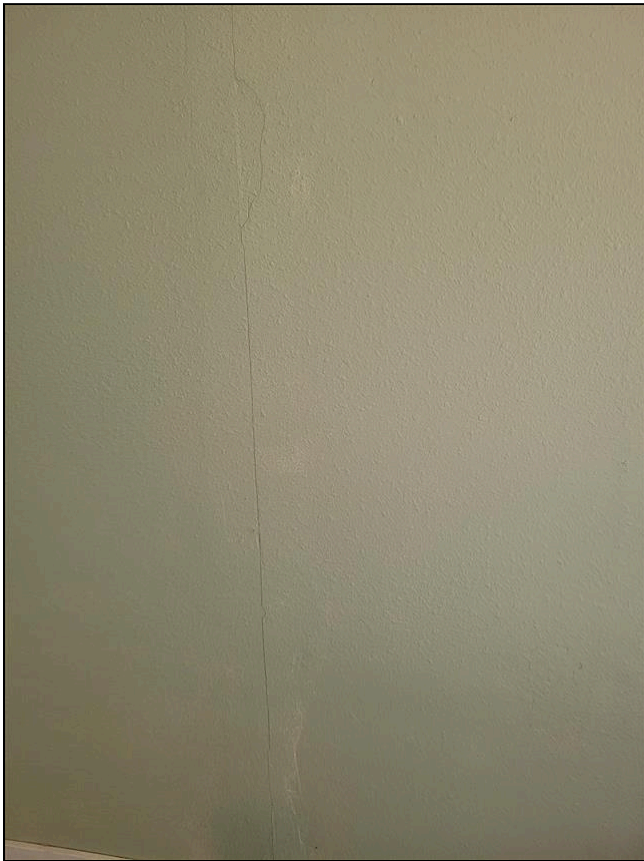
3.1 The following walls had issues: East school room and main room.

3.1 Item 1(Picture) East school room wall-settling cracks

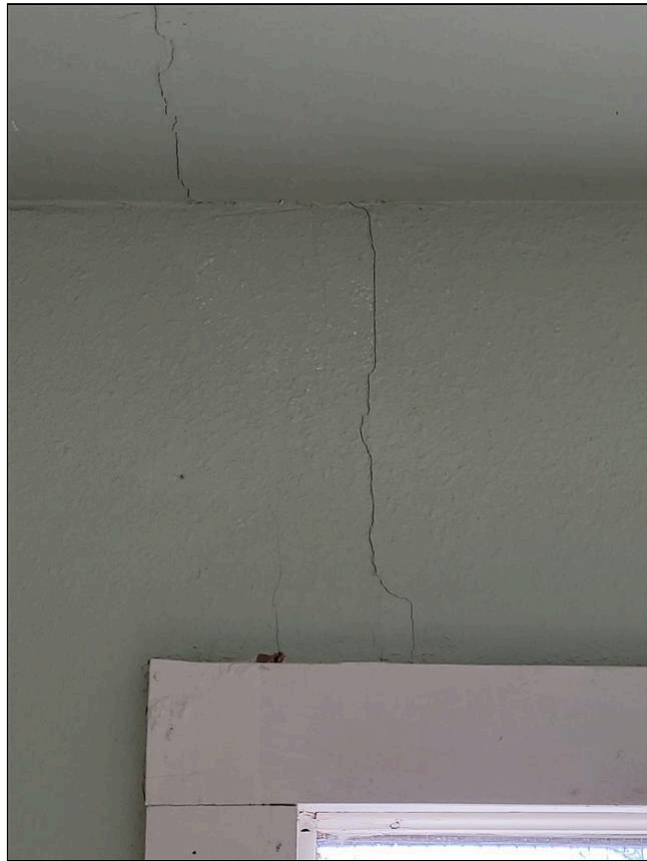
3.1 Item 2(Picture) East school room wall-settling cracks

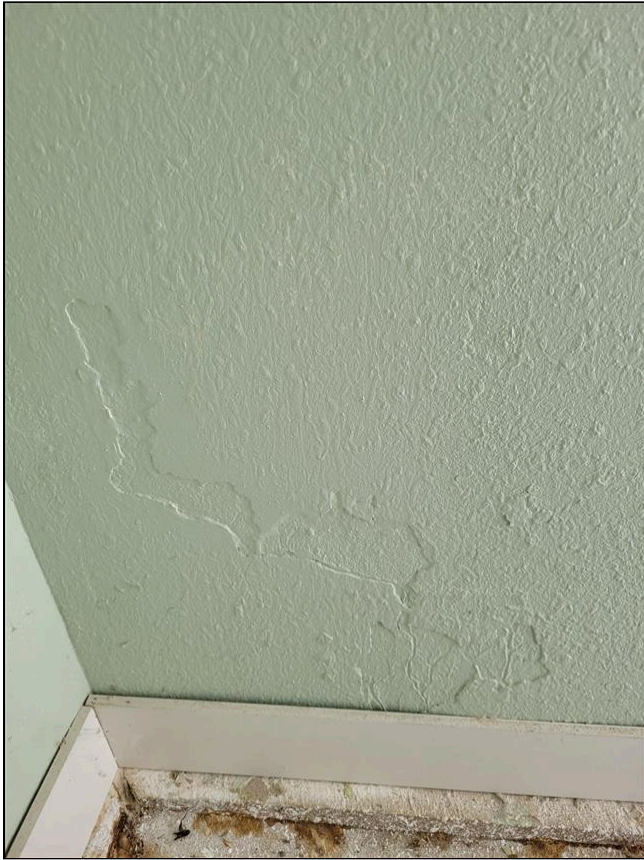
3.1 Item 3(Picture) East school room wall-possible wood destroying insect damage

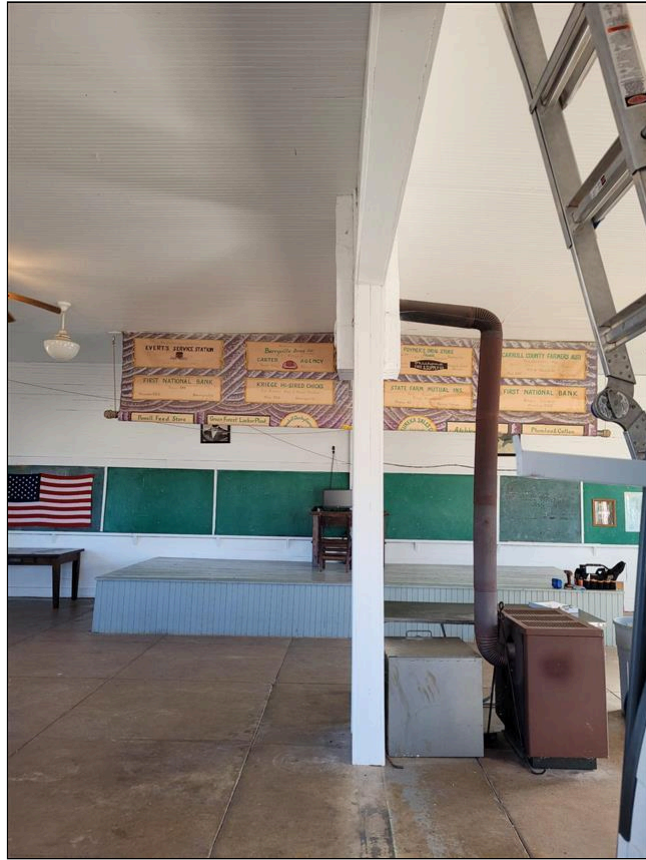
3.1 Item 4(Picture) Main room supporting wall-appears to be leaning to the North

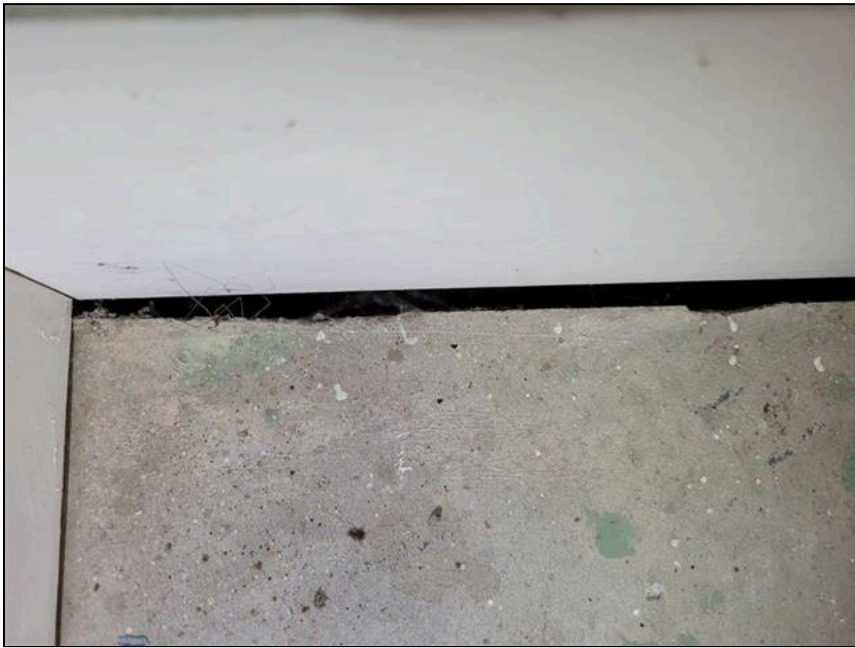
(2) *The floor had several settling cracks and gaps on the slab.*

3.2 Item 3(Picture) Floor-gap in concrete

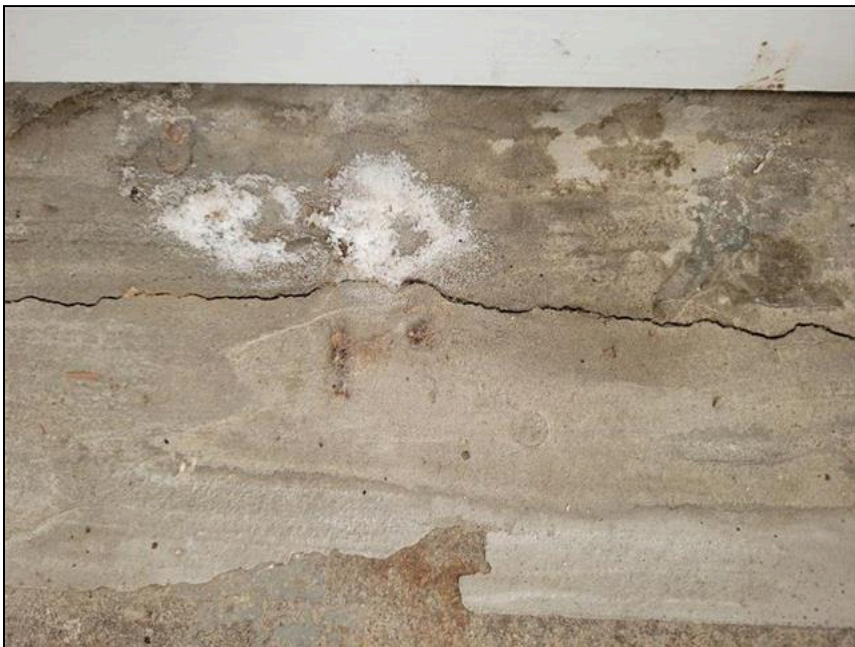
3.2 Item 4(Picture) Floor-settling cracks

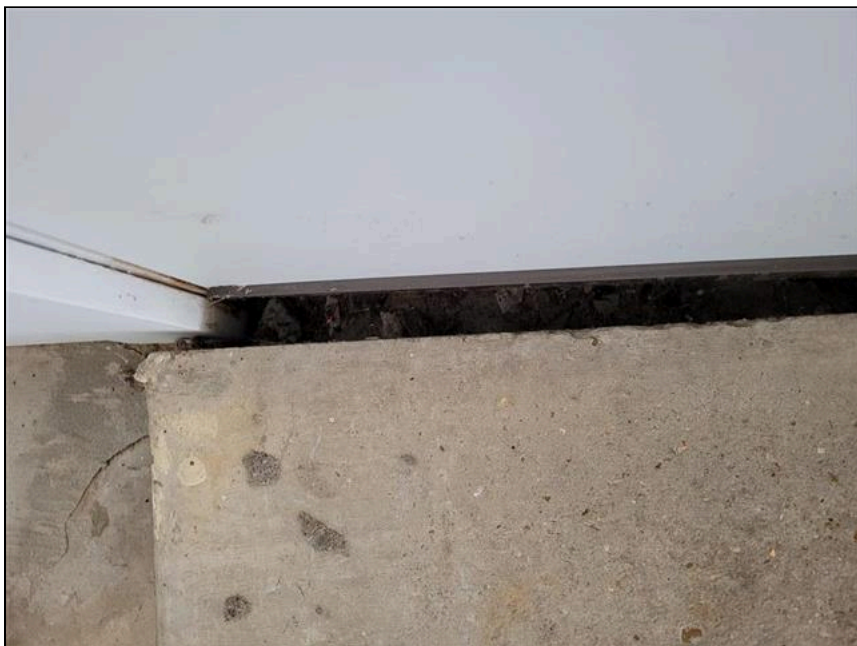
3.2 Item 5(Picture) Entry door floor-gap

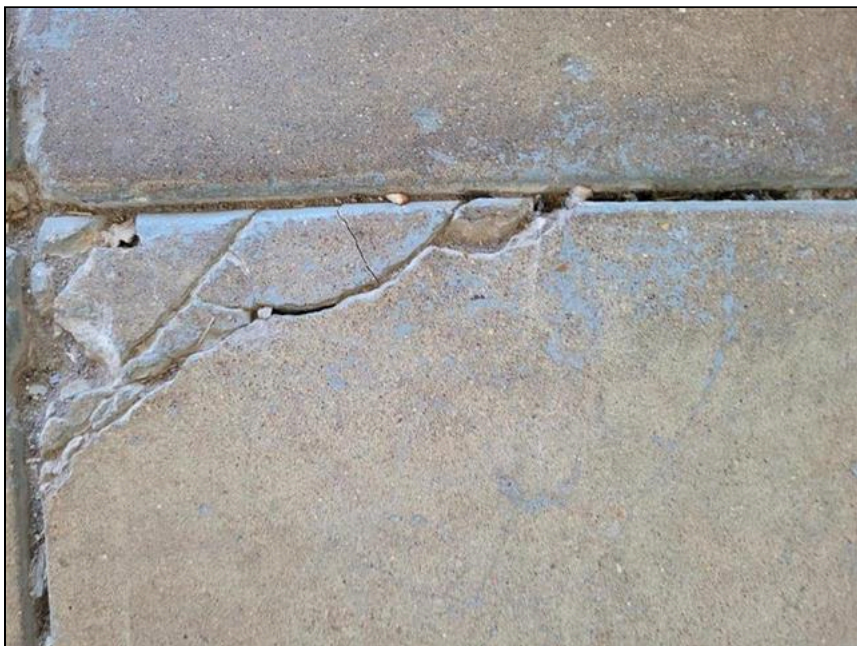
3.2 Item 6(Picture) Floor-damage

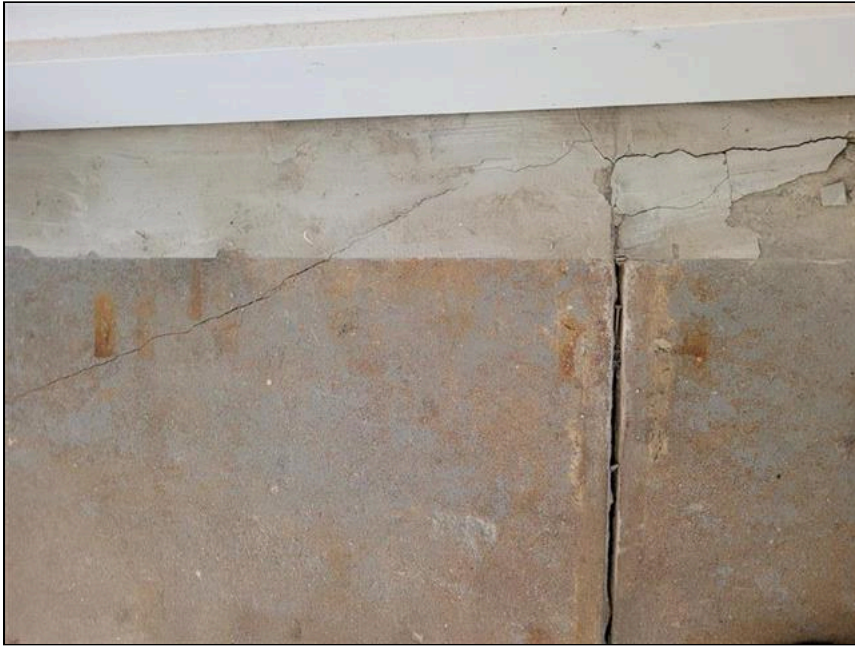
3.2 Item 7(Picture) Floor-settling cracks

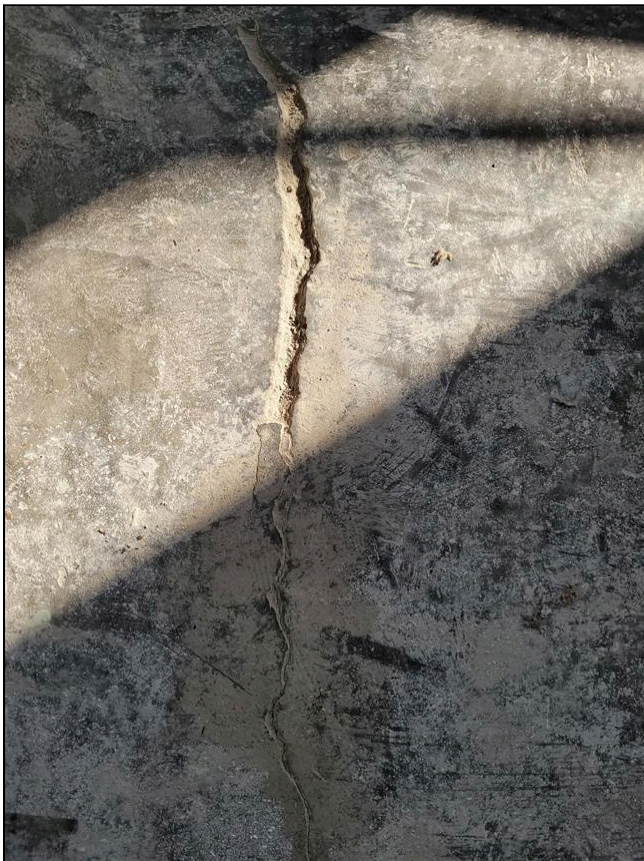
3.2 Item 8(Picture) East school room floor-large settling cracks

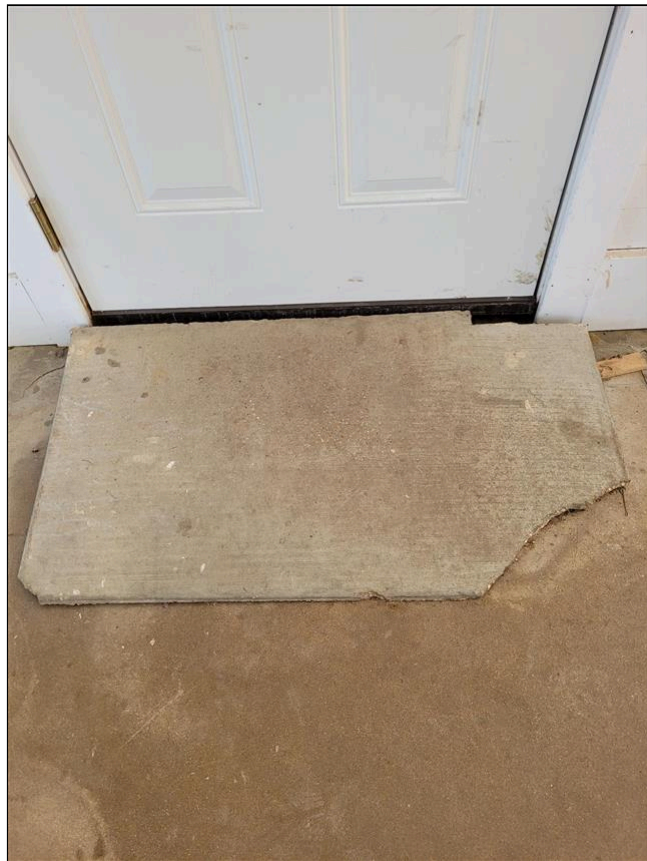
3.2 Item 9(Picture) Front door ramp-loose

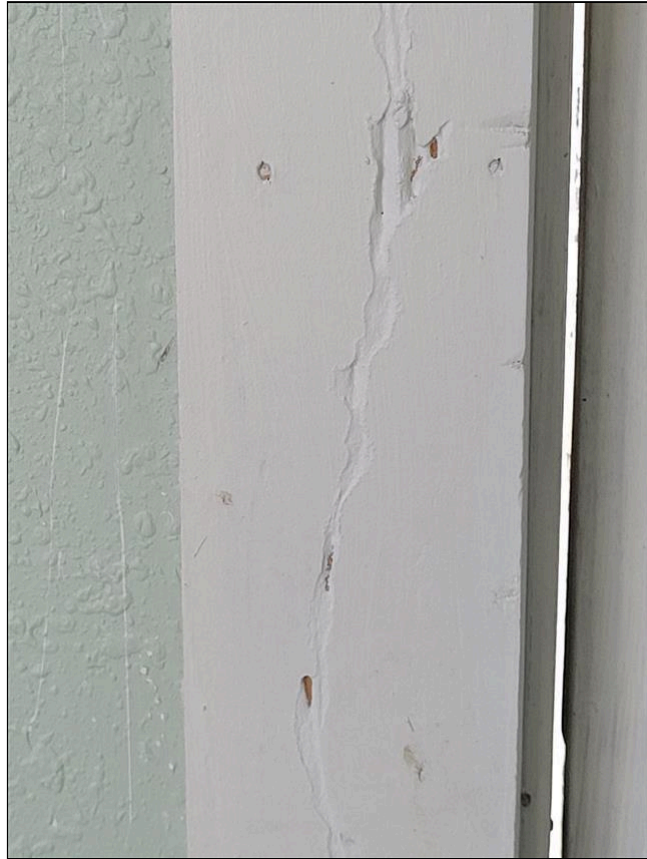
3.4 *There is some damaged window trim.*

3.4 Item 2(Picture) East school room trim-possible would destroying insect damage

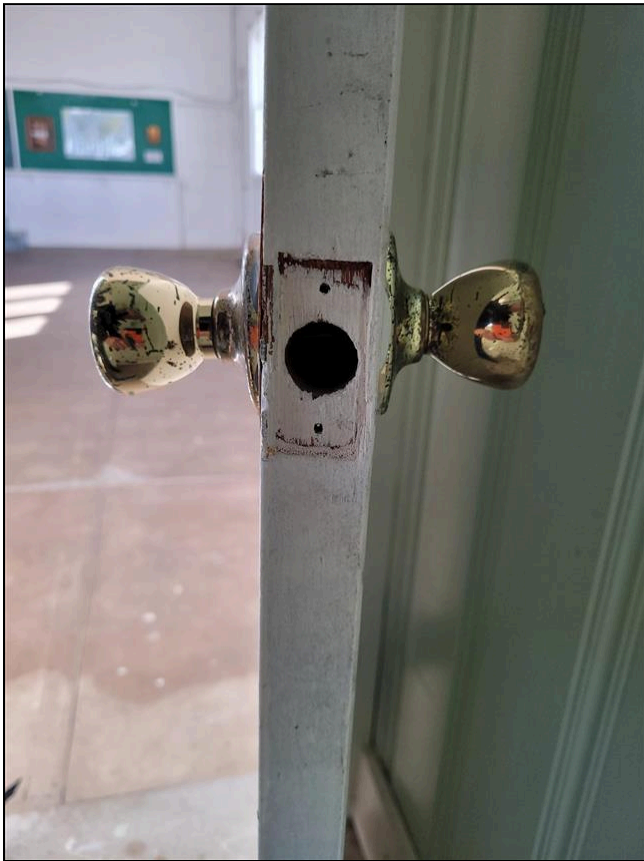
3.5 (1) *The bathroom doors were damaged and are missing the latches.*

3.5 Item 1(Picture) Men's bathroom door-missing latch

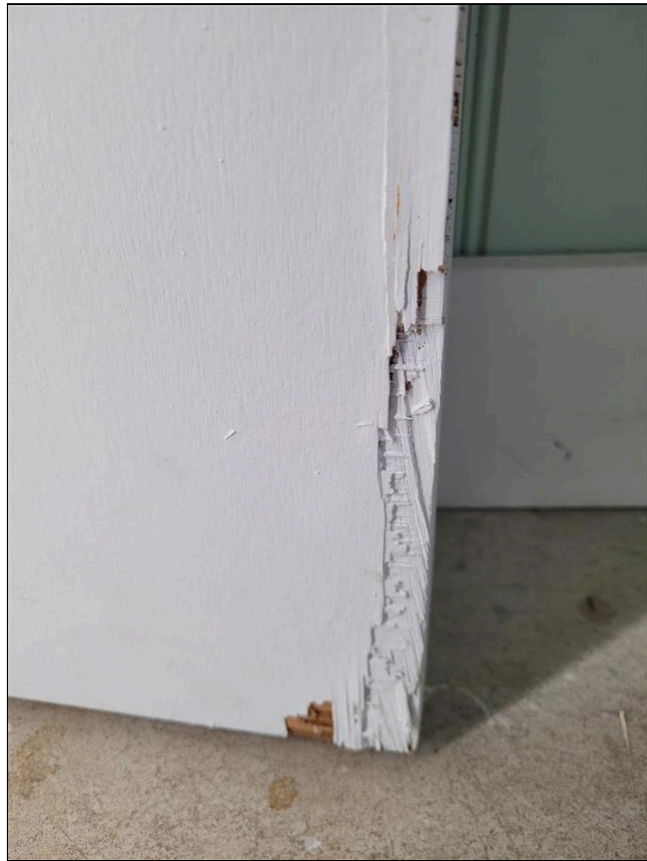
3.5 Item 2(Picture) Men's bathroom door-damaged

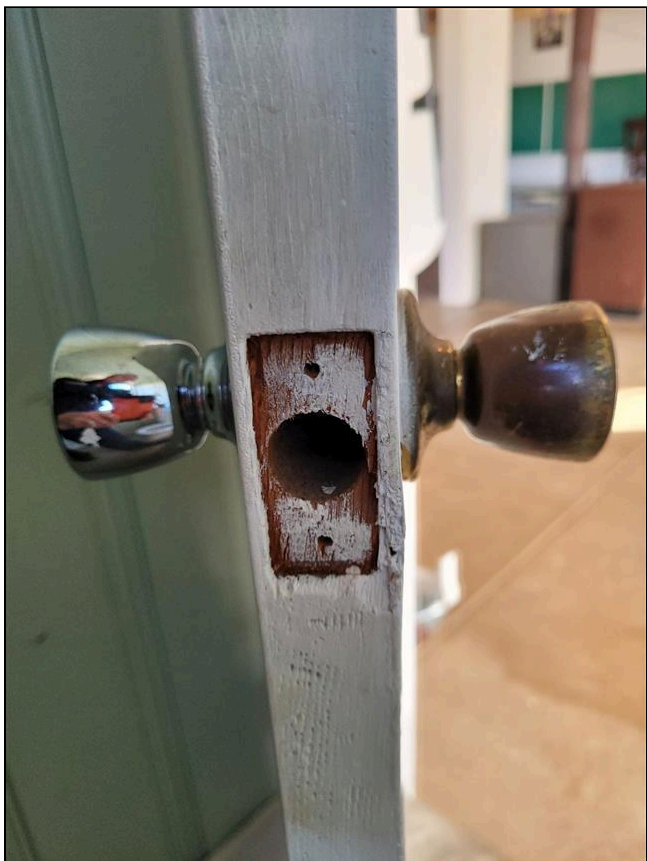
3.5 Item 3(Picture) Women's bathroom door-missing latch

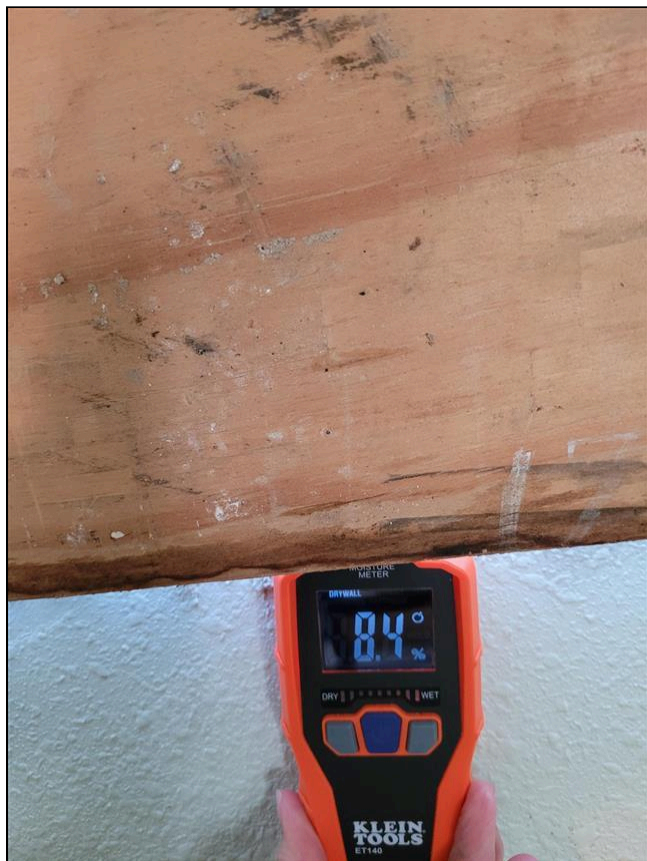
There were low moisture levels around the North window at the time of the inspection.

3.6 Item 3(Picture) East school room window area-low moisture reading

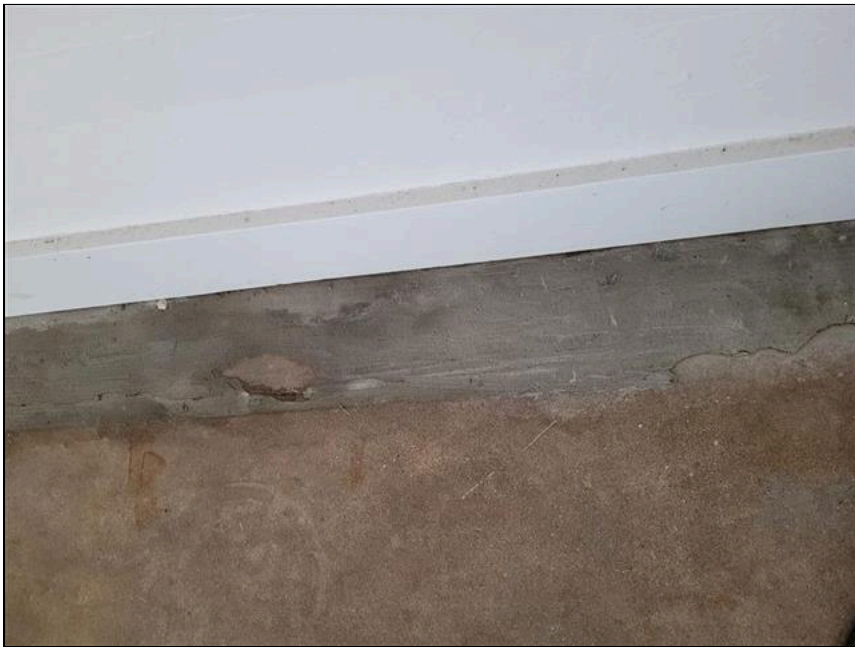
(2) The concrete appears to have areas that were not poured at the same time as the rest of the slab. Settling could occur in these areas.

4.0 Item 5(Picture) Exterior wall-slab area not continuous

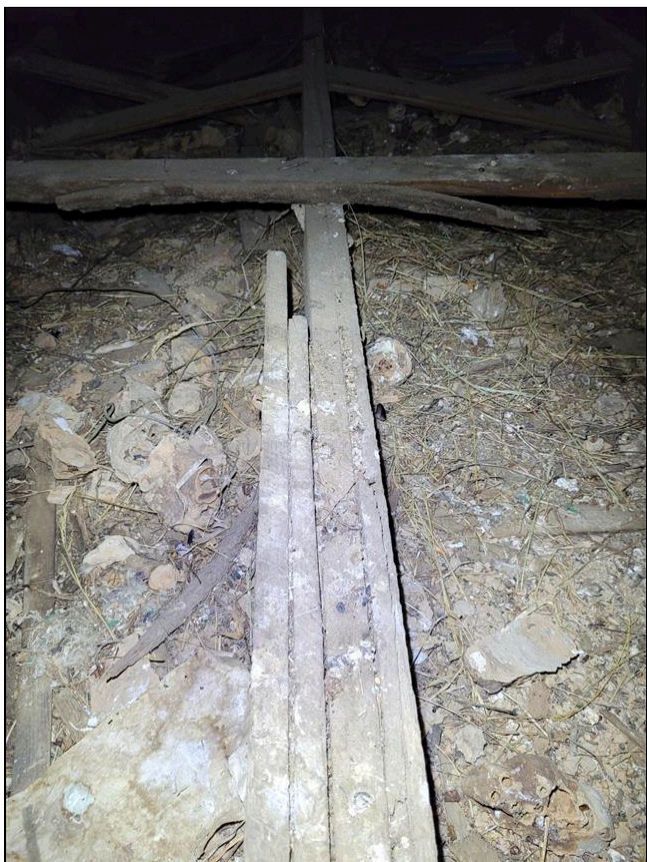
The spans on the framing components appear to be long without supporting walls.

4.3 Item 1(Picture) 1"x6" ceiling joists

I recommend a qualified professional investigate all areas further and advise on all repairs that are needed.

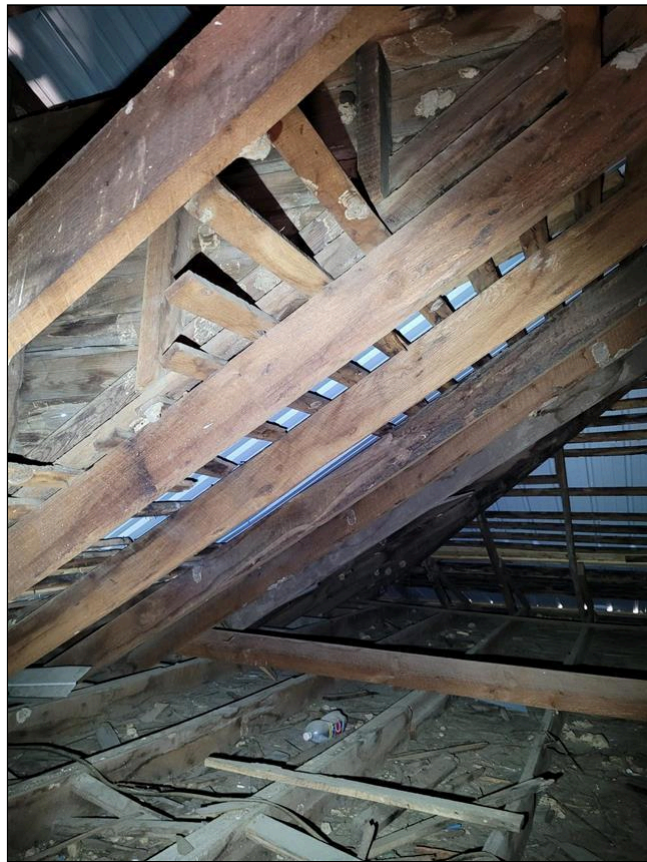
4.4 (1) *There are many areas of roof framing that are not to current standards. Many areas appear to need beams and supports added to prevent possible failure in the future.*

4.4 Item 6(Picture) Missing roof supports

Many areas have missing roof purlins. I recommend a qualified professional investigate all areas further and advise on all repairs that are needed.

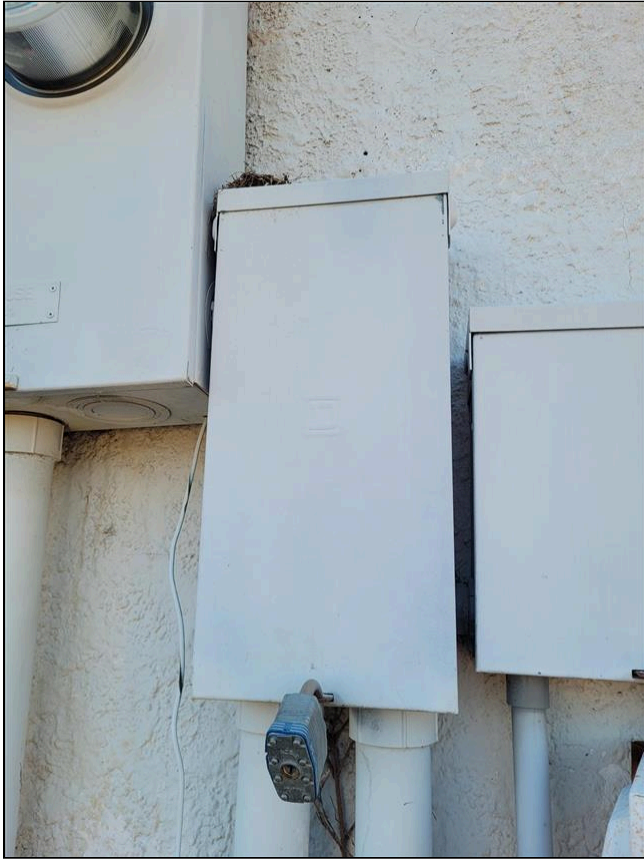
6.1 Item 1(Picture) Locked-not inspected

6.1 (1) *I recommend a licensed electrician evaluate the entire electrical system and advise on all repairs that are needed.*

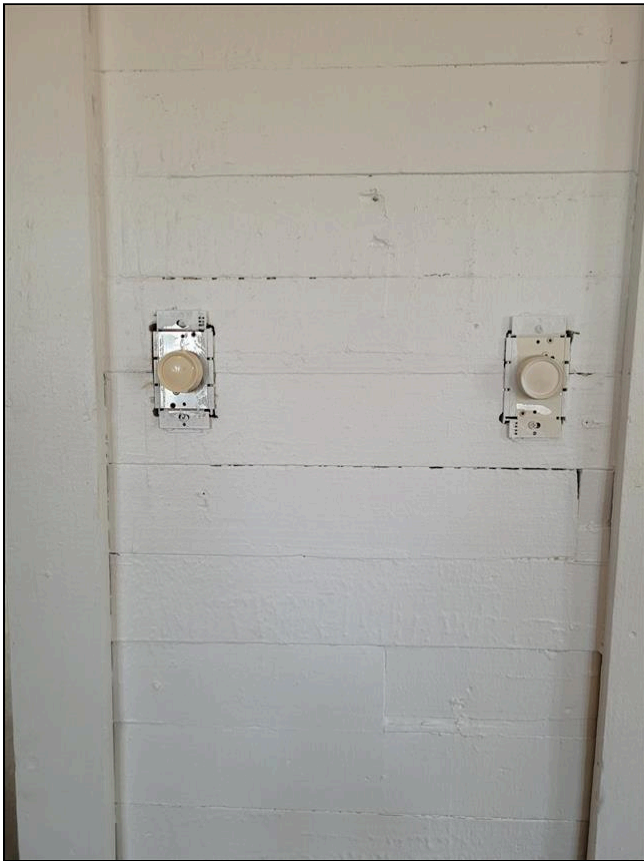
The lights in the main area did not work at the time of the inspection.

The main area had exposed wiring. Conduit is recommended to prevent accidental damage to wires.

6.2 Item 1(Picture) Dimmer switches-overheating/no switch covers

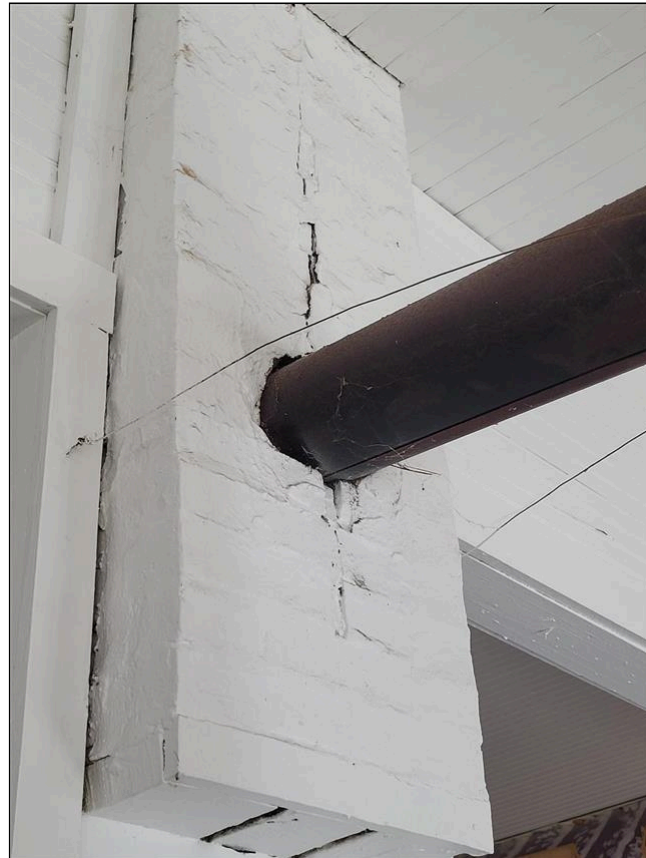
7.3 Item 2(Picture) Possible settling of bricks

7.3 (1) The chimney liner was not inspected by our company. I recommend a qualified chimney sweep inspect for safety.

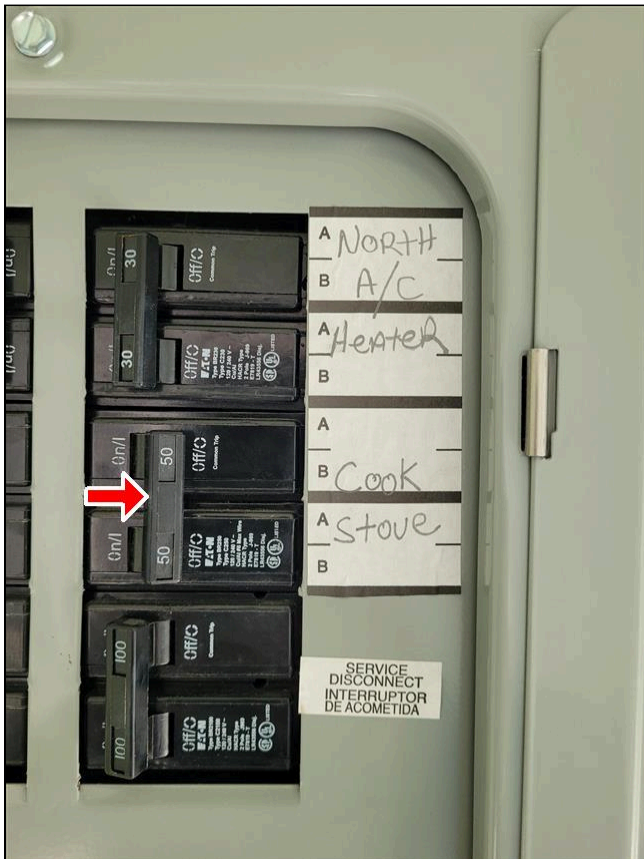
9.0 Breaker turned off-outlet not tested

9.0 Item 1(Picture) Breaker turned off-not tested
