Inspection Report

Property Address:
74 County Road 624
Oak Grove Arkansas 72638

Abba Home Inspections, LLC

Date: 1/17/2023	Time: 08:58 AM	Report ID: F-Fairweather8425
Property: 74 County Road 624 Oak Grove Arkansas 72638	Customer: Rob Fairweather	Real Estate Professional:

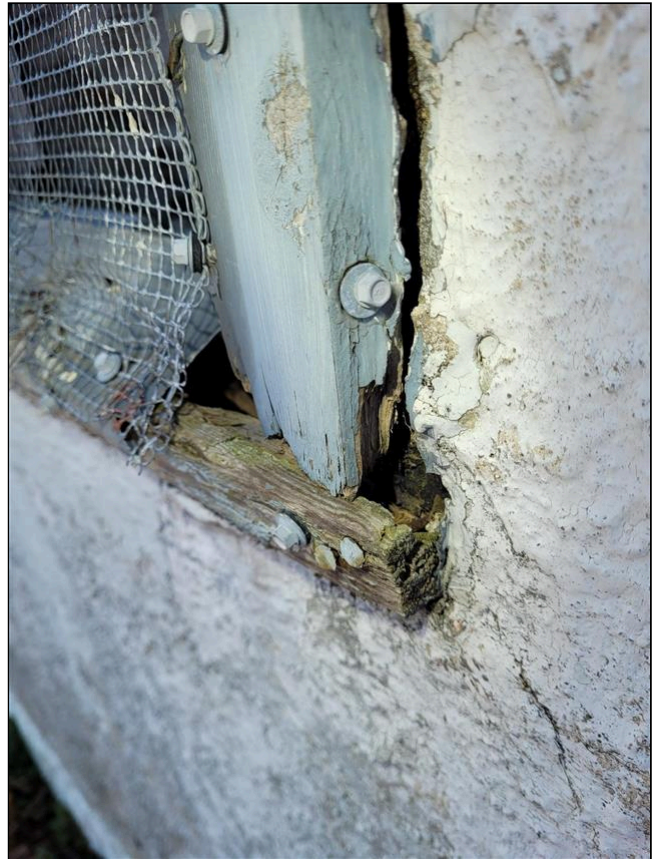
2.2 Item 4(Picture) Water intrusion likely

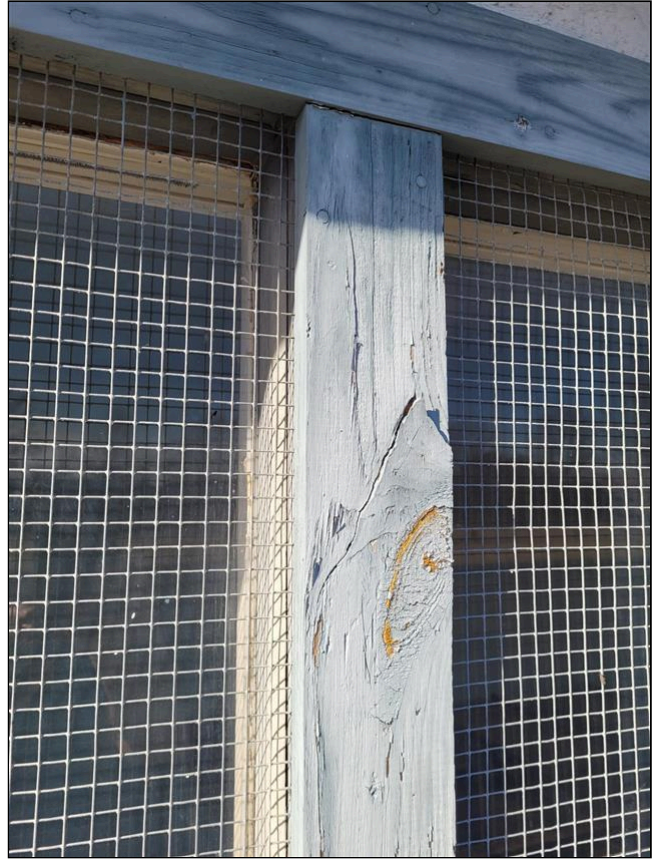
(3) **The windows and trim on the East side are aged and should be replaced.**

2.2 Item 6(Picture) Aged window trim

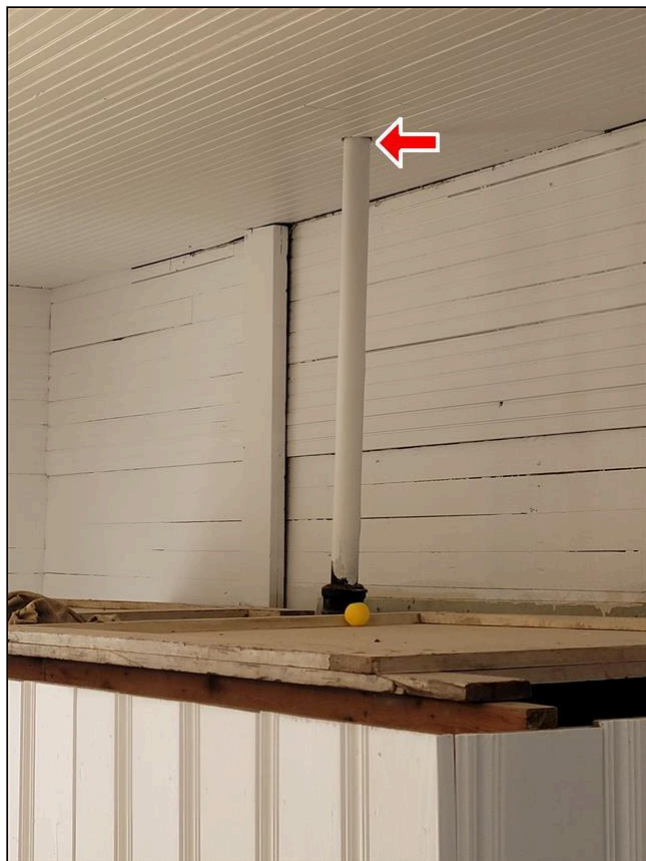
The DWV pipe above the bathrooms does not exit through the roof. DWV pipes should vent to the exterior.

5.0 Item 1(Picture) DWV pipe-not exiting roof area

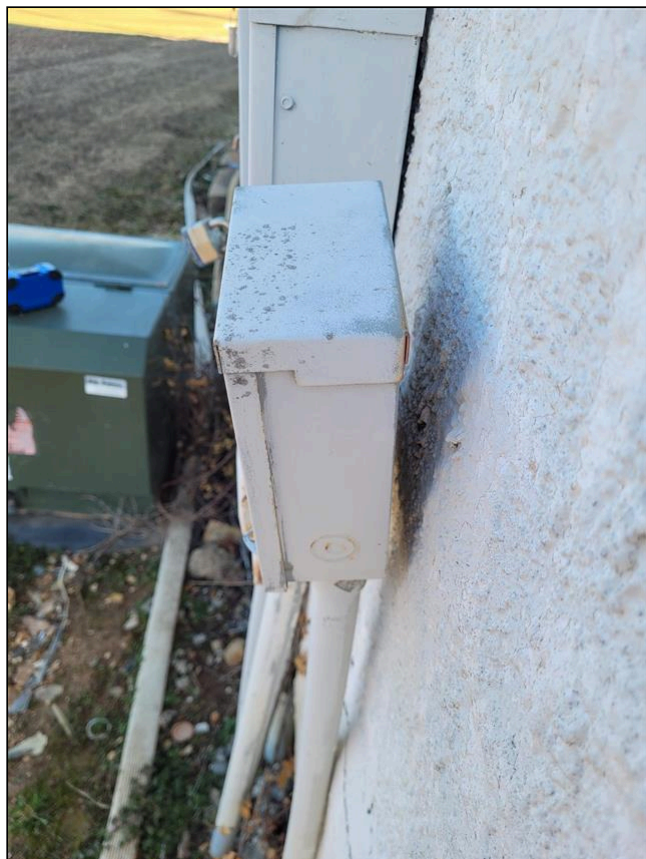
6.1 Item 8(Picture) Anchor disconnect panel

(6) Anchor the service disconnect panel to the exterior wall.

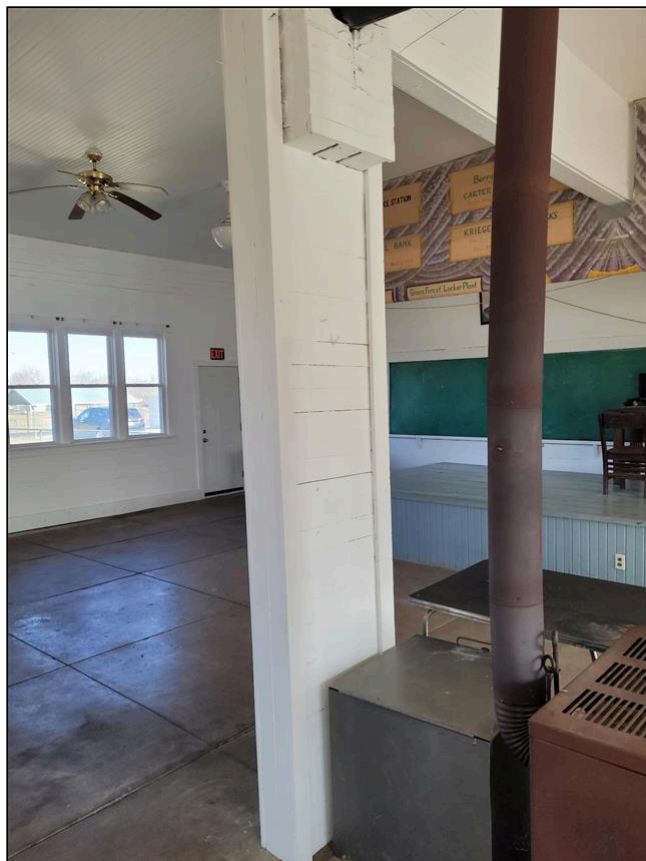
(2) *The bricks under the chimney appear to have been removed. This could result in collapse of the brick chimney.*

7.3 Item 1(Picture) Removed brick chimney

(1) *The chimney liner was not inspected by our company. I recommend a qualified chimney sweep inspect for safety.*
