Inspection Report

Property Address:
74 County Road 624
Oak Grove Arkansas 72638

Abba Home Inspections, LLC

Date: 1/17/2023	Time: 08:58 AM	Report ID: F-Fairweather8425
Property: 74 County Road 624 Oak Grove Arkansas 72638	Customer: Rob Fairweather	Real Estate Professional:

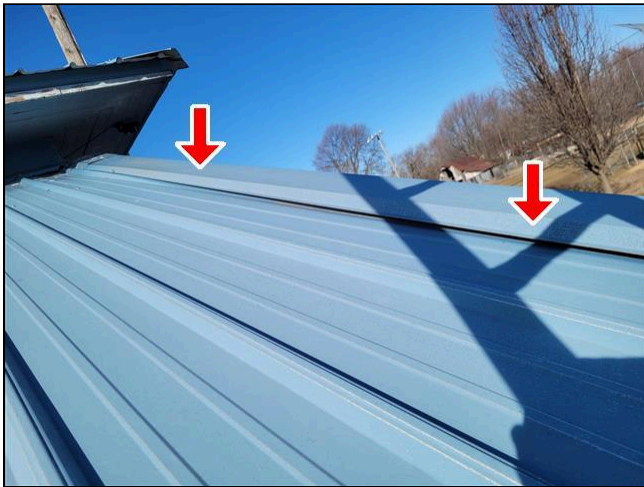
1.0 Item 4(Picture) Missing screws

Install and secure all loose/missing screws, where needed.

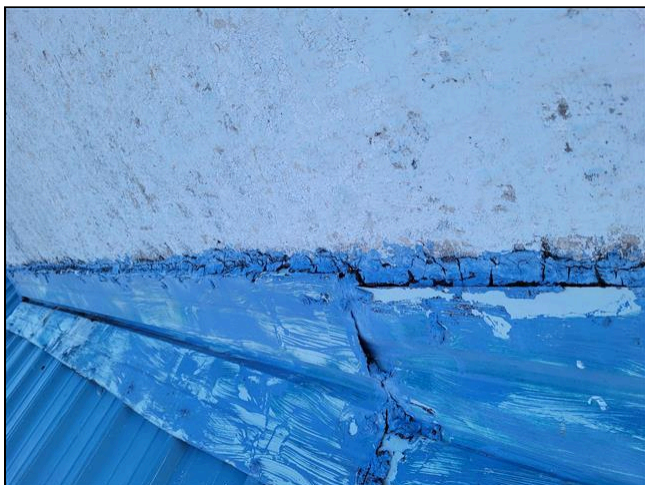
1.1 Item 7(Picture) Cracked sealant

1.1 All areas should be flashed/sealed properly to prevent water intrusion and framing damage.

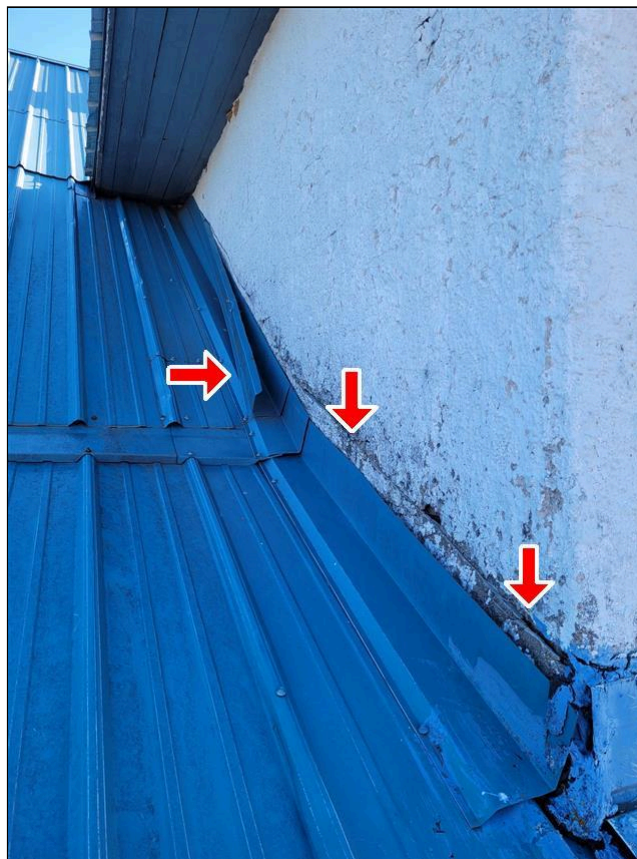
1.1 Item 8(Picture) Loose/missing flashing

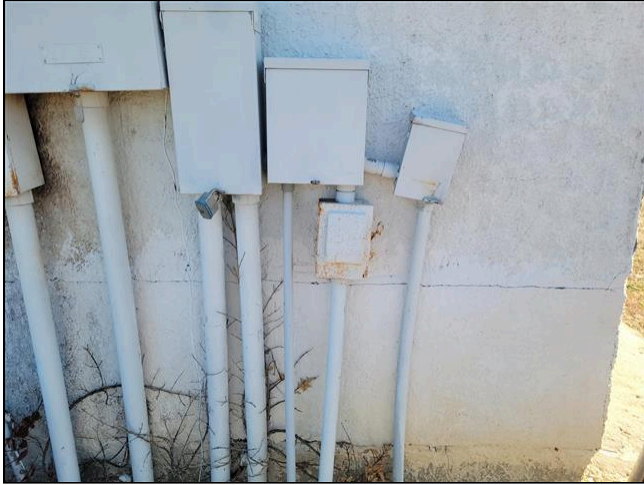
2.0 (1) There are numerous areas on the exterior with cracks. Some areas appear to be bulging.

Water could enter and cause framing damage.

2.0 Item 1(Picture) Cracked exterior

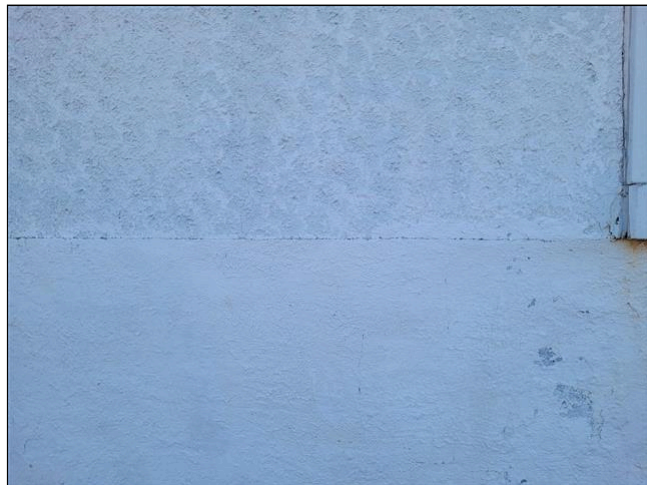
2.0 Item 4(Picture) Cracked exterior

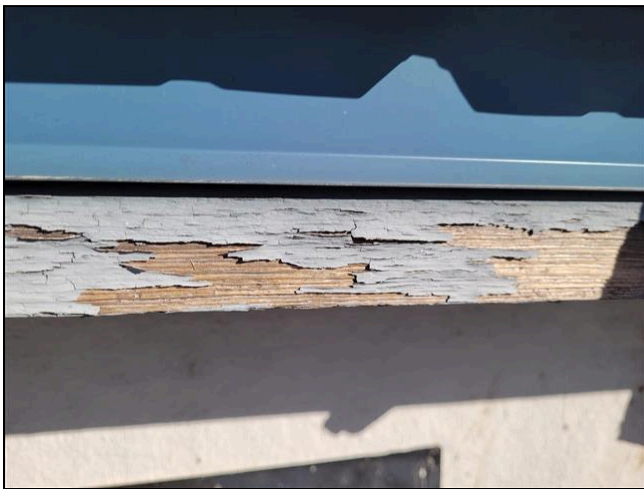
2.0 Item 7(Picture) Scrape/paint-as needed

(2) **All components should be scraped and painted, as needed, to prevent deterioration in the future.**

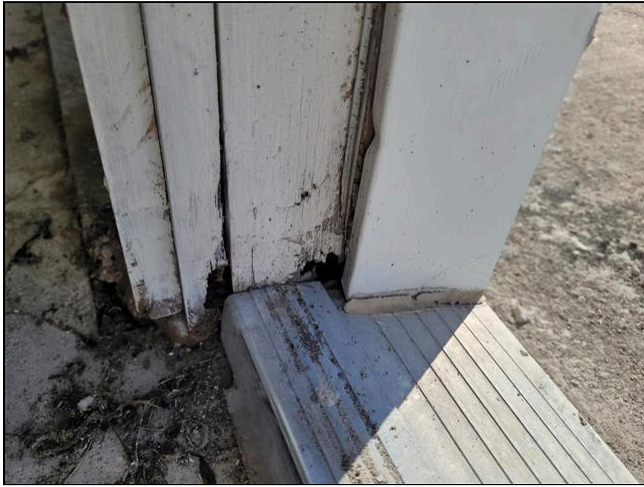
2.1 (1) *There are door and jambs with damage.*

2.1 Item 1(Picture) Rotten jamb-Southeast side

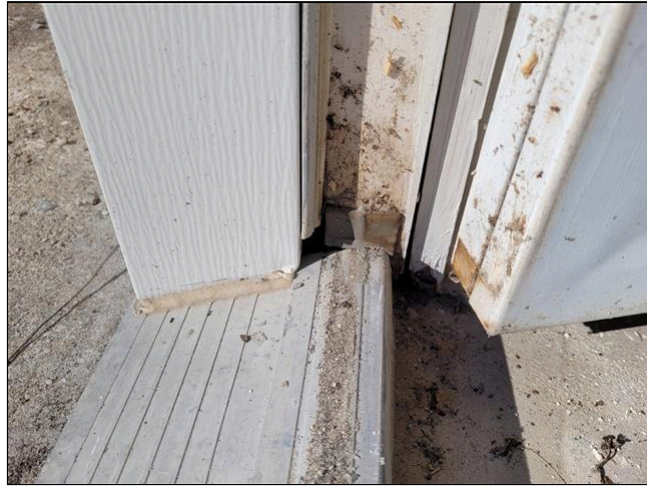
2.1 Item 2(Picture) Rotten jamb-Southeast side

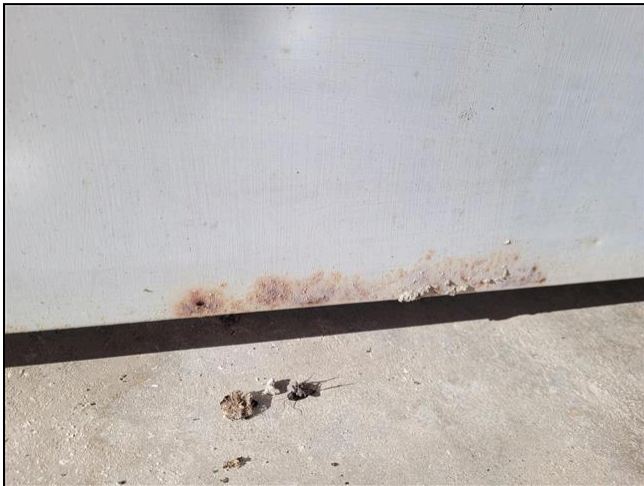
2.1 Item 3(Picture) Rust holes-Southeast side

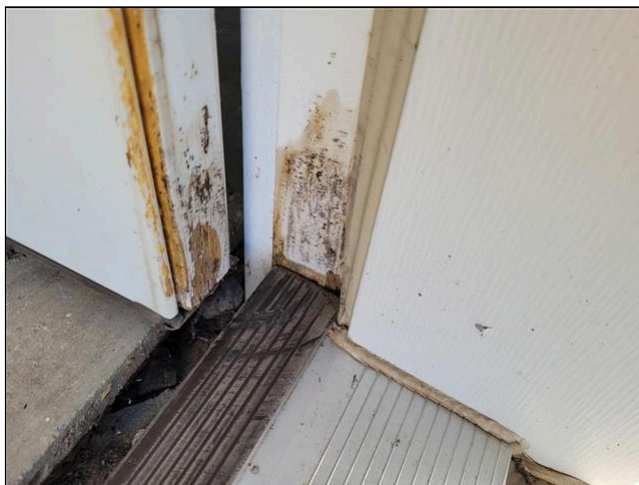
2.1 Item 6(Picture) Water intrusion-South door

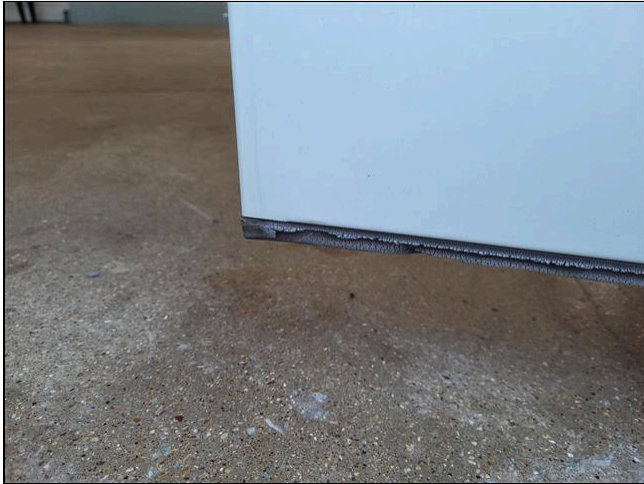
2.1 Item 7(Picture) Replace all damaged threshold seals

(2) Replace all damaged threshold seals and weather stripping to prevent any water intrusion into the home and possible damage.

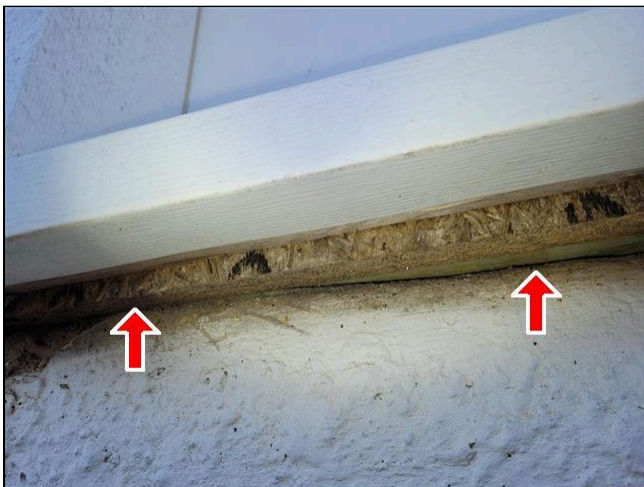
2.1 Item 9(Picture) No visible flashing

(3) All doors should be properly flashed to prevent water intrusion and framing damage.

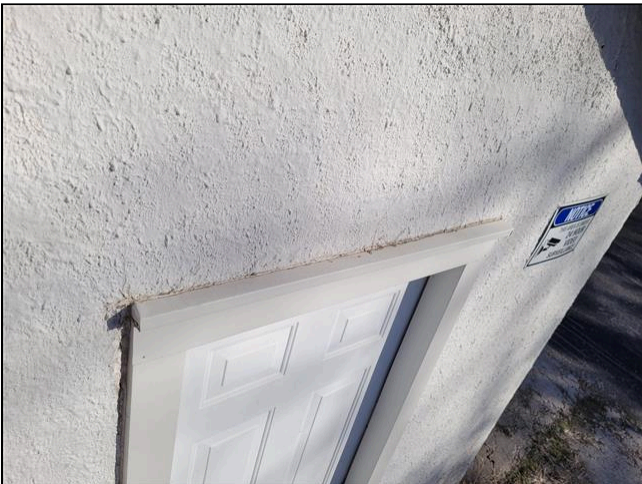
(5) *There is no Z flashing installed above the exterior doors to prevent water intrusion.*

2.1 Item 11(Picture) No Z flashing-doors

This was not required when this building was constructed. Consider installing in the future.

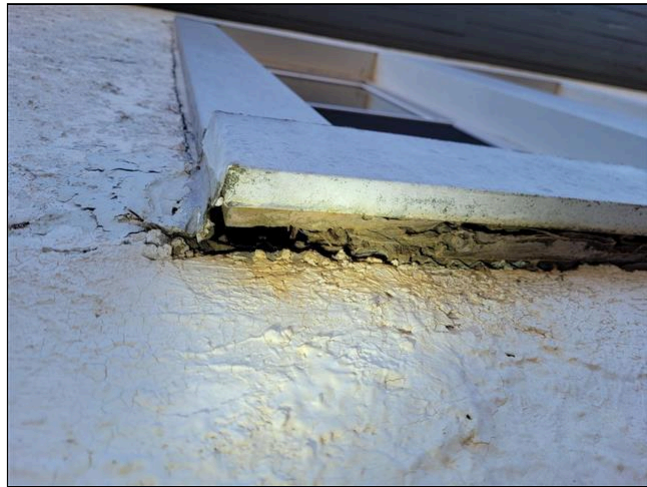
2.2 Item 2(Picture) Rotten window framing

2.2 (1) ***I recommend sealing around all windows to help prevent possible water intrusion and framing damage.***

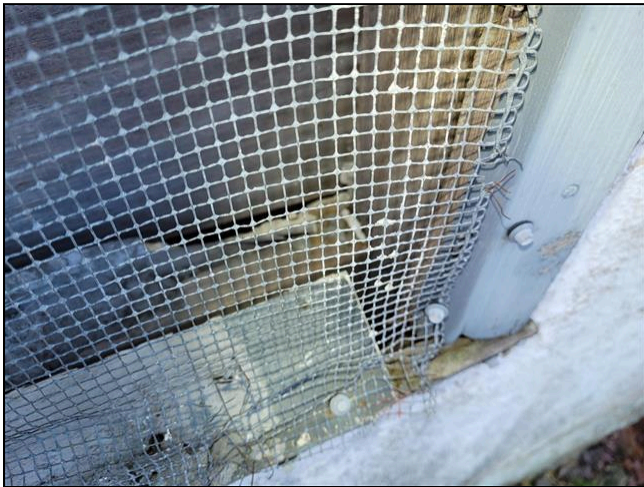
(2) ***The window pane on the North side is missing. Water intrusion into the wall is likely.***

2.2 Item 3(Picture) Missing pane-North side

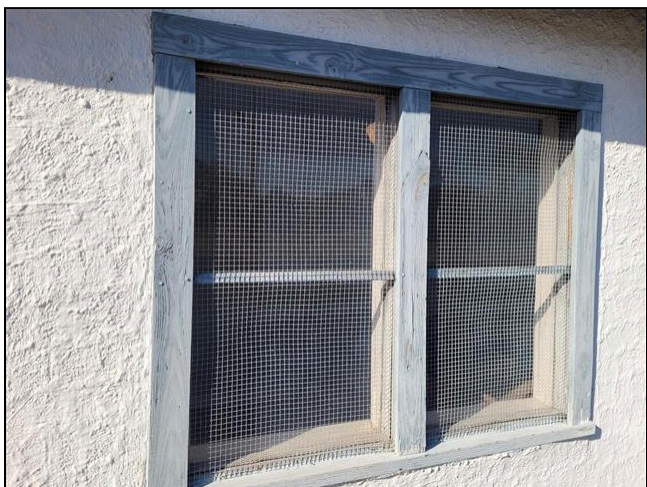
(3) **The windows and trim on the East side are aged and should be replaced.**

2.2 Item 5(Picture) Aged windows and trim

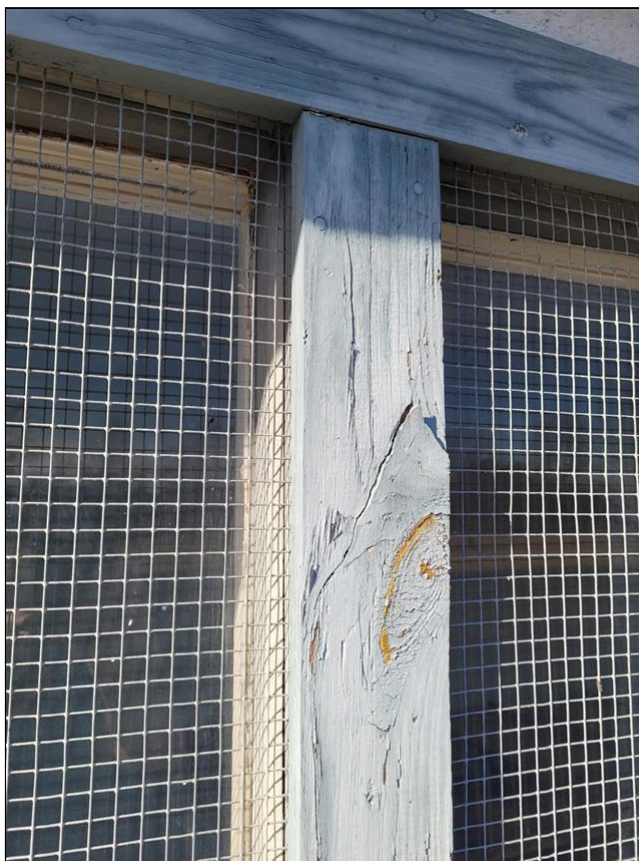
2.2 Item 6(Picture) Aged window trim

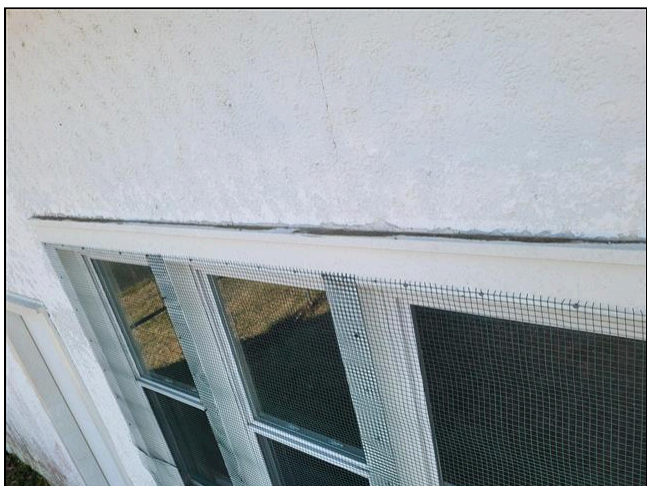
(4) **There is no Z flashing installed above the windows to prevent water intrusion.**

2.2 Item 7(Picture) No Z flashing-windows

This was not required when this building was constructed. Consider installing in the future.

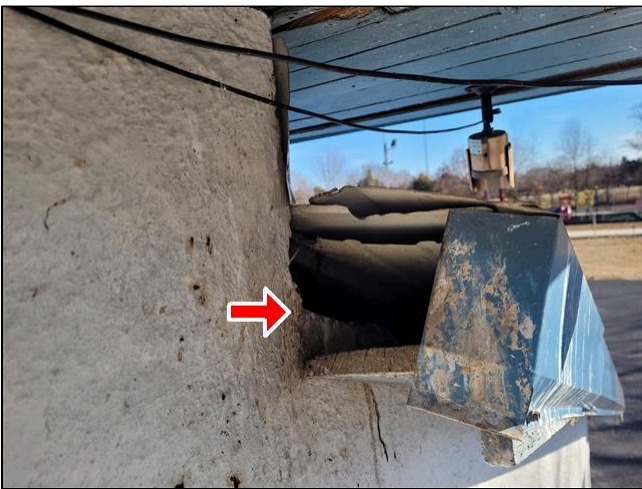
2.4 There are areas that are aged/damaged and need replaced.

2.4 Item 1(Picture) Open soffit area

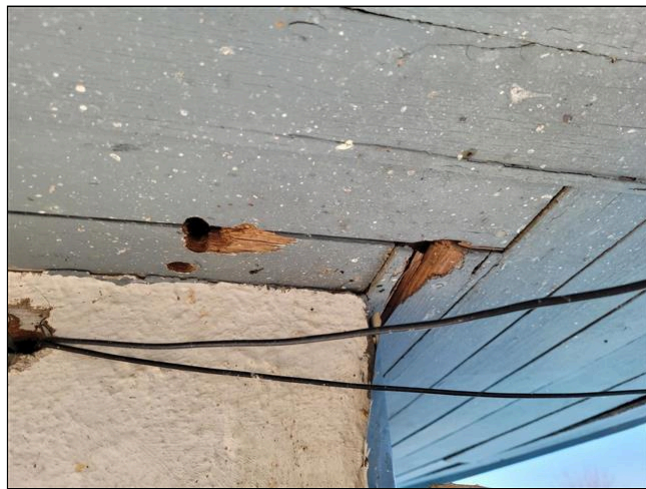
2.4 Item 2(Picture) Aged soffit material

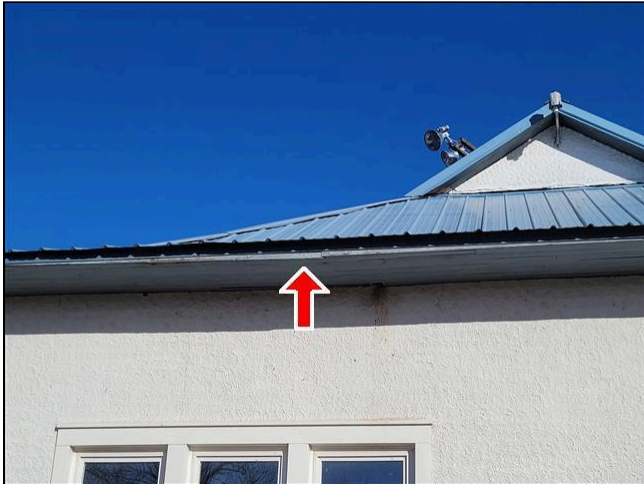
2.4 Item 3(Picture) Dropping fascia

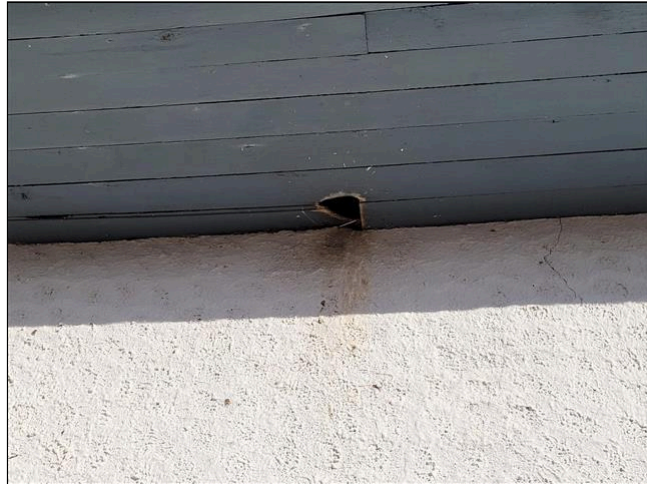
2.4 Item 4(Picture) Hole-soffit

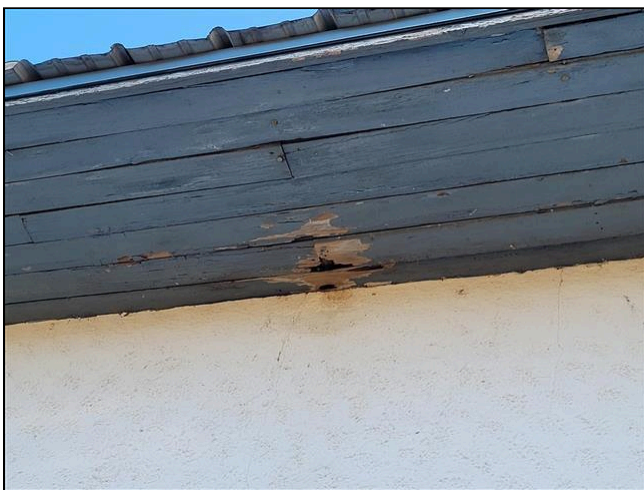
2.4 Item 5(Picture) Damaged soffit material

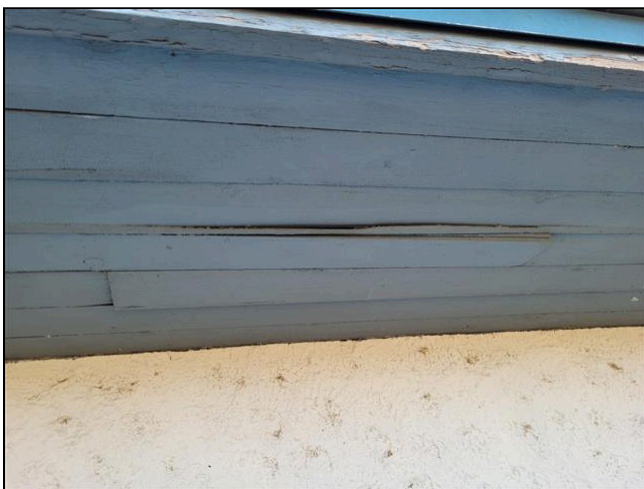
2.4 Item 7(Picture) Aged soffit material

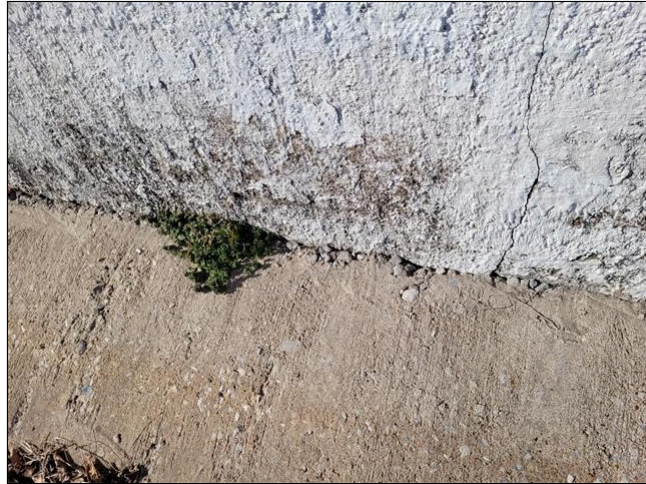
2.5 Item 2(Picture) Improper grading method

2.5 (1) All areas of grading on the exterior should cause the water to drain away from the foundation to prevent water intrusion.

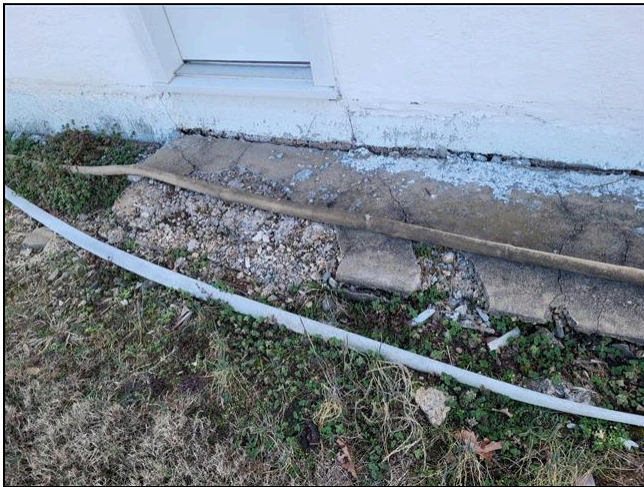
2.5 Item 4(Picture) Damaged concrete

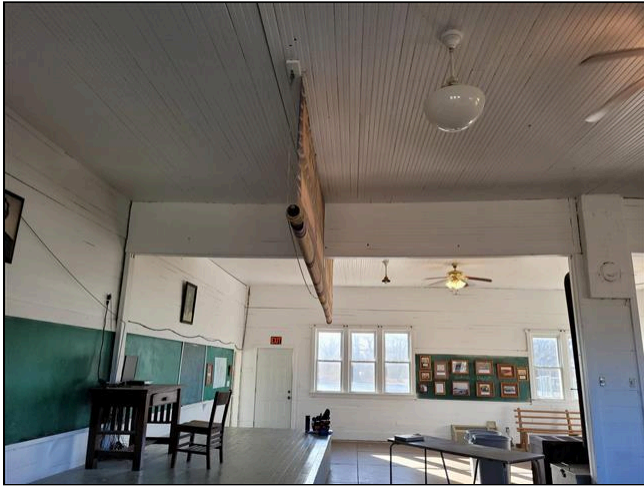
3.0 Item 3(Picture) Main beam-appears to be sagging

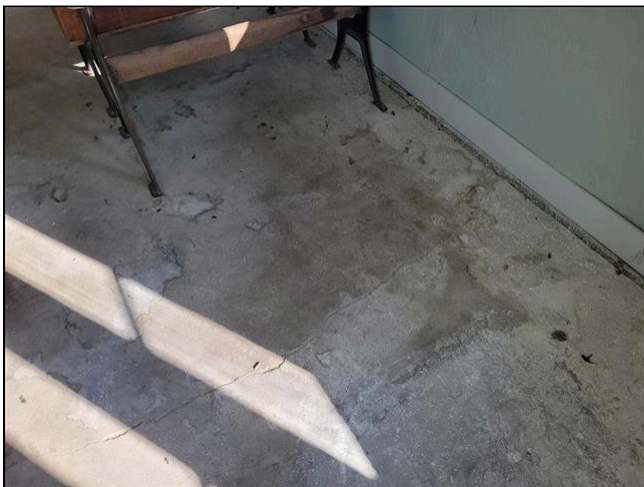
3.2 (1) There appears to be evidence of water stains on the floor of the East school room. I am unable to determine the amount of water that could enter or the frequency that this could occur.

3.2 Item 1(Picture) Previous water staining

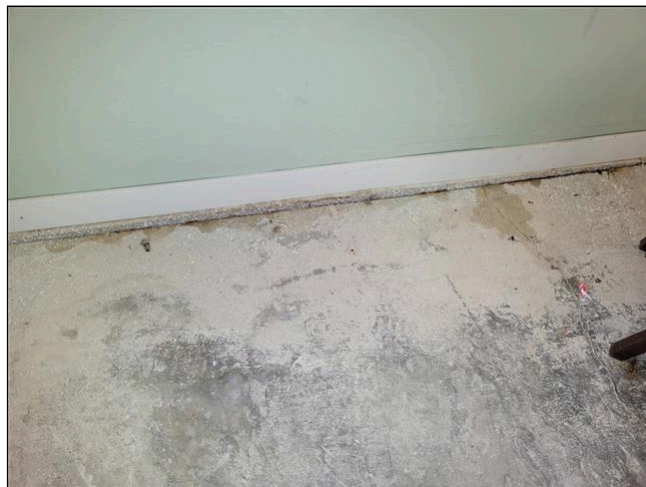
3.2 Item 2(Picture) Previous water staining

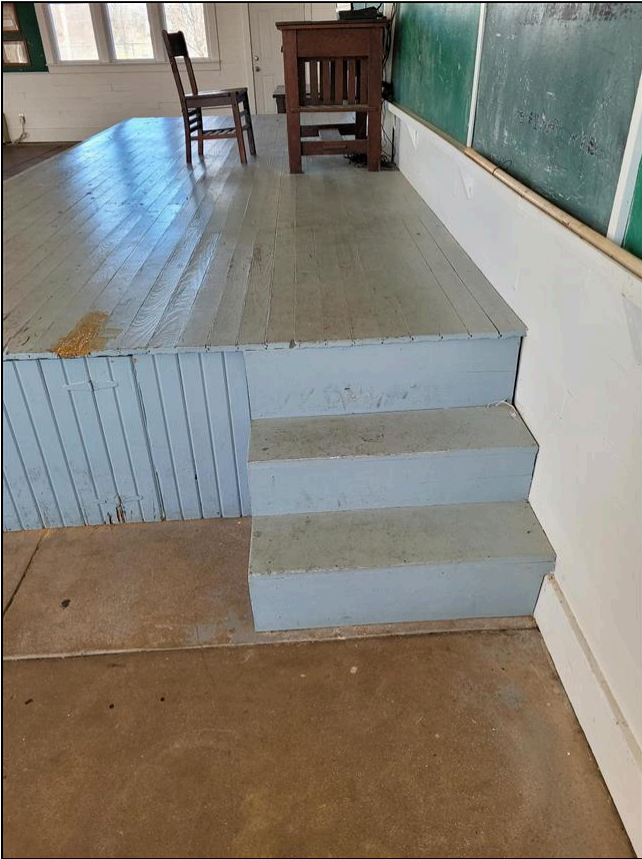
3.3 Item 1(Picture) Handrail-needed for the stage

3.3 *A hand rail system is needed for the stage area and for the steps entering the East school room.*

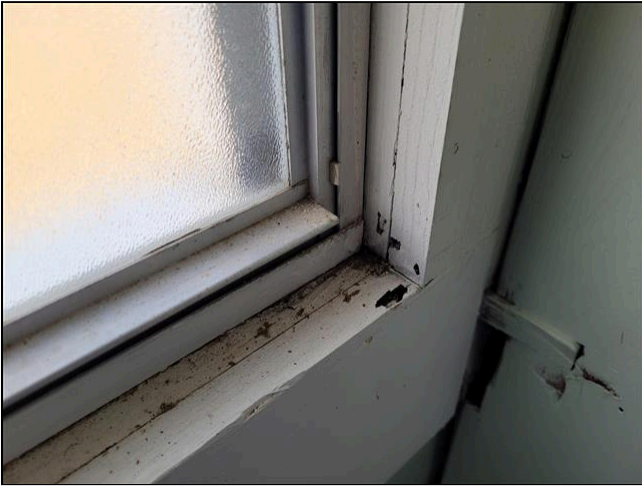
3.4 *There is some damaged window trim.*

3.4 Item 1(Picture) Damaged window trim-bathroom

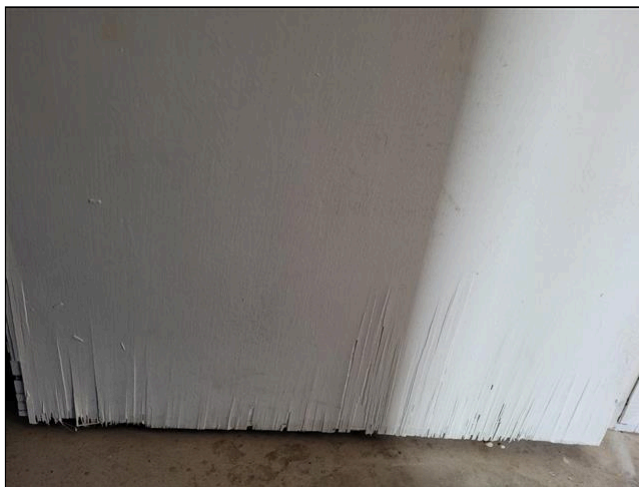
3.5 (1) *The bathroom doors were damaged and are missing the latches.*

3.5 Item 4(Picture) Women's bathroom door-damaged

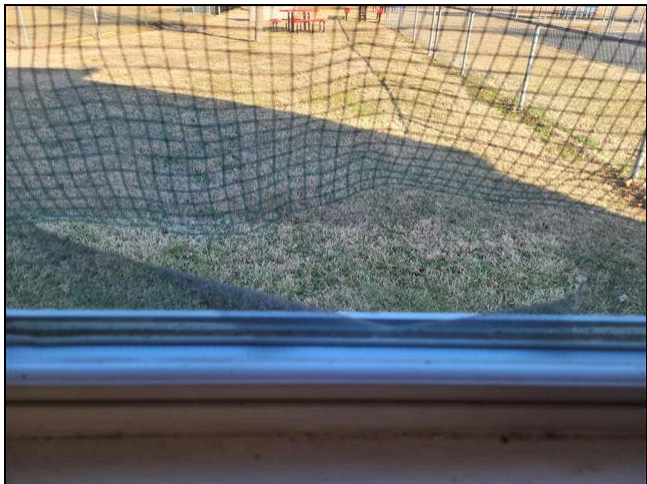
3.6 There are windows were double, single, and fixed hung with damage to several exterior screens.

3.6 Item 1(Picture) Window exterior screens-damaged

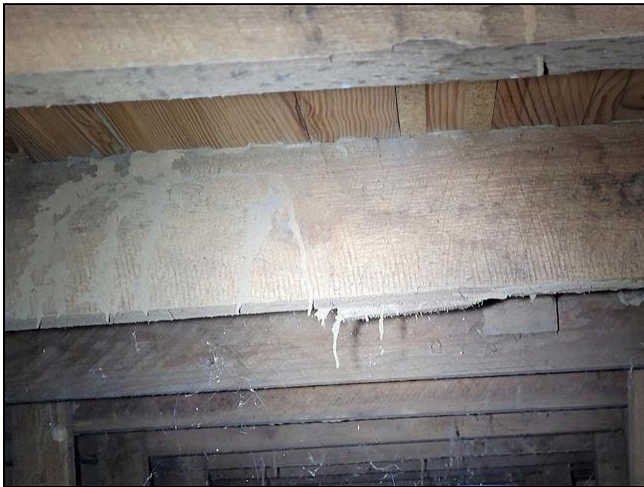
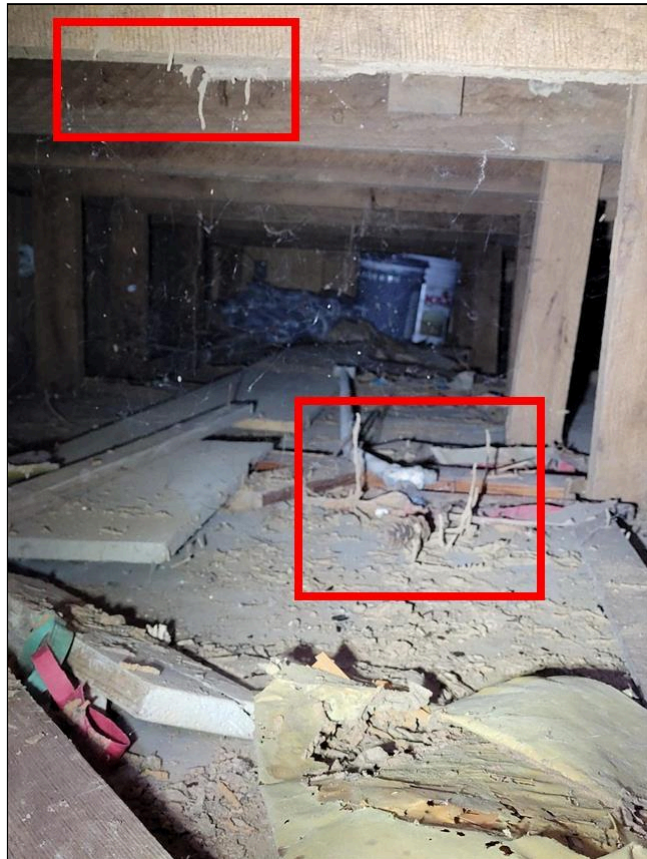
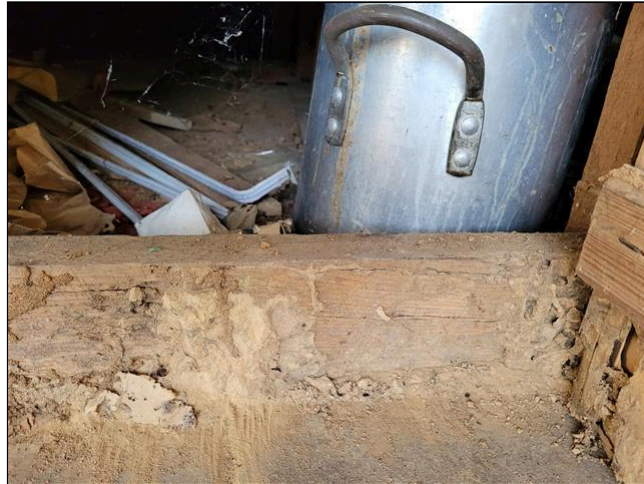
3.7 Item 1(Picture) Wood destroying insect activity

3.7 Item 2(Picture) Wood destroying insect activity

3.7 Item 3(Picture) Wood destroying insect activity

3.7 Item 4(Picture) Wood destroying insect activity

3.7 *There is evidence of wood destroying insect activity in the building. Further investigation is recommended.*

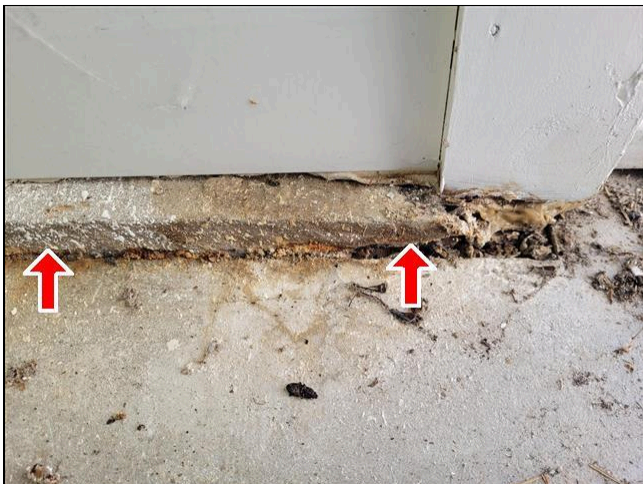
4.0 (1) There are walls that appear to be sitting on wooden components. Deterioration is present. Concrete footings may not be present.

4.0 Item 1(Picture) Wood-no visible concrete footing

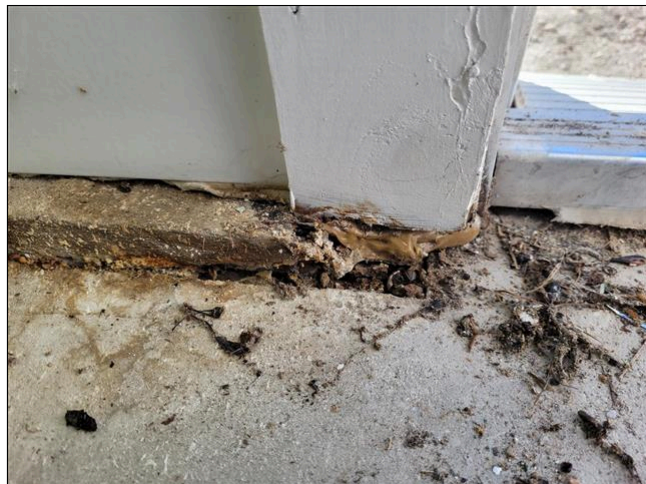
Previous evidence of wood destroying insect activity is present.

4.0 Item 2(Picture) Wood destroying insect activity

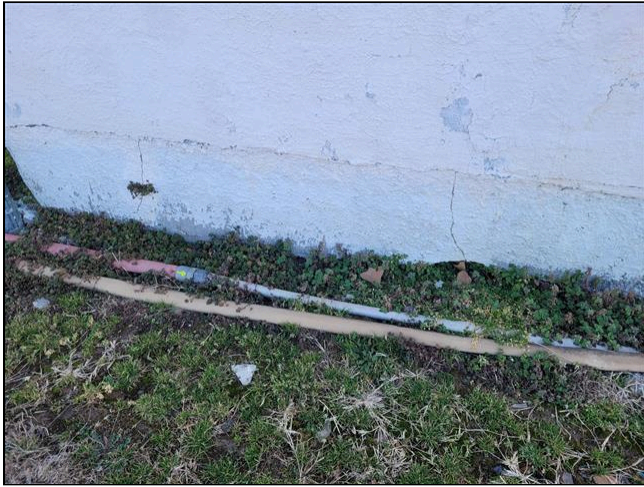
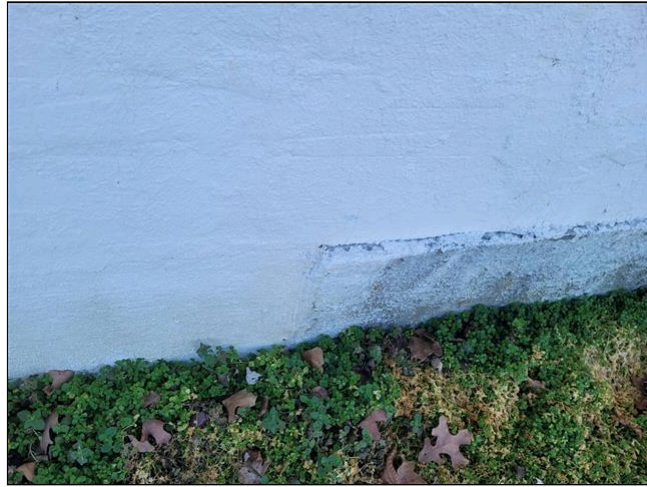
There are cracks on the foundation area on the exterior.

4.0 Item 3(Picture) Cracks

4.0 Item 4(Picture) Cracks

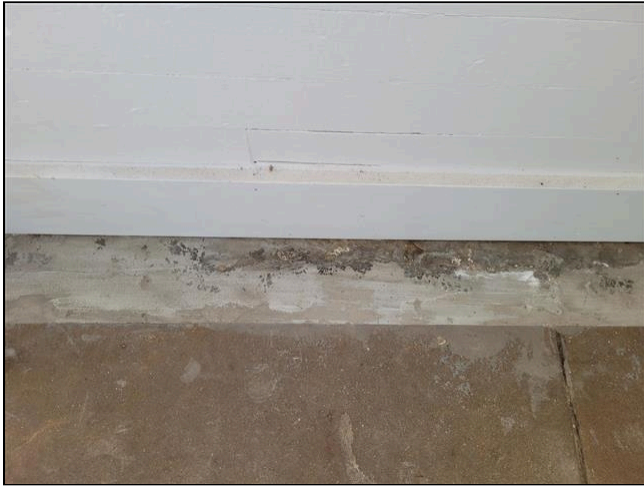
(2) The concrete appears to have areas that were not poured at the same time as the rest of the slab. Settling could occur in these areas.

4.0 Item 6(Picture) Exterior wall-slab area not continuous

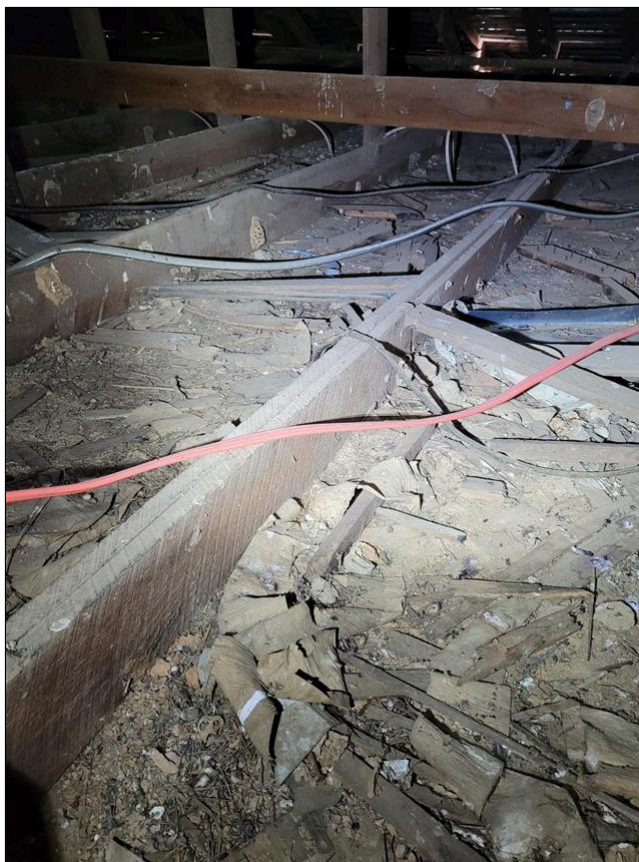
4.3 Item 2(Picture) 1"x6" ceiling joists

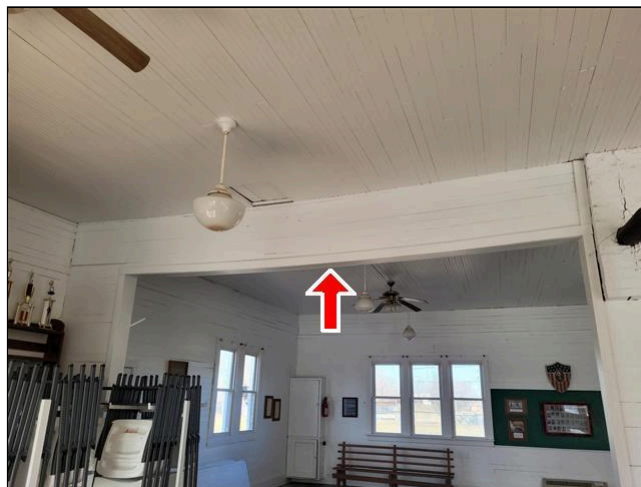
4.3 Item 3(Picture) Sagging

4.3 Item 4(Picture) Sagging

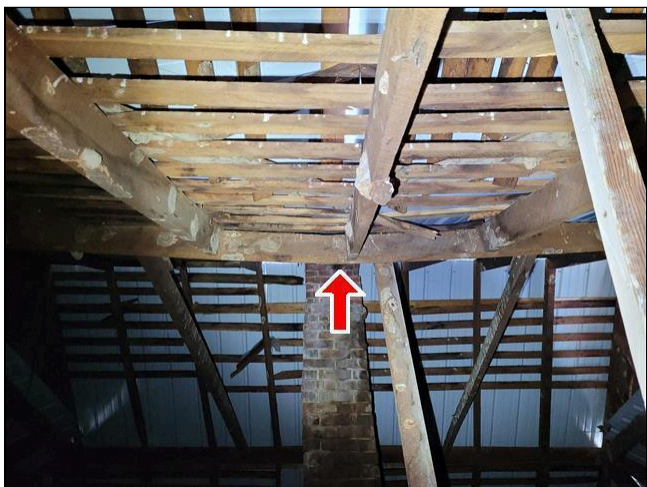
4.4 (1) *There are many areas of roof framing that are not to current standards. Many areas appear to need beams and supports added to prevent possible failure in the future.*

There are areas that are not supported correctly. This appears to be allowing settling to happen.

4.4 Item 1(Picture) Sagging framing area/incorrect anchoring method

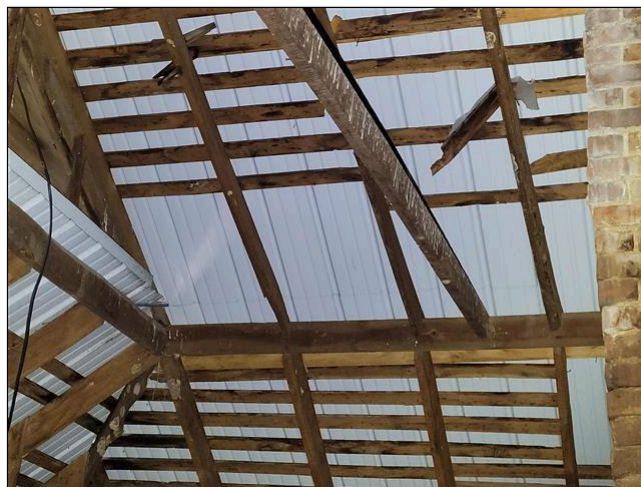
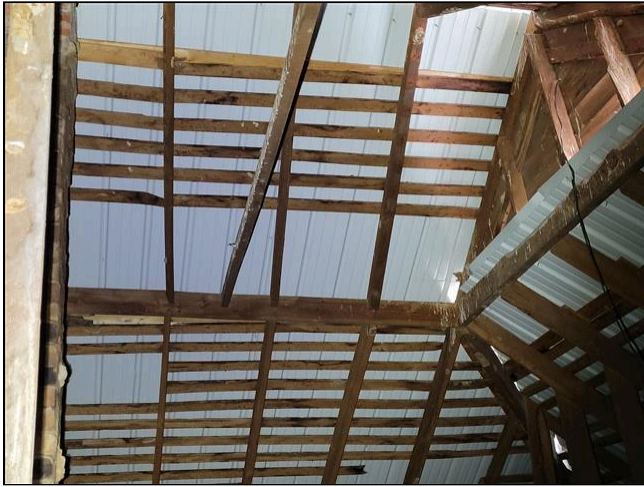
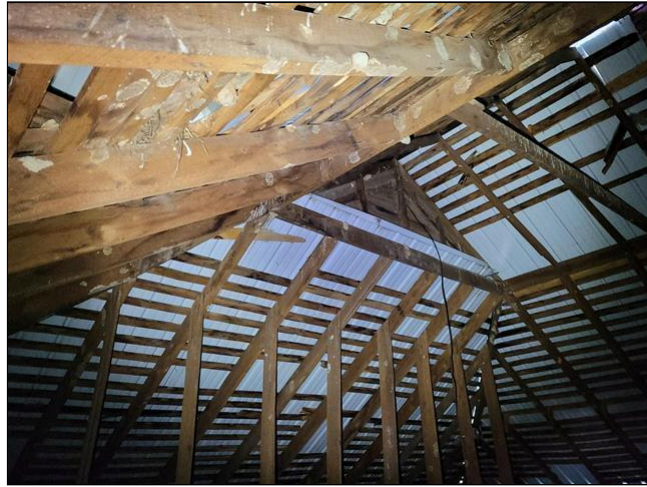
4.4 Item 2(Picture) Missing purlins

4.4 Item 3(Picture) Missing purlins

4.4 Item 4(Picture) Missing purlins

Many areas have missing roof purlins. I recommend a qualified professional investigate all areas further and advise on all repairs that are needed.

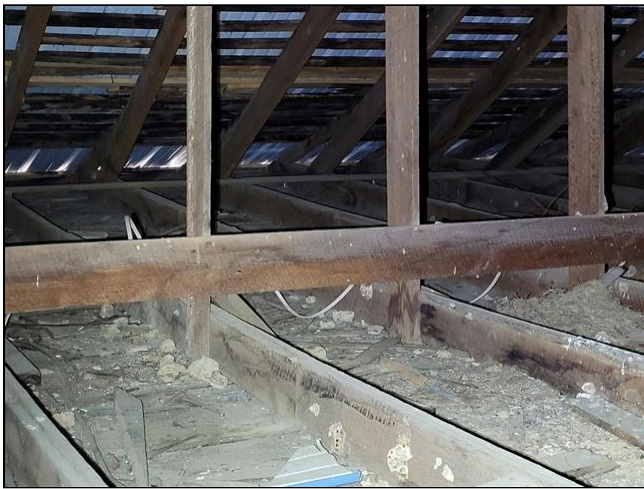
4.4 Item 5(Picture) Improper framing method

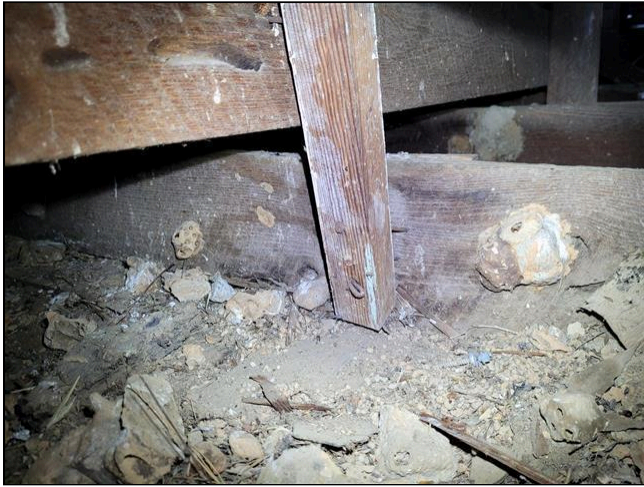
4.4 Item 7(Picture) Improper roof support anchoring method

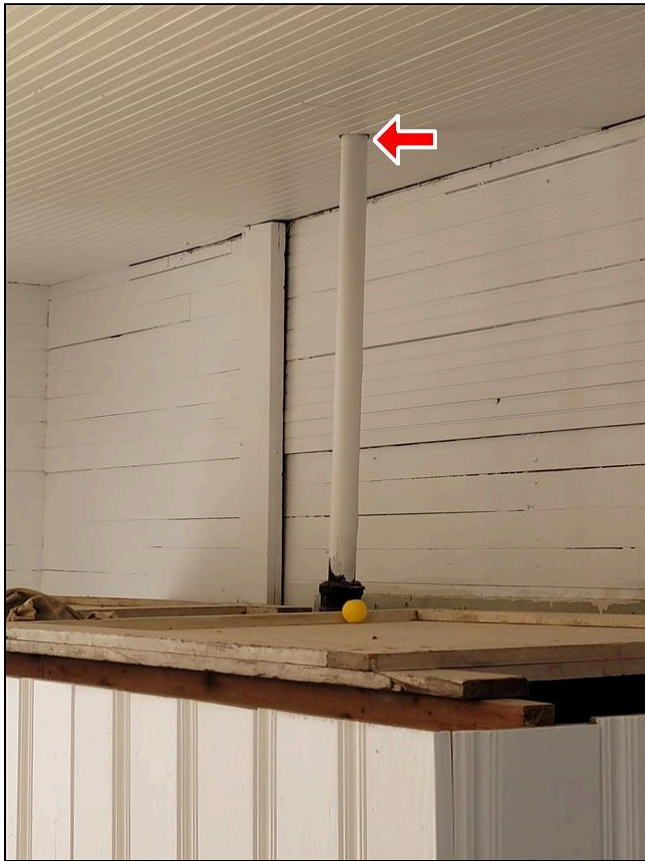
5.0 The DWV pipe above the bathrooms does not exit through the roof. DWV pipes should vent to the exterior.

5.0 Item 1(Picture) DWV pipe-not exiting roof area

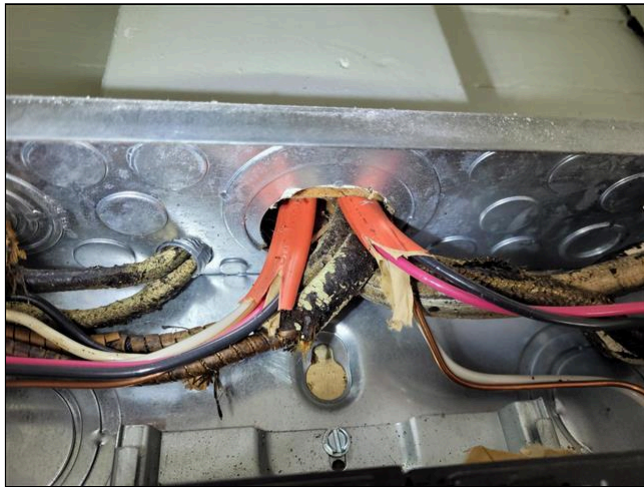
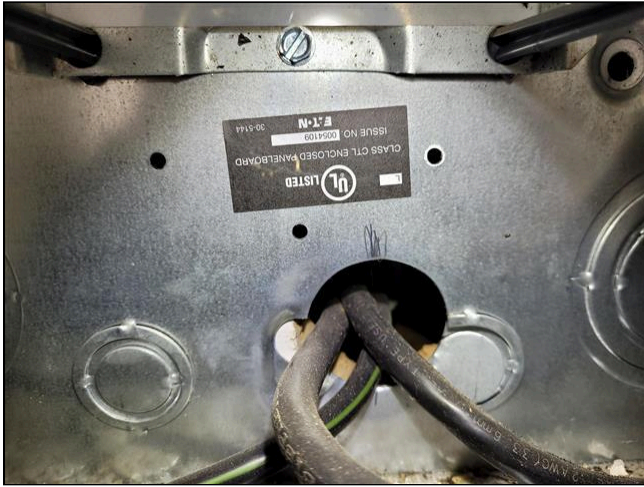
Bushings are needed in the main panel to prevent wire chafing and possibly energizing the panel.

6.1 Item 3(Picture) Bushing needed

6.1 Item 4(Picture) Bushing needed

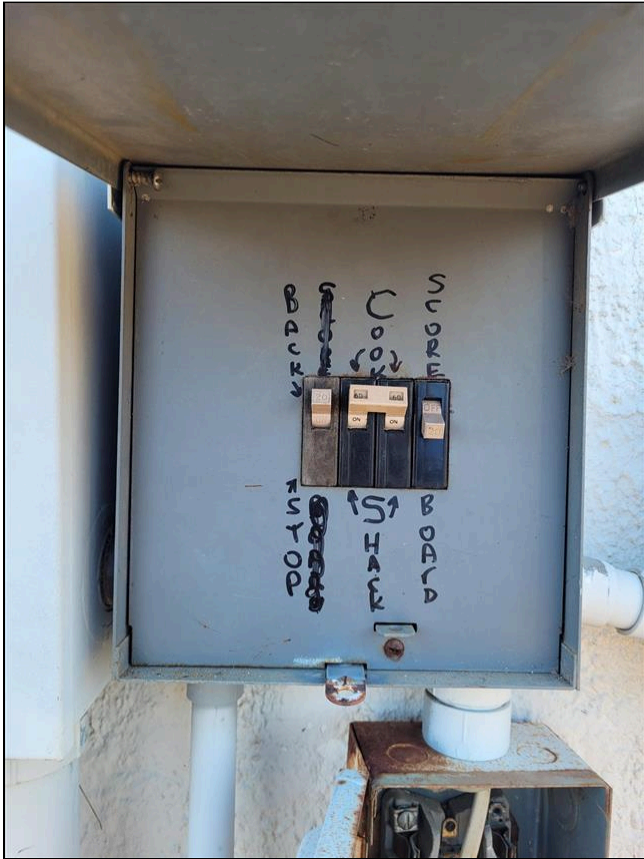
Breaker turned off, not inspected

6.1 Item 7(Picture) Score board breaker-turned off, not tested

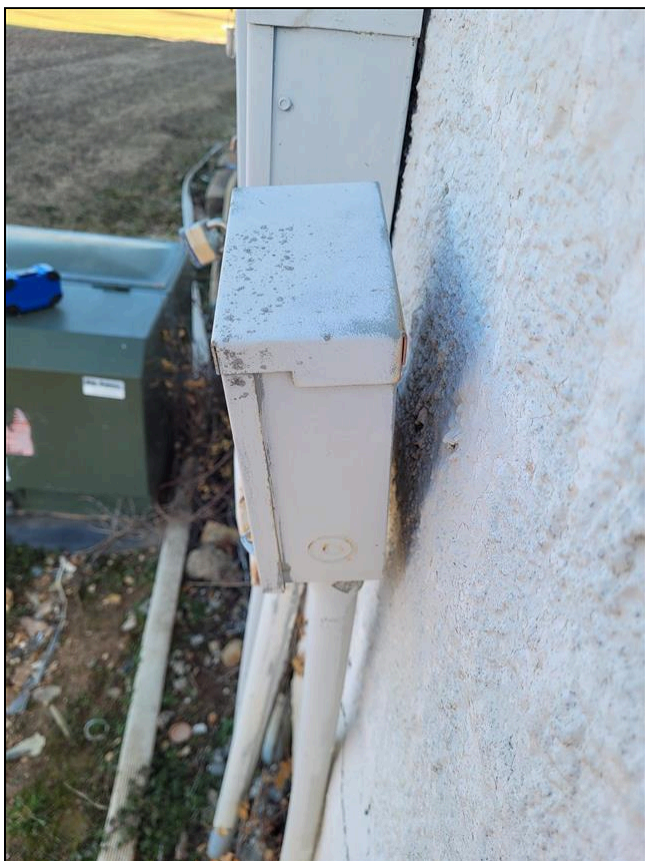
6.1 Item 8(Picture) Anchor disconnect panel

(6) *Anchor the service disconnect panel to the exterior wall.*

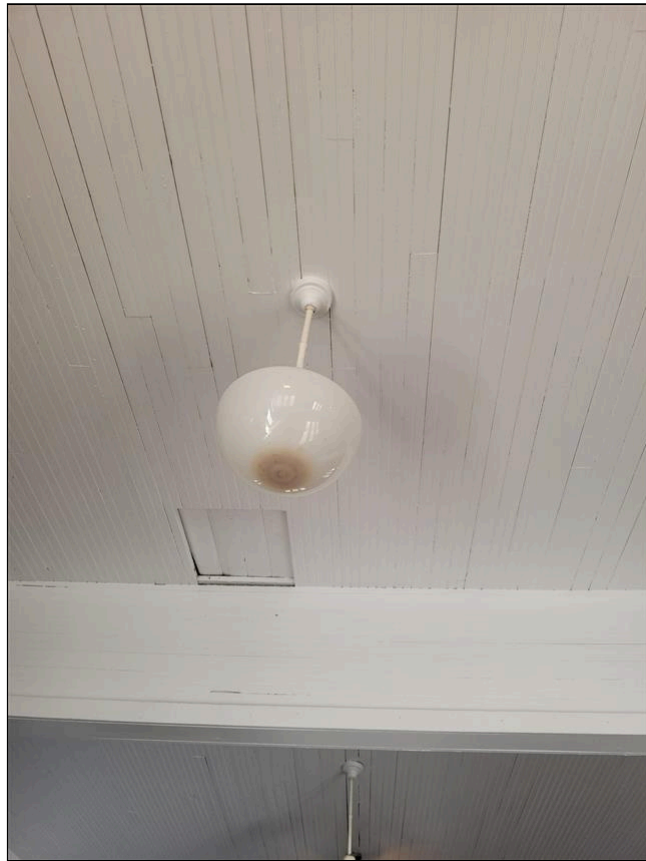
6.2 Item 2(Picture) Main area light-did not work

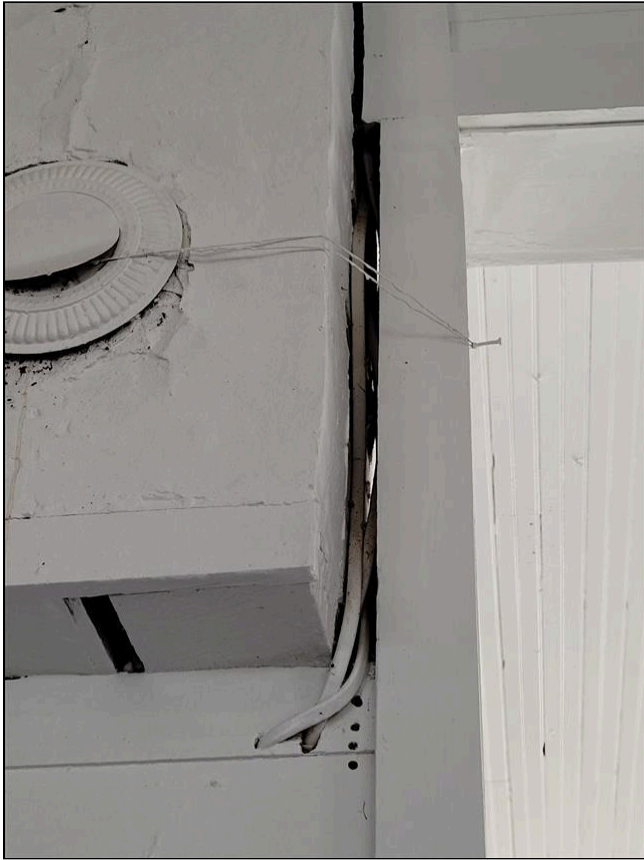
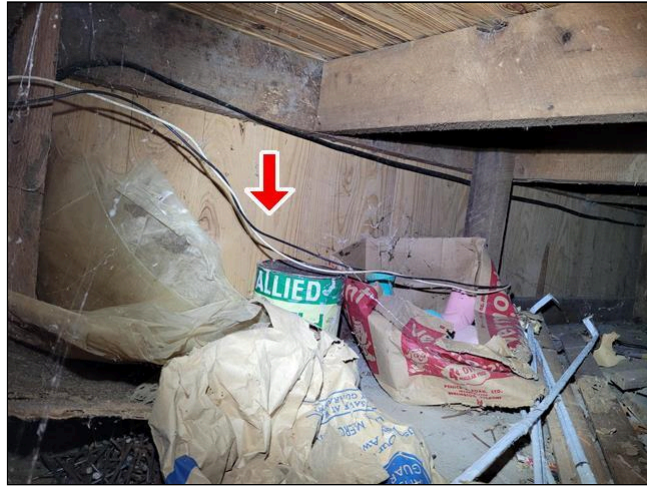
The main area had exposed wiring. Conduit is recommended to prevent accidental damage to wires.

6.2 Item 3(Picture) Exposed wiring-conduit needed

6.2 Item 4(Picture) Exposed wiring-conduit needed

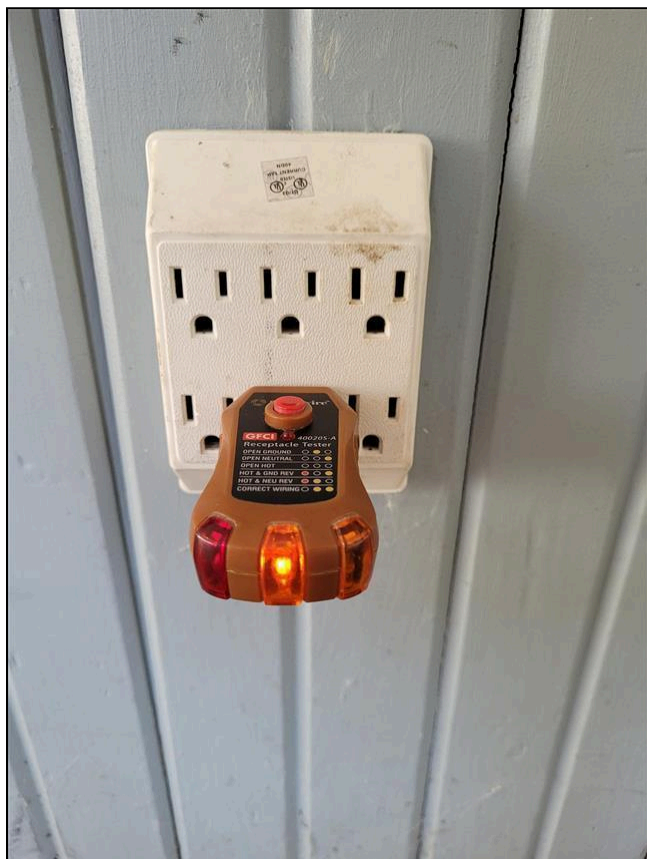
6.3 There were open grounds throughout the facility.

Most of the outlets were 2 prong outlets.

6.3 Item 1(Picture) Electrical outlets-open grounds

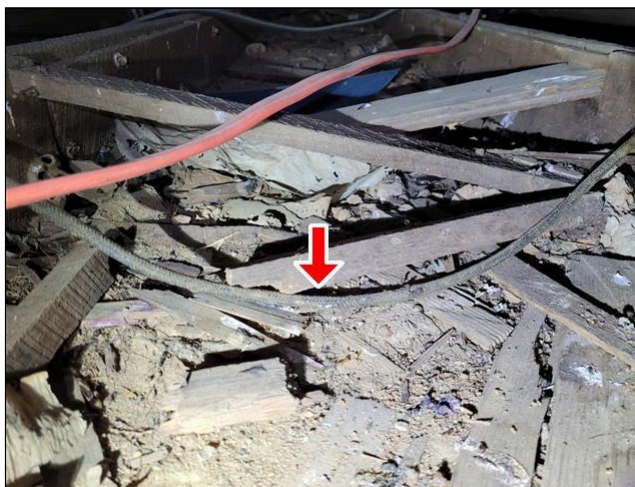
Aged fabric wiring is present.

6.3 Item 2(Picture) Aged fabric wiring
