Inspection Report

Property Address:
74 County Road 624
Oak Grove Arkansas 72638

Abba Home Inspections, LLC

Date: 1/17/2023	Time: 08:58 AM	Report ID: F-Fairweather8425
Property: 74 County Road 624 Oak Grove Arkansas 72638	Customer: Rob Fairweather	Real Estate Professional:

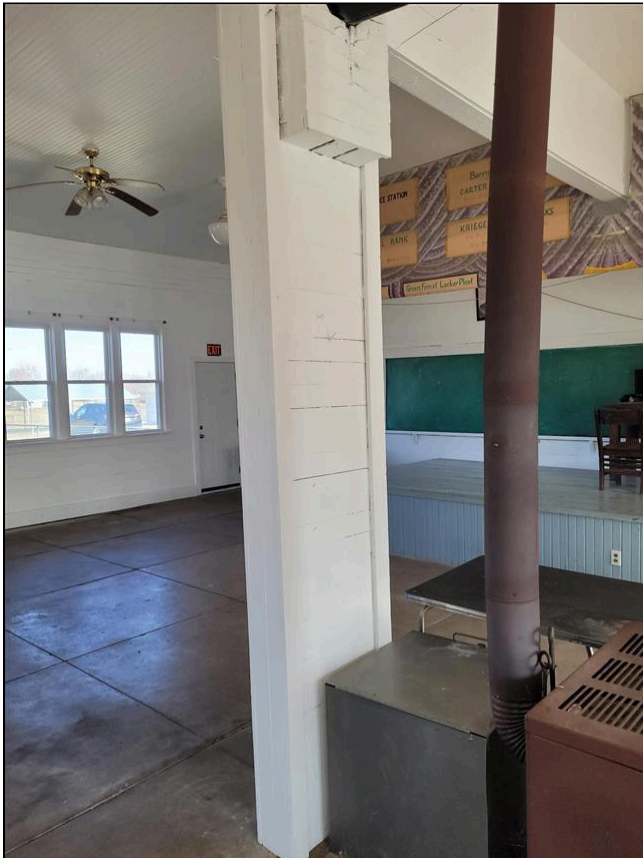
(2) The bricks under the chimney appear to have been removed. This could result in collapse of the brick chimney.

7.3 Item 1(Picture) Removed brick chimney

7.3 (1) The chimney liner was not inspected by our company. I recommend a qualified chimney sweep inspect for safety.

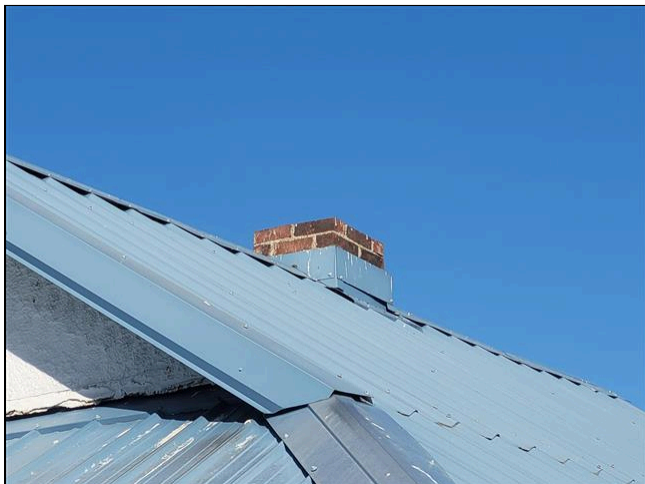
7.4 Item 1(Picture) No visible chimney cap

7.4 (1) *I recommend that a qualified chimney sweep inspect, and clean the flue pipe before using the fireplace/ woodstove.*

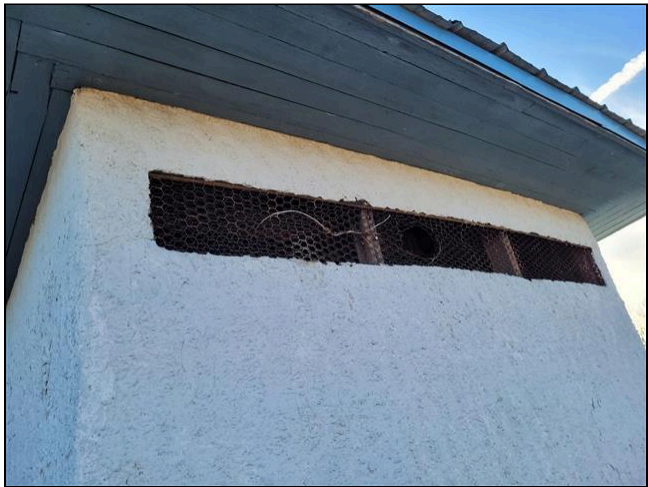
8.1 Item 1(Picture) Damaged attic vent material

8.1 The attic should be sealed to prevent access to animals.

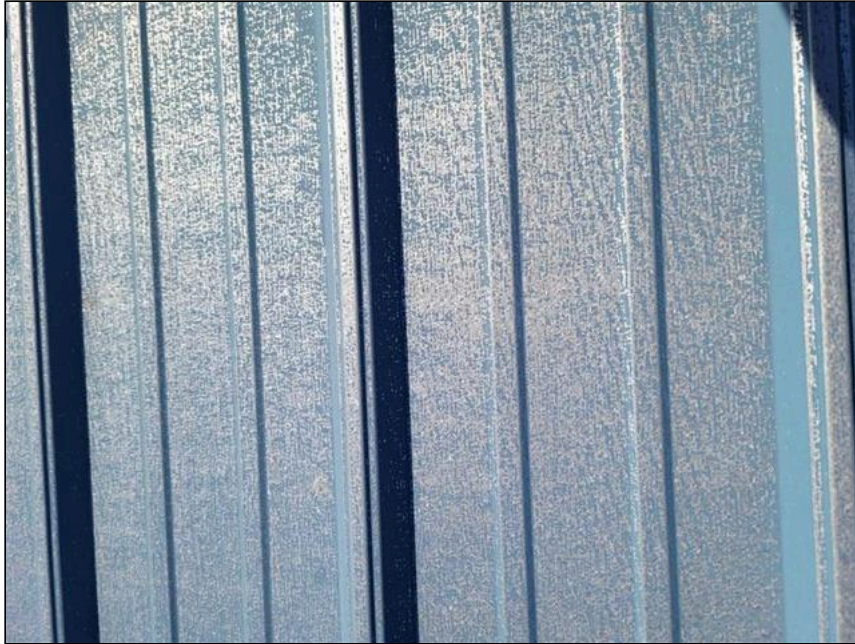
(1) *The paint is coming off and the panels may begin to rust in the future.*

1.0 Item 1(Picture) Paint-coming off

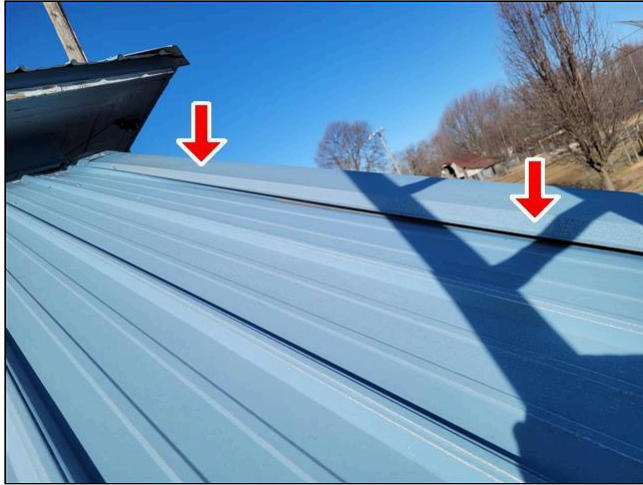
1.0 Item 4(Picture) Missing screws

Install and secure all loose/missing screws, where needed.

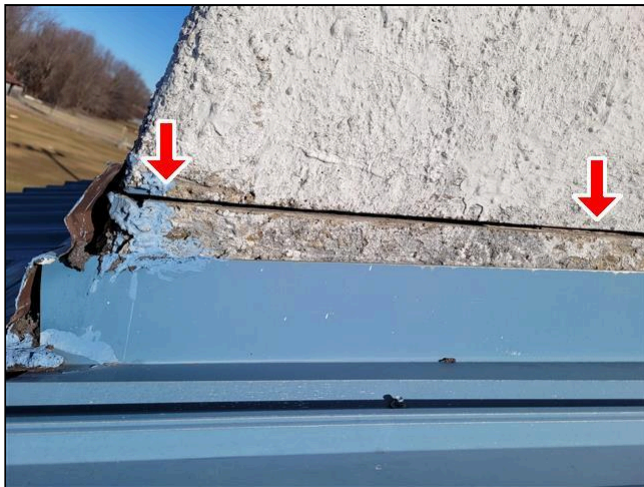
1.1 Item 5(Picture) Flash/seal all areas properly/
missing flashing

All areas should be flashed/sealed properly to prevent water intrusion and framing damage.

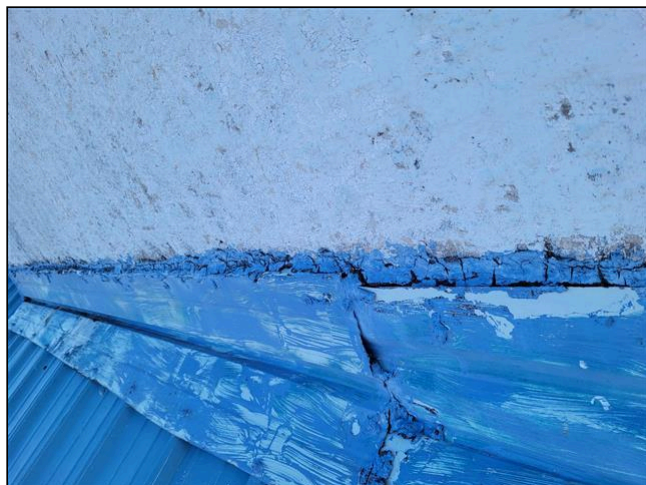
1.1 Item 7(Picture) Cracked sealant

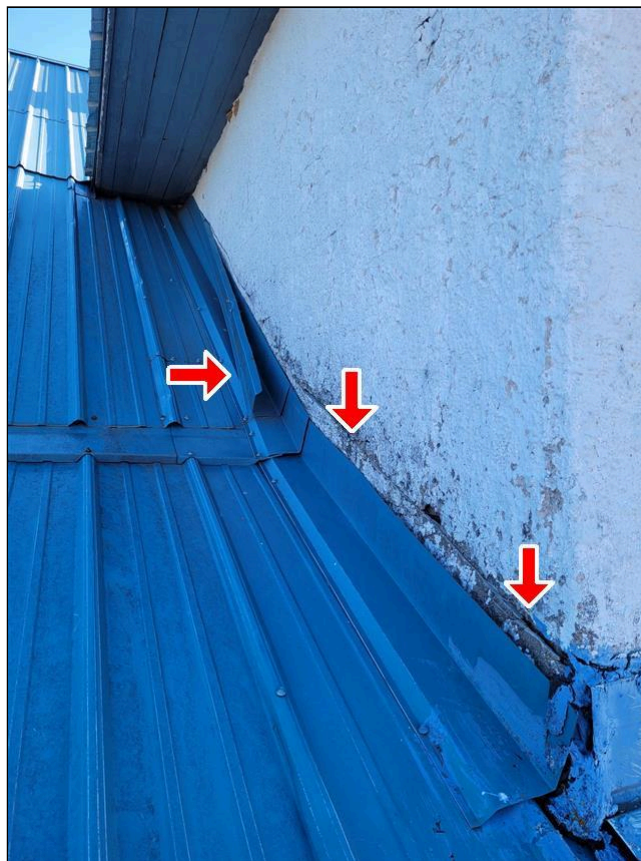
1.1 Item 8(Picture) Loose/missing flashing

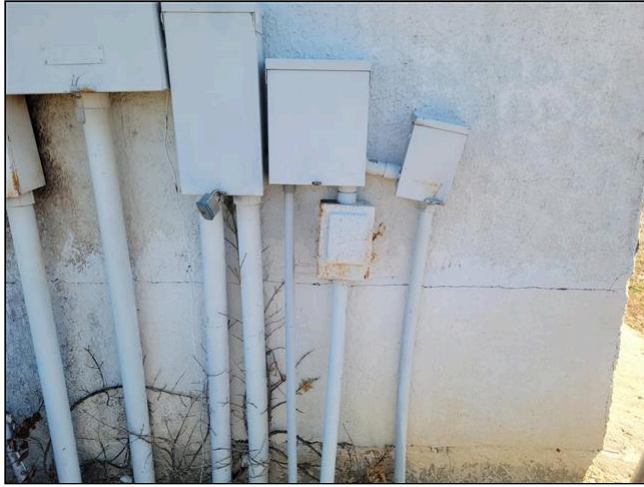
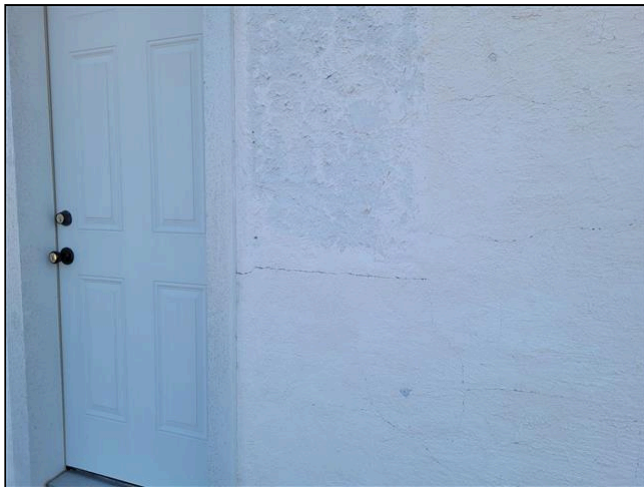
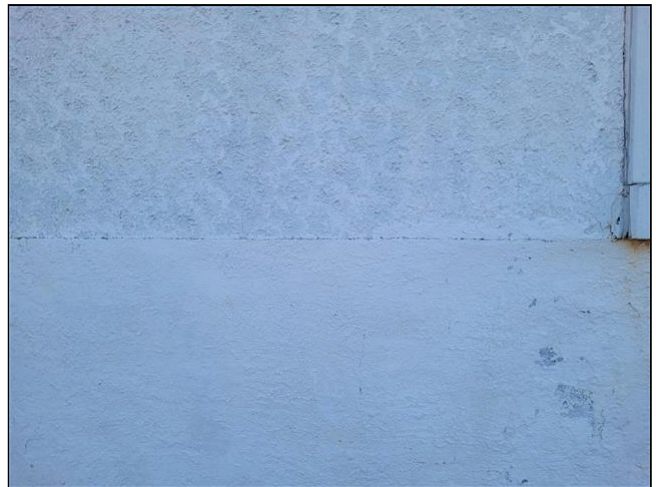
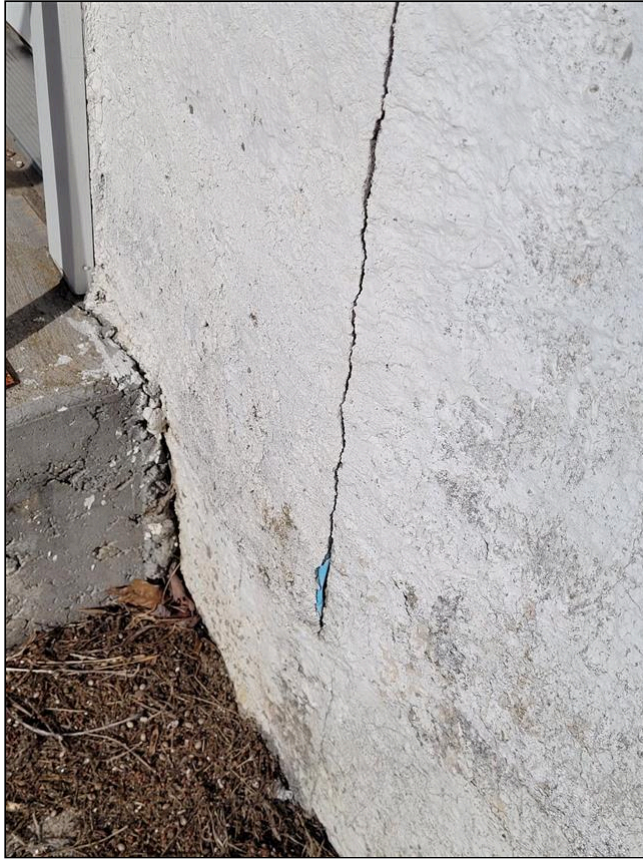
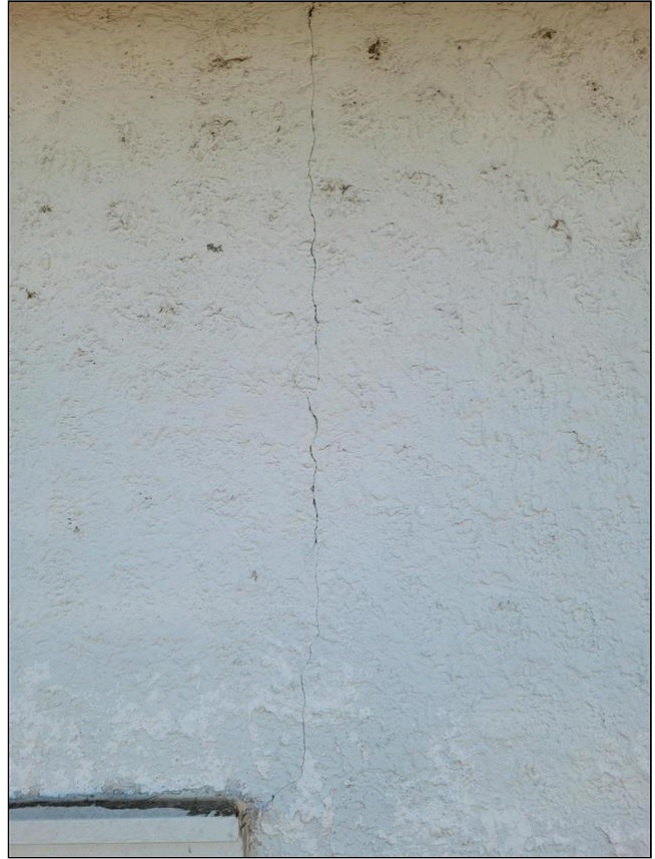
(1) *There are numerous areas on the exterior with cracks. Some areas appear to be bulging.*

Water could enter and cause framing damage.

2.0 Item 1(Picture) Cracked exterior

2.0 Item 3(Picture) Cracked exterior

2.0 Item 4(Picture) Cracked exterior

2.0 Item 5(Picture) Cracked exterior

2.0 Item 6(Picture) Cracked exterior

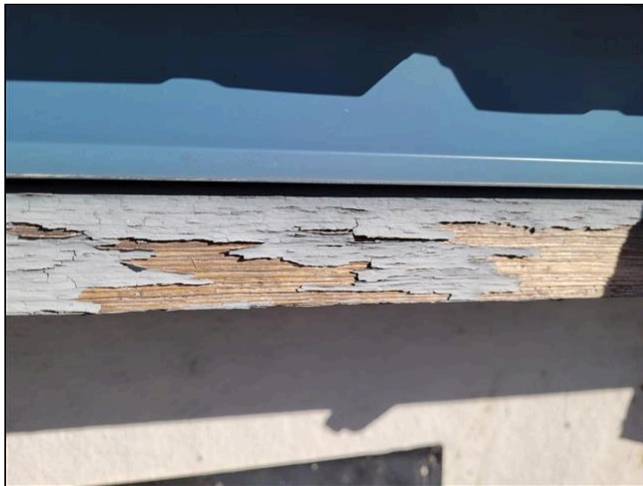
2.0 Item 7(Picture) Scrape/paint-as needed

(2) **All components should be scraped and painted, as needed, to prevent deterioration in the future.**

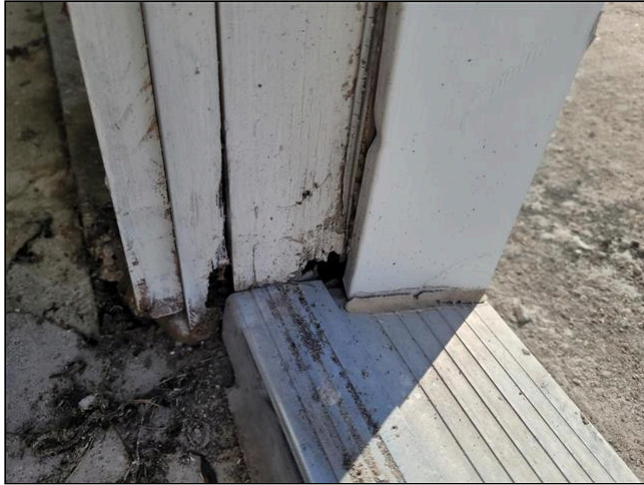
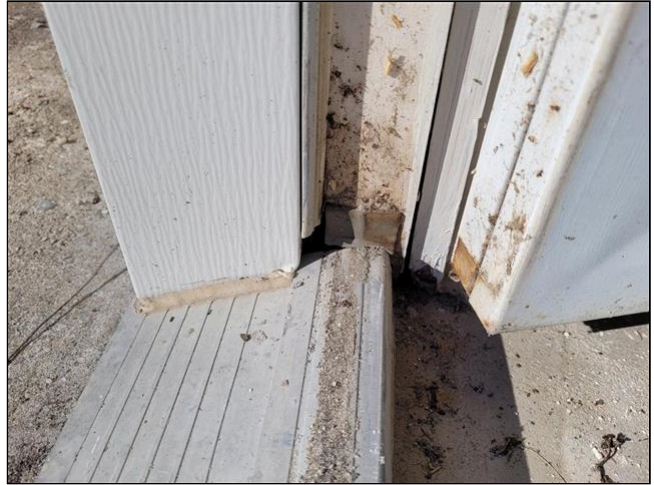
(1) **There are door and jambs with damage.**

2.1 Item 1(Picture) Rotten jamb-Southeast side

2.1 Item 2(Picture) Rotten jamb-Southeast side

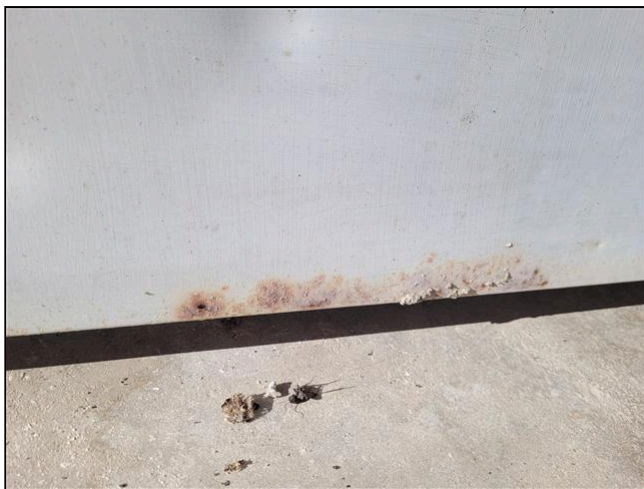
2.1 Item 3(Picture) Rust holes-Southeast side

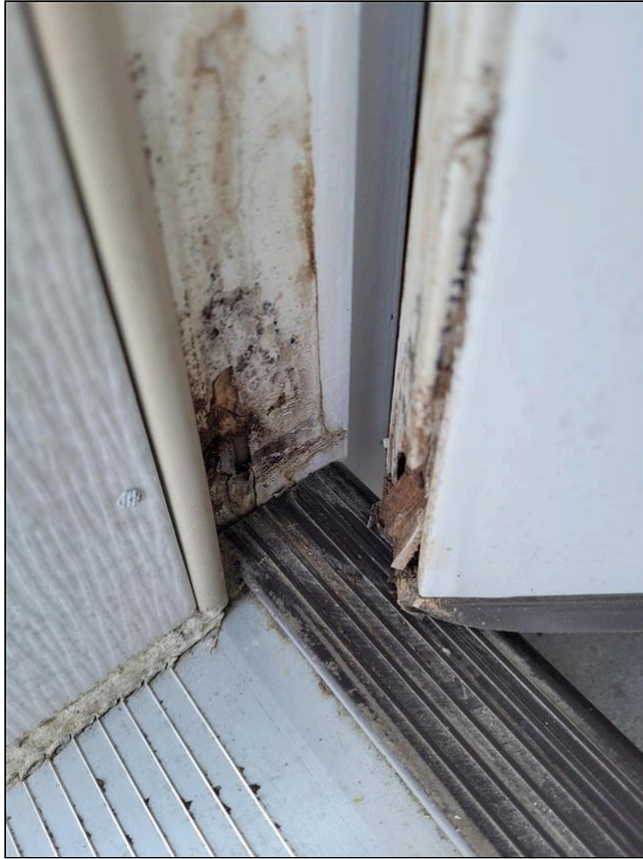
2.1 Item 5(Picture) Rotten jamb, rotten door-North door

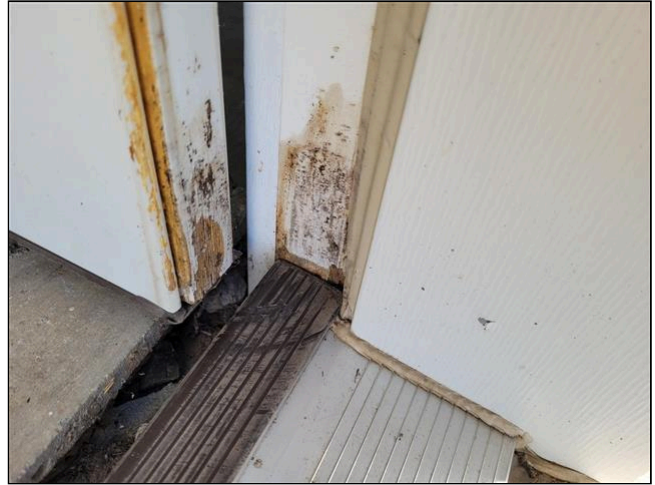
2.1 Item 6(Picture) Water intrusion-South door

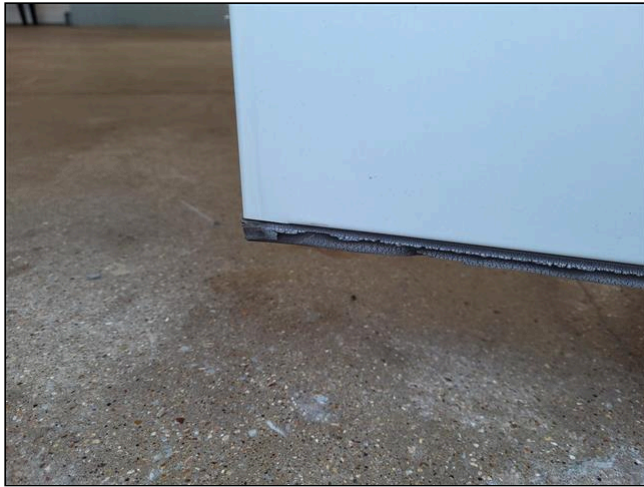
2.1 Item 7(Picture) Replace all damaged threshold seals

(2) **Replace all damaged threshold seals and weather stripping to prevent any water intrusion into the home and possible damage.**

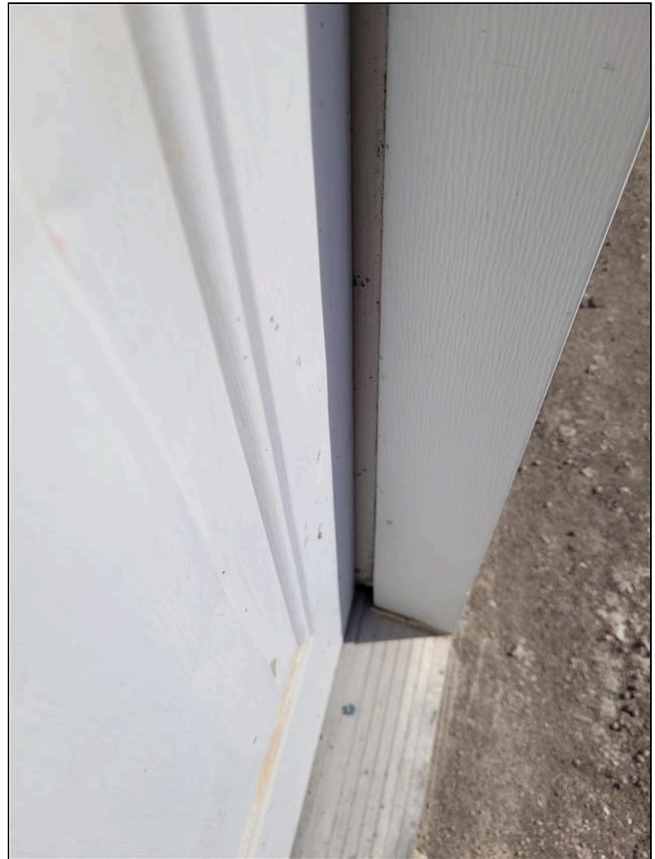
2.1 Item 8(Picture) Unsealed door-Southeast door

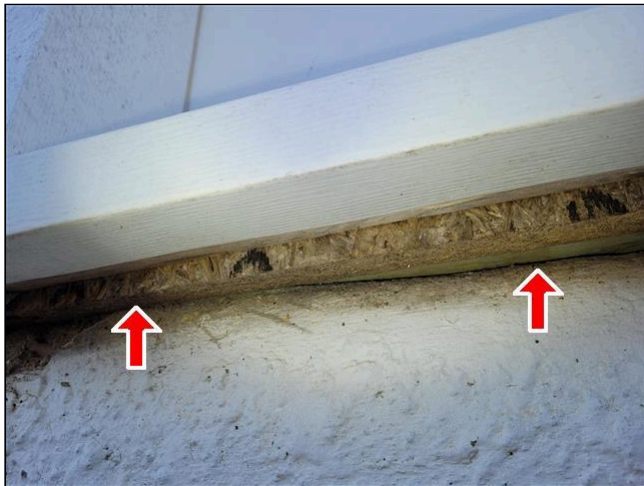
2.1 Item 9(Picture) No visible flashing

(3) **All doors should be properly flashed to prevent water intrusion and framing damage.**

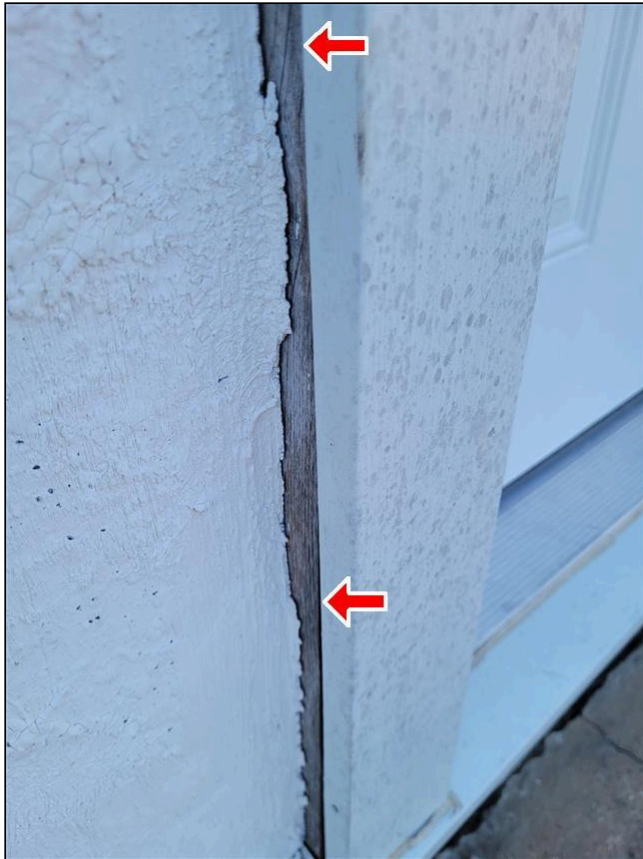
2.1 Item 10(Picture) Exposed wood

(4) **I recommend sealing around all doors to help prevent possible water intrusion and framing damage.**

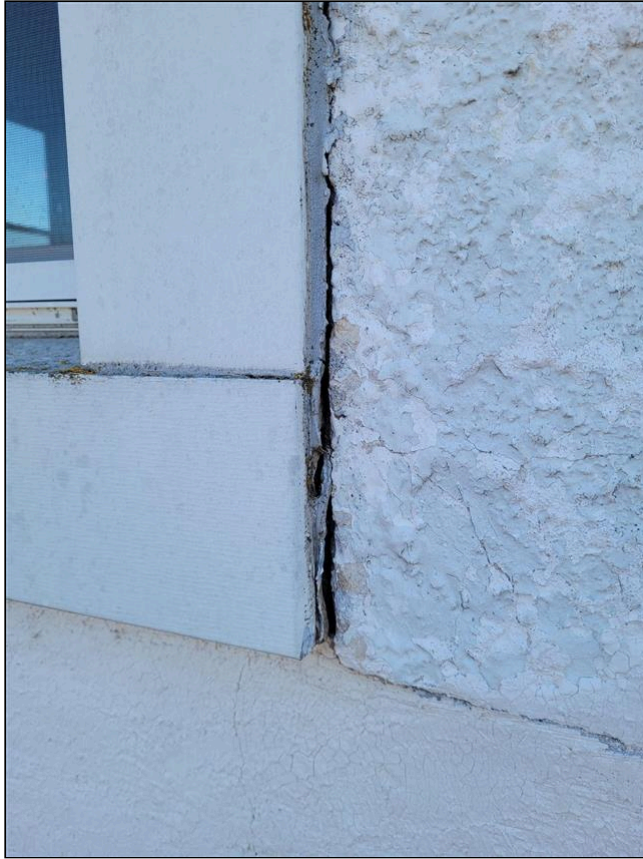
2.2 Item 1(Picture) Sealant needed-windows

- (1) ***I recommend sealing around all windows to help prevent possible water intrusion and framing damage.***

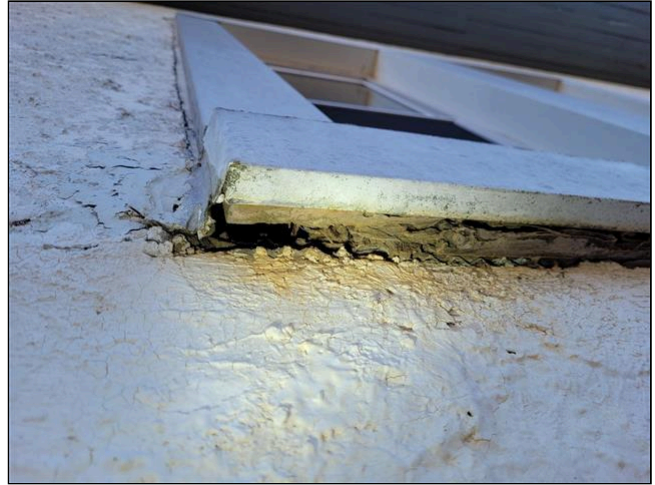
2.2 Item 2(Picture) Rotten window framing

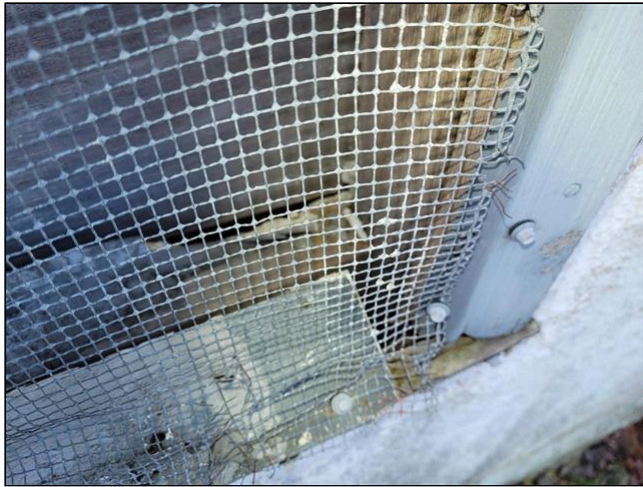
(2) *The window pane on the North side is missing. Water intrusion into the wall is likely.*

2.2 Item 3(Picture) Missing pane-North side

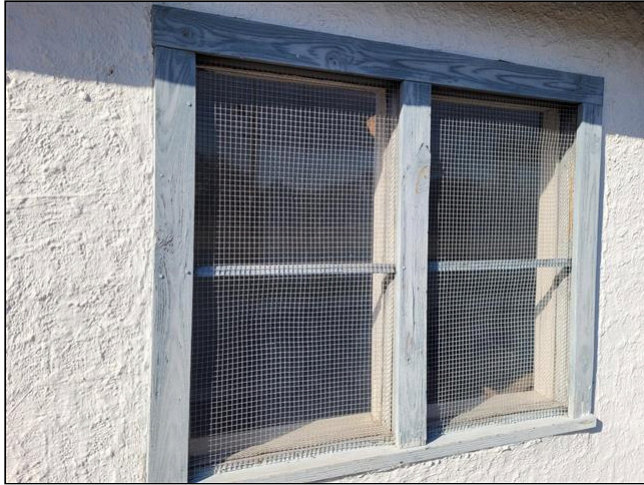
(3) **The windows and trim on the East side are aged and should be replaced.**

2.2 Item 5(Picture) Aged windows and trim

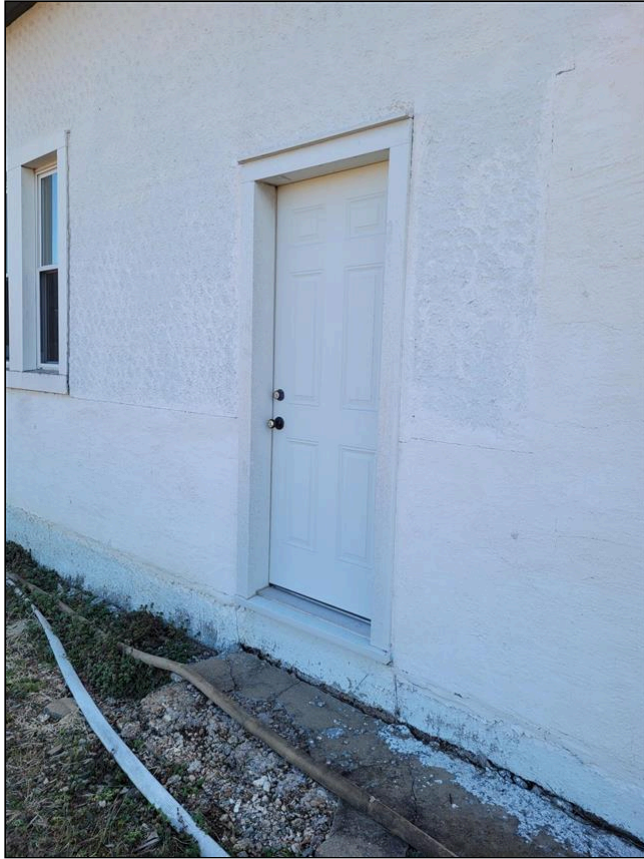
2.3 Item 1(Picture) Step and handrail needed-West side

I recommend installing a step and handrail system on the West side.

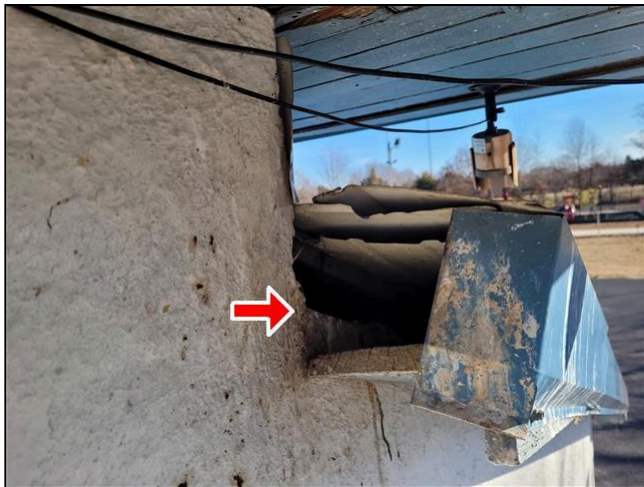
There are areas that are aged/damaged and need replaced.

2.4 Item 1(Picture) Open soffit area

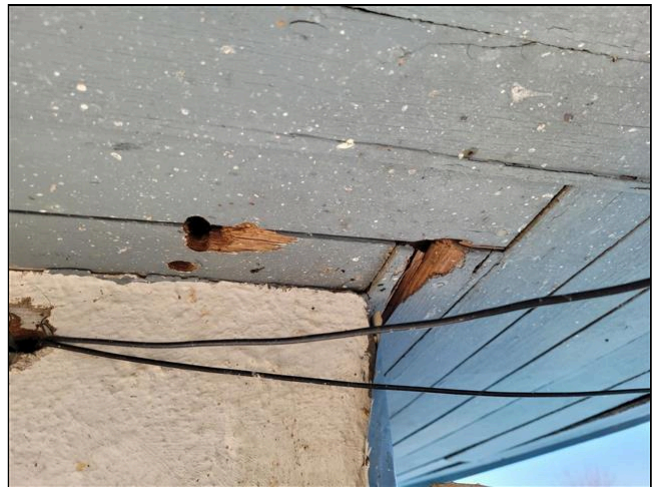
2.4 Item 2(Picture) Aged soffit material

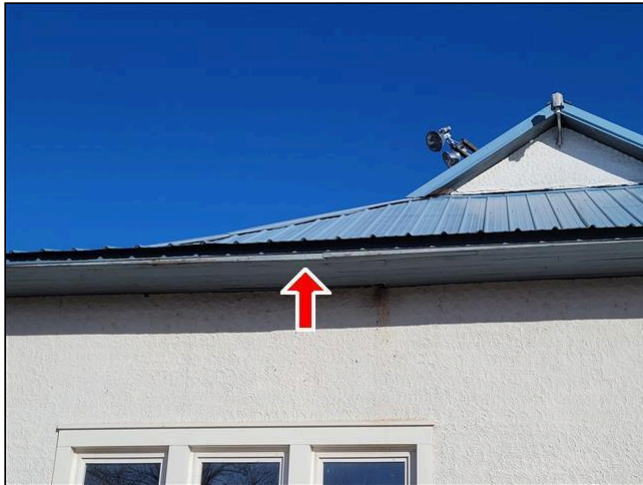
2.4 Item 3(Picture) Dropping fascia

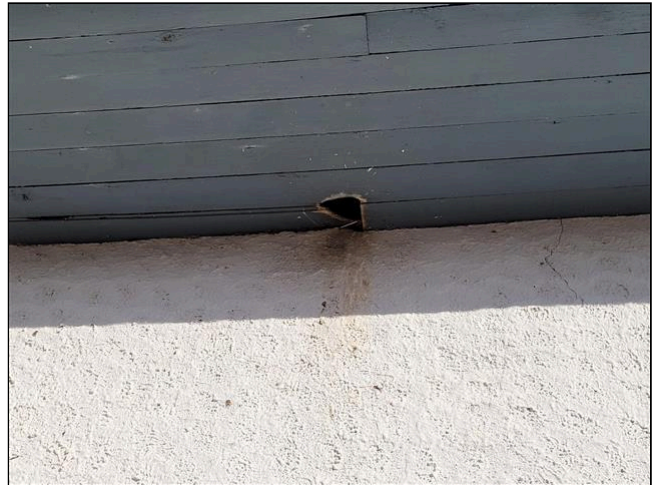
2.4 Item 4(Picture) Hole-soffit

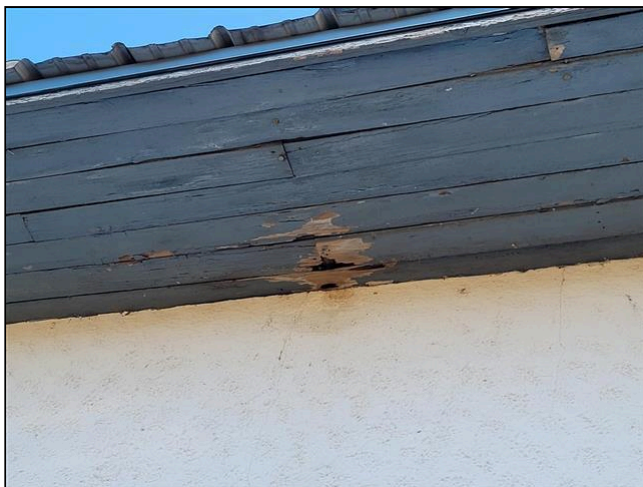
2.4 Item 5(Picture) Damaged soffit material

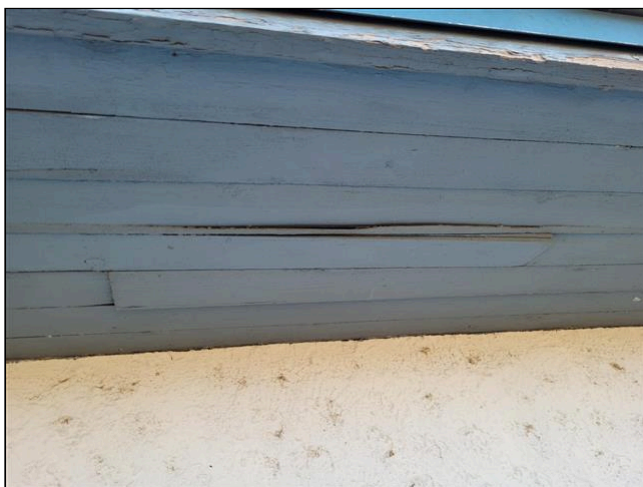
2.4 Item 7(Picture) Aged soffit material

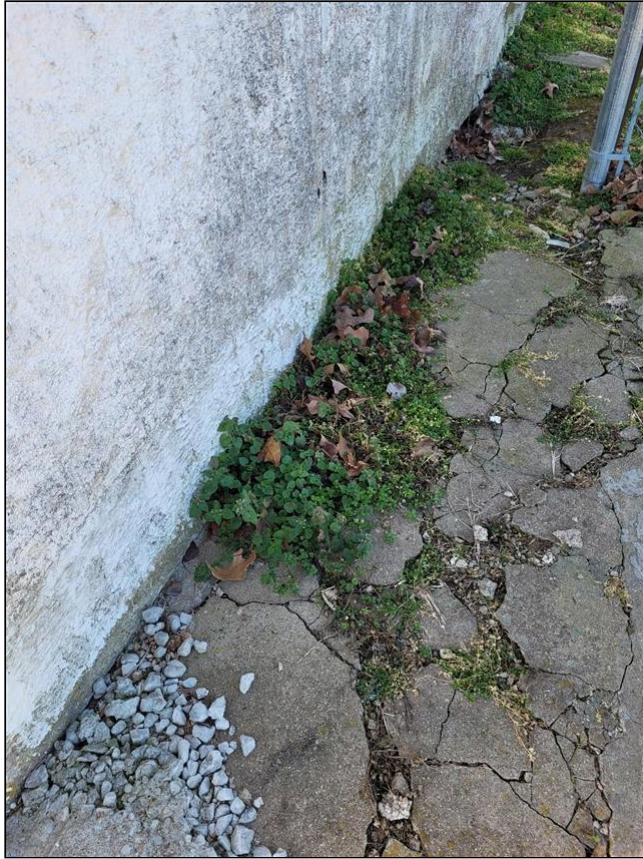
2.5 Item 1(Picture) Improper grading method

(1) All areas of grading on the exterior should cause the water to drain away from the foundation to prevent water intrusion.

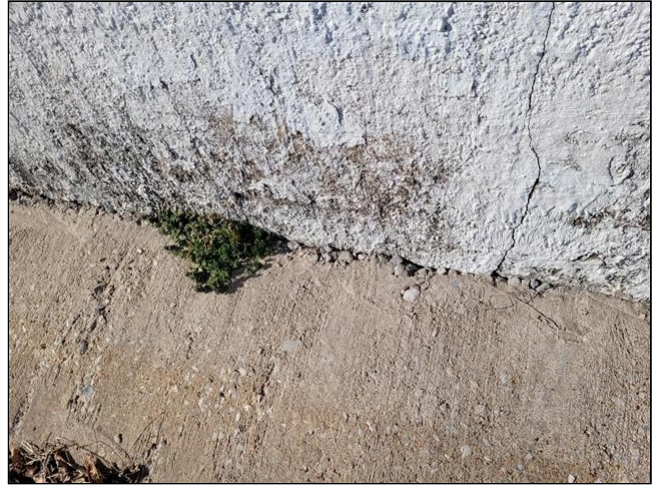
2.5 Item 2(Picture) Improper grading method

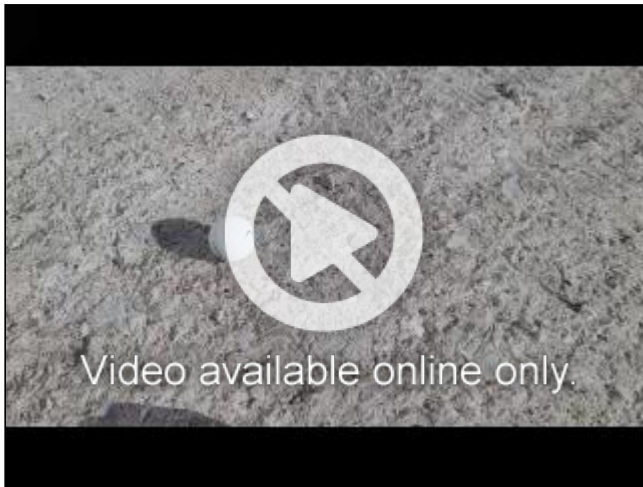
2.5 Item 3(Video) Improper grading

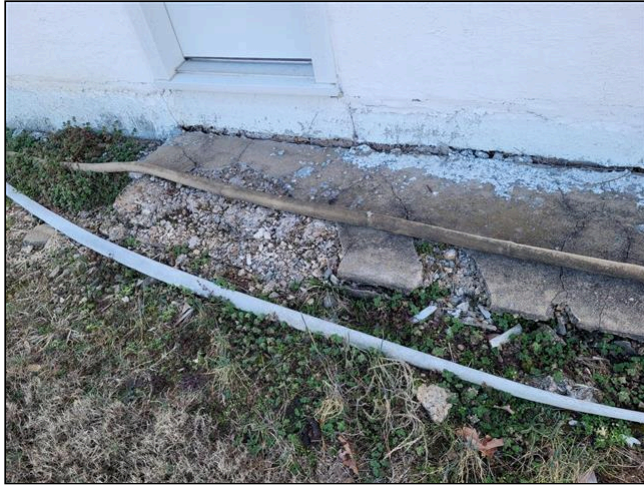
2.5 Item 4(Picture) Damaged concrete

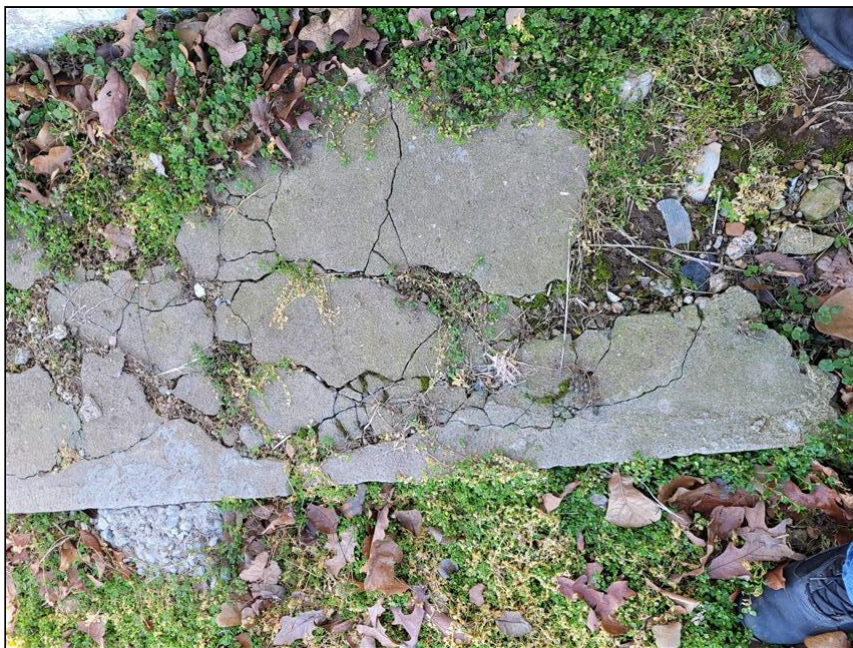
2.5 Item 5(Picture) Damaged concrete

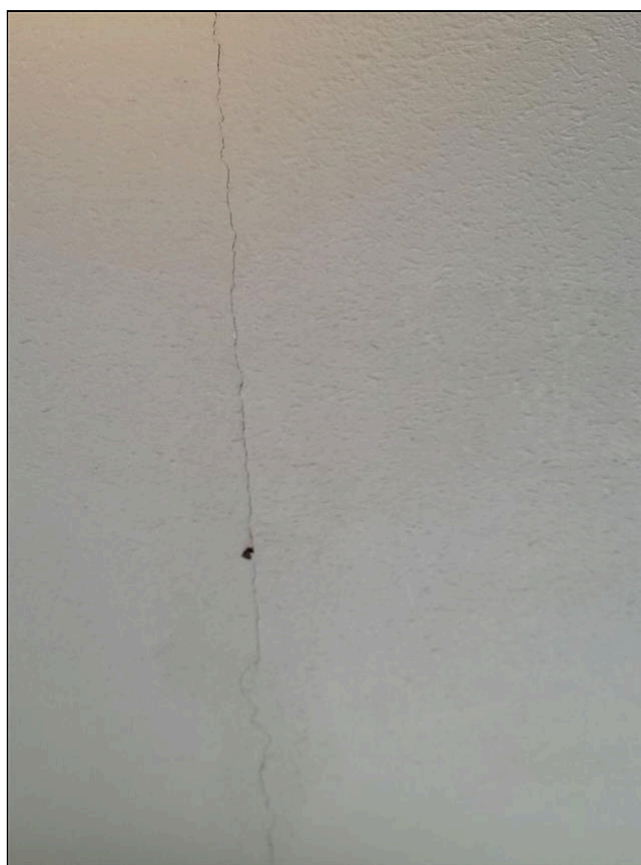
There is evidence of settling on the ceilings.

3.0 Item 4(Picture) School room ceiling-settling crack

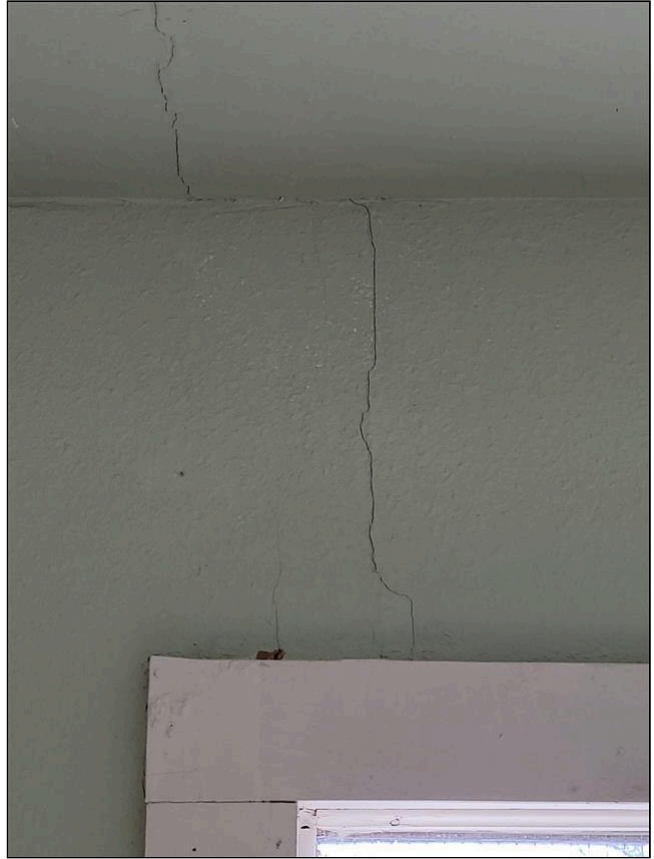
3.1 Item 2(Picture) East school room wall-settling cracks

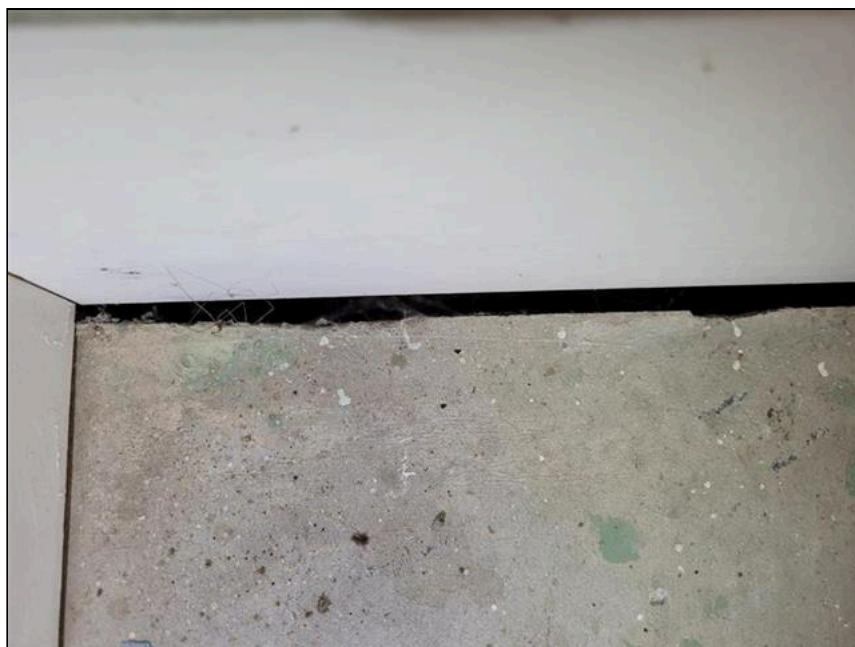
(2) *The floor had several settling cracks and gaps on the slab.*

3.2 Item 3(Picture) Floor-gap in concrete

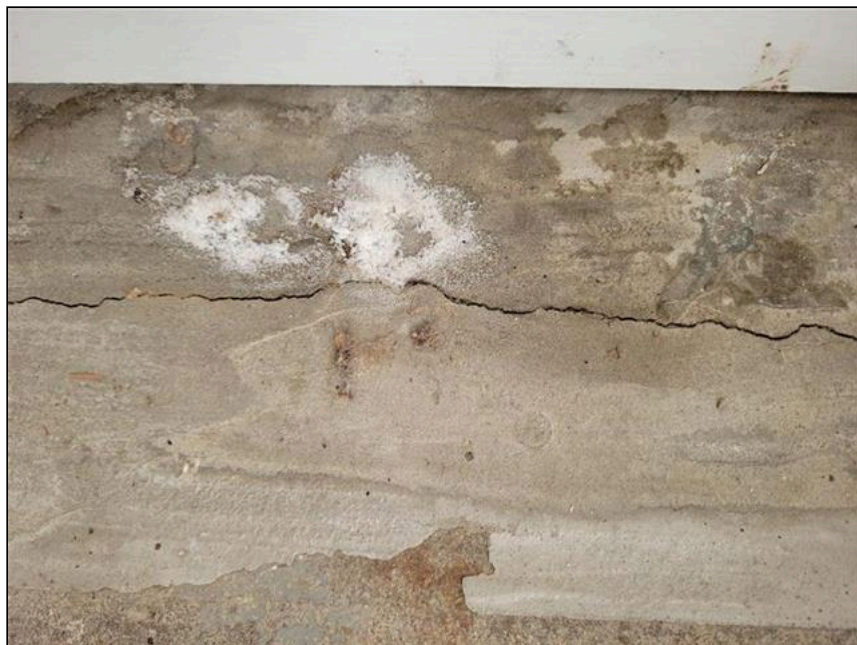
3.2 Item 4(Picture) Floor-settling cracks

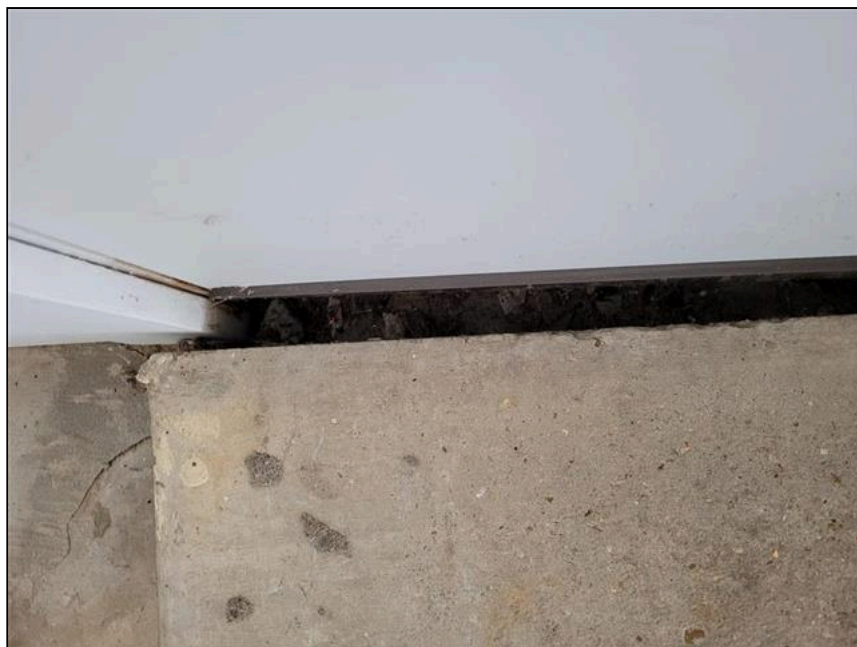
3.2 Item 5(Picture) Entry door floor-gap

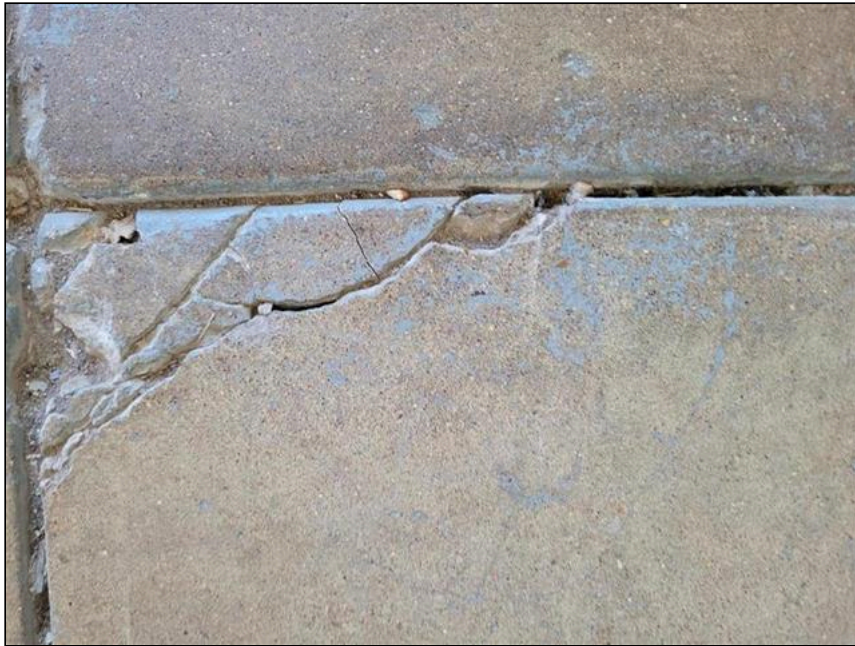
3.2 Item 6(Picture) Floor-damage

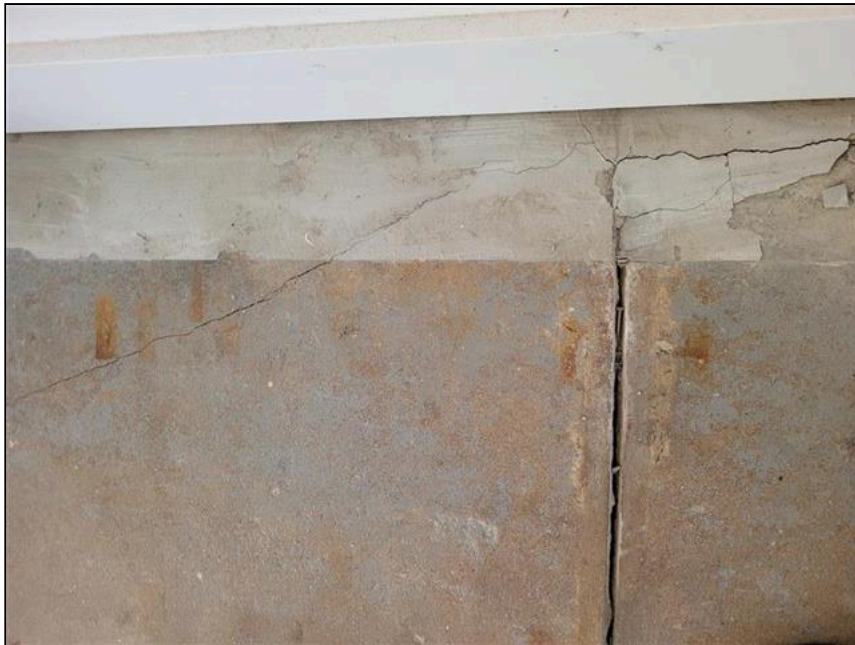
3.2 Item 7(Picture) Floor-settling cracks

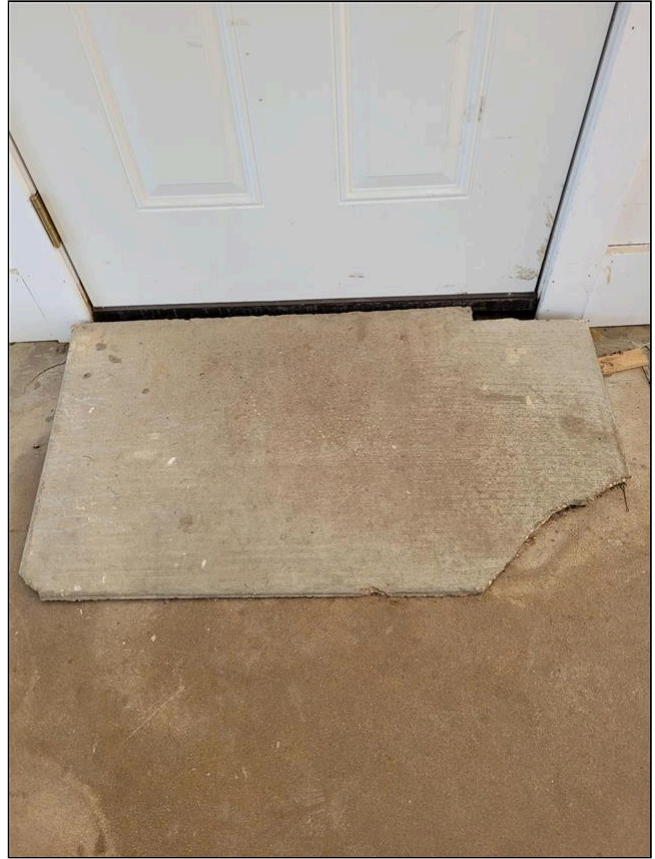
3.2 Item 9(Picture) Front door ramp-loose

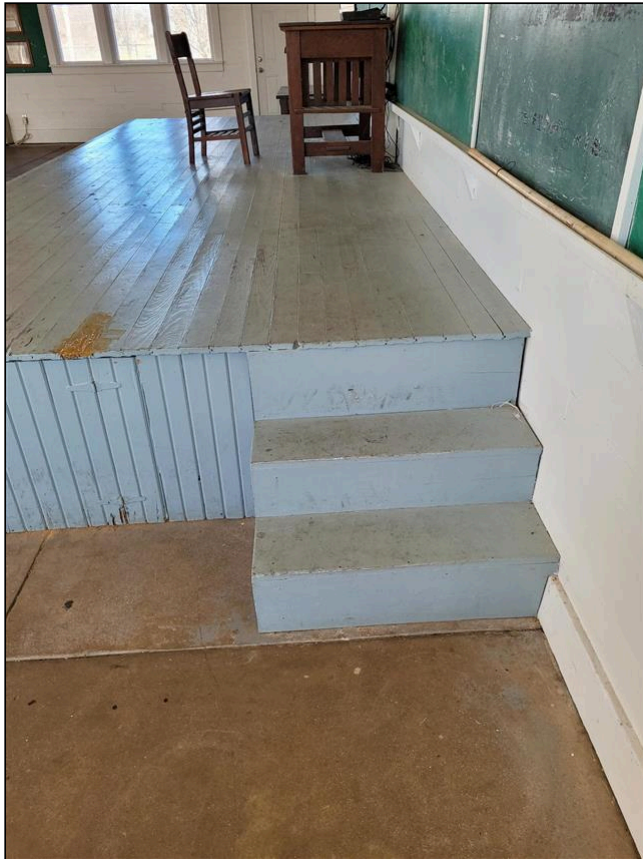
3.3 Item 1(Picture) Handrail-needed for the stage

A hand rail system is needed for the stage area and for the steps entering the East school room.

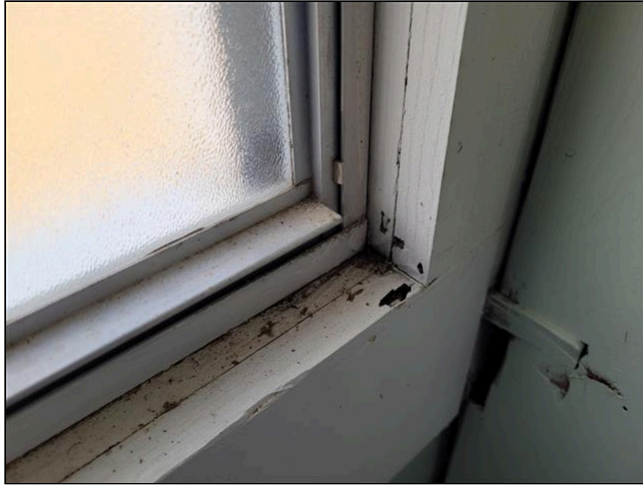
There is some damaged window trim.

3.4 Item 1(Picture) Damaged window trim-bathroom

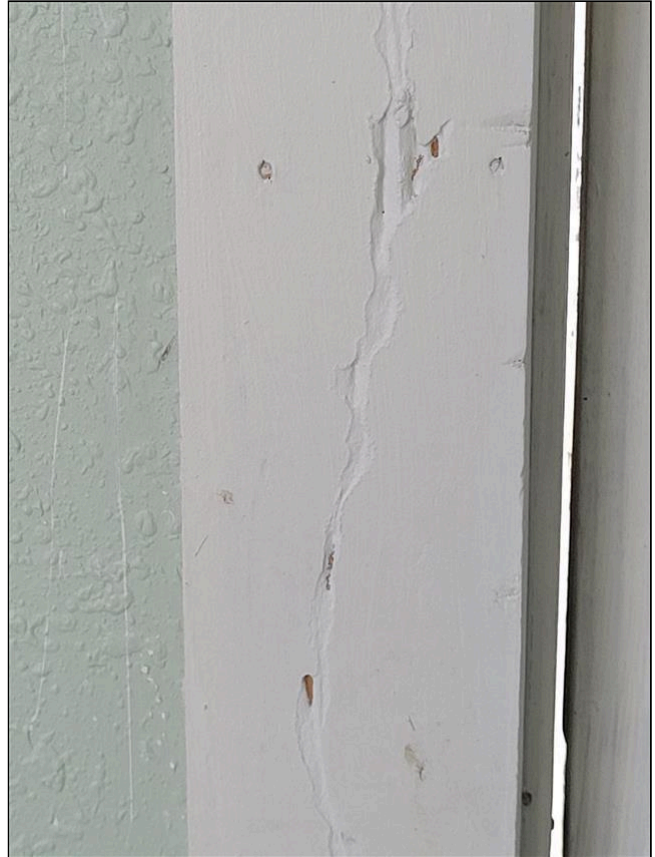
3.4 Item 2(Picture) East school room trim-possible would destroying insect damage

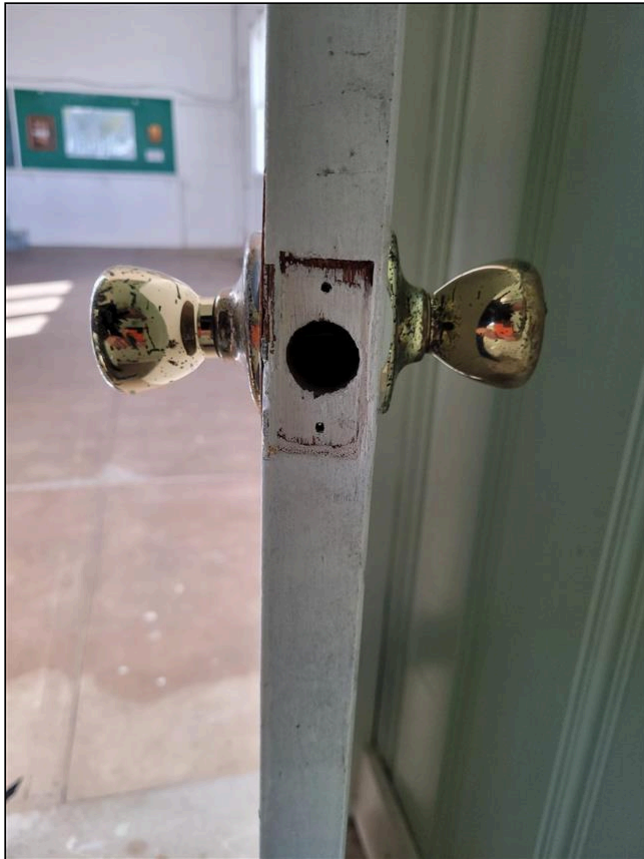
(1) **The bathroom doors were damaged and are missing the latches.**

3.5 Item 1(Picture) Men's bathroom door-missing latch
