Inspection Report

Property Address:
74 County Road 624
Oak Grove Arkansas 72638

Abba Home Inspections, LLC

Date: 1/17/2023	Time: 08:58 AM	Report ID: F-Fairweather8425
Property: 74 County Road 624 Oak Grove Arkansas 72638	Customer: Rob Fairweather	Real Estate Professional:

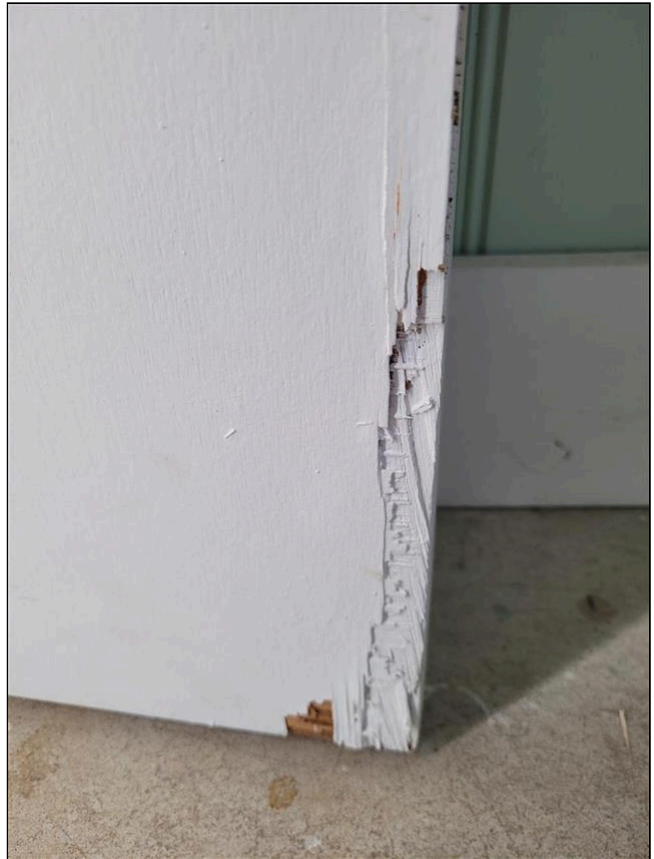
(1) **The bathroom doors were damaged and are missing the latches.**

3.5 Item 2(Picture) Men's bathroom door-damaged

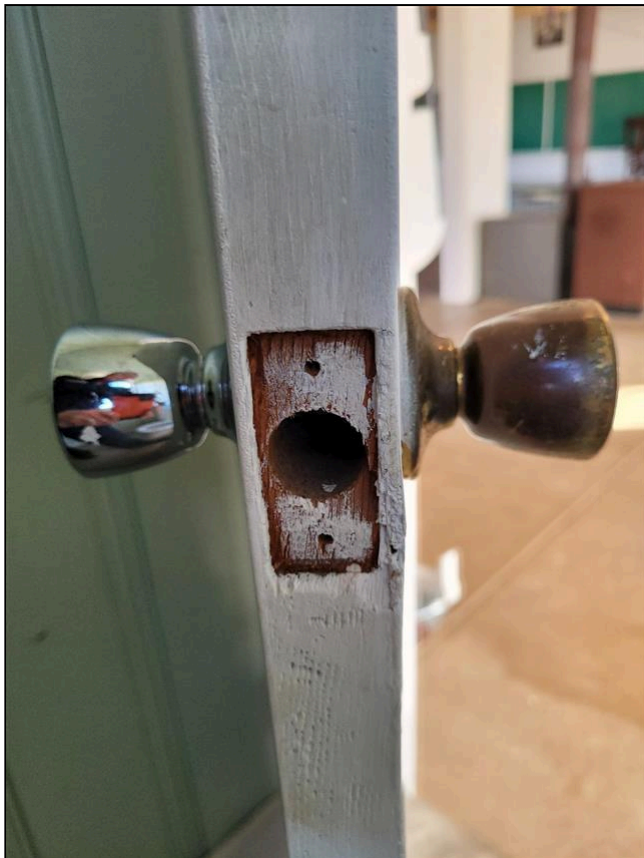
3.5 Item 3(Picture) Women's bathroom door-missing latch

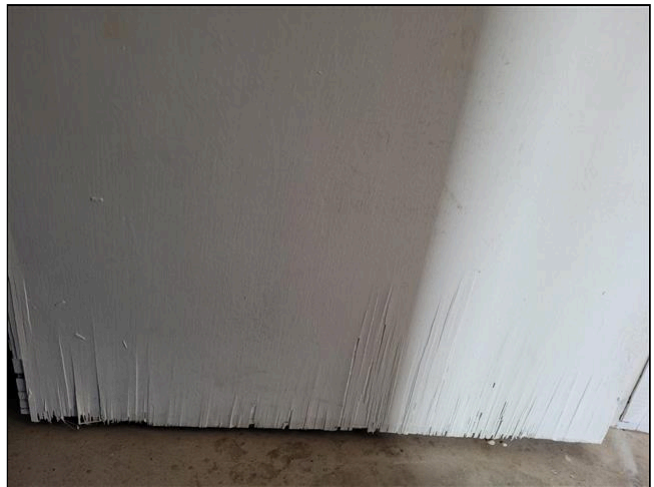
3.5 Item 4(Picture) Women's bathroom door-damaged

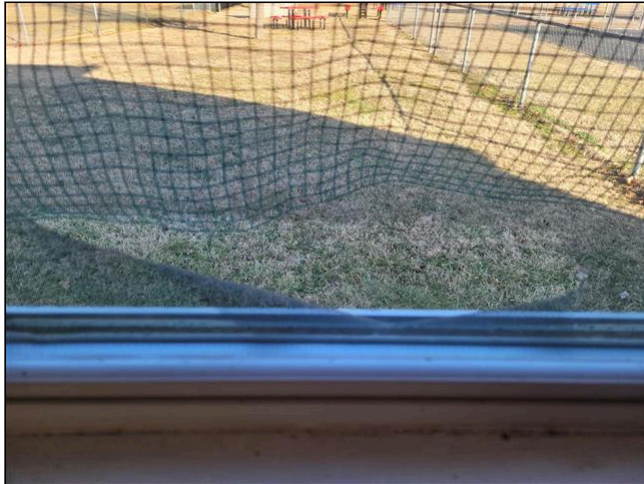
There are windows were double, single, and fixed hung with damage to several exterior screens.

3.6 Item 1(Picture) Window exterior screens-damaged

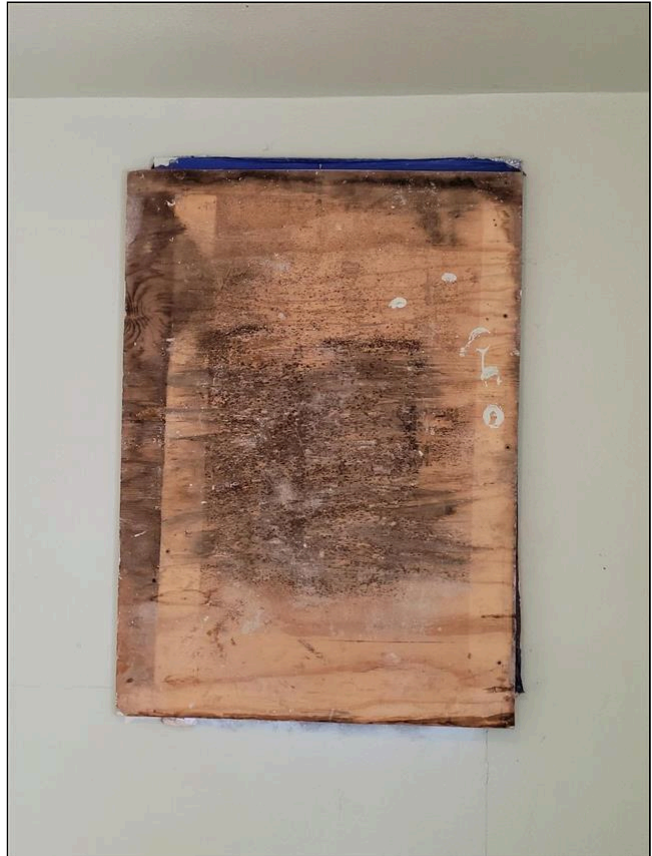
The East school room windows were fixed and one was missing the pane.

3.6 Item 2(Picture) East school room window-missing pane

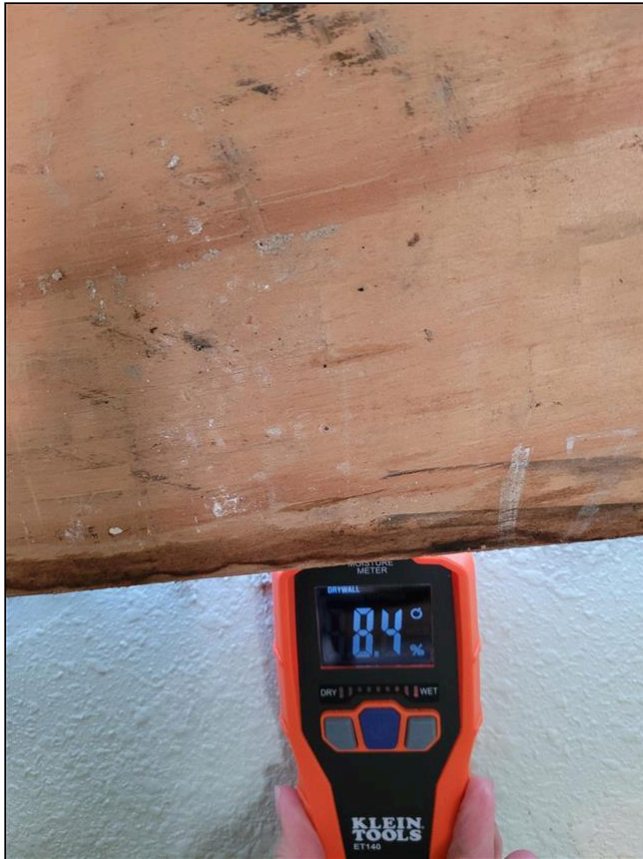
There were low moisture levels around the North window at the time of the inspection.

3.6 Item 3(Picture) East school room window area-low moisture reading

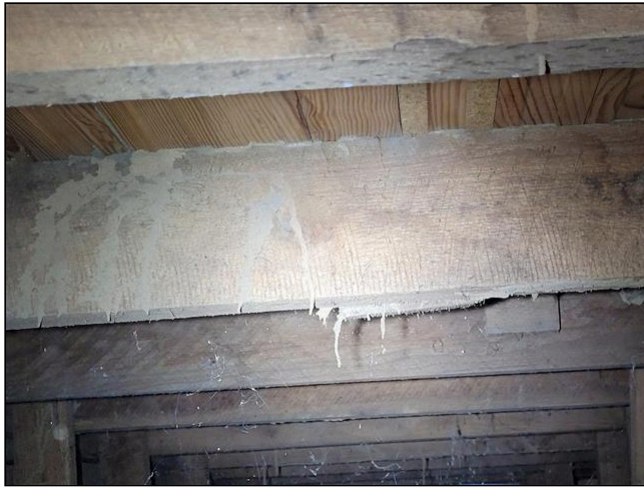
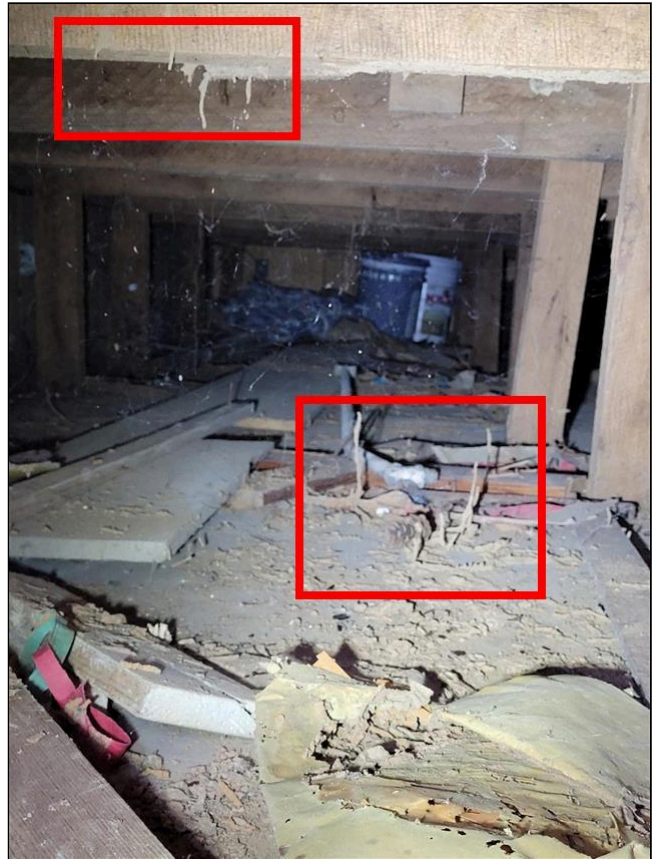
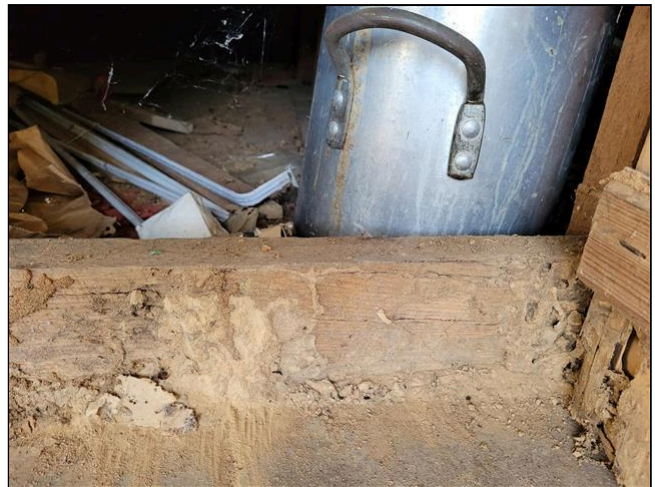
There is evidence of wood destroying insect activity in the building. Further investigation is recommended.

3.7 Item 1(Picture) Wood destroying insect activity

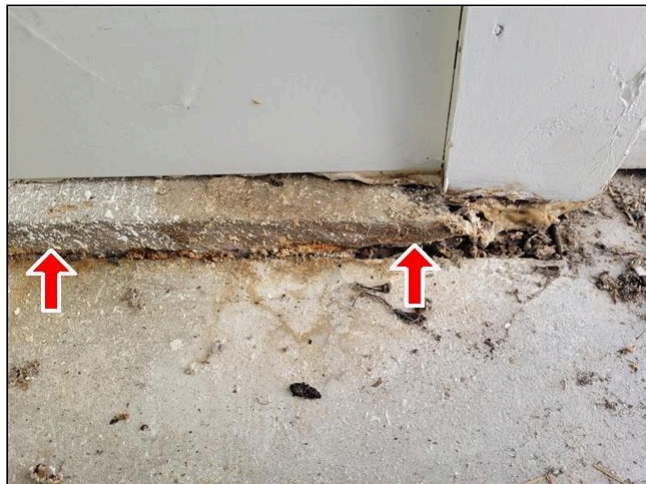
(1) There are walls that appear to be sitting on wooden components. Deterioration is present. Concrete footings may not be present.

4.0 Item 1(Picture) Wood-no visible concrete footing

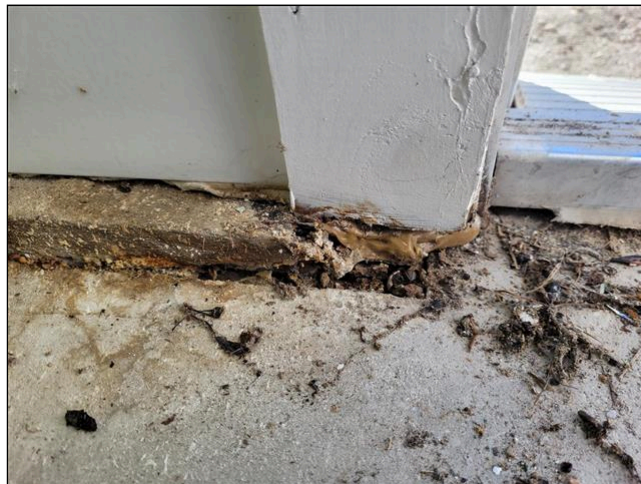
Previous evidence of wood destroying insect activity is present.

4.0 Item 2(Picture) Wood destroying insect activity

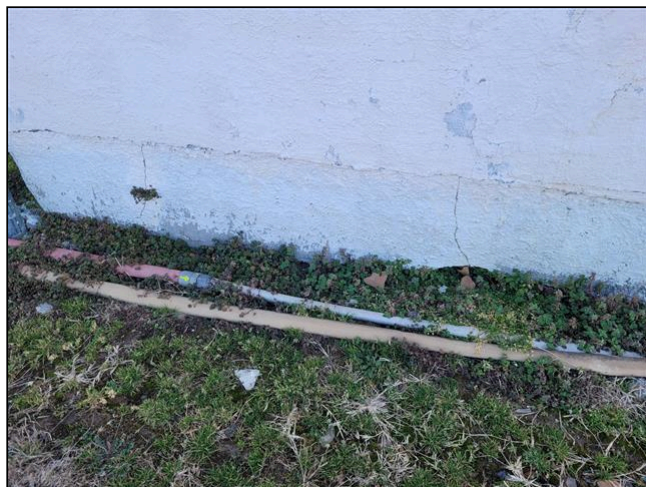
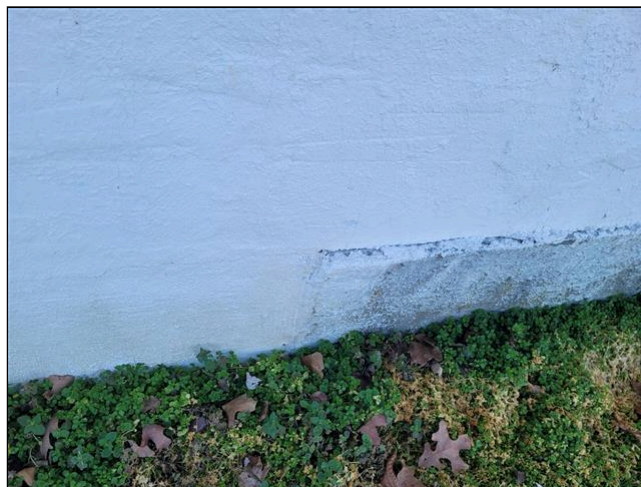
There are cracks on the foundation area on the exterior.

4.0 Item 3(Picture) Cracks

4.0 Item 4(Picture) Cracks

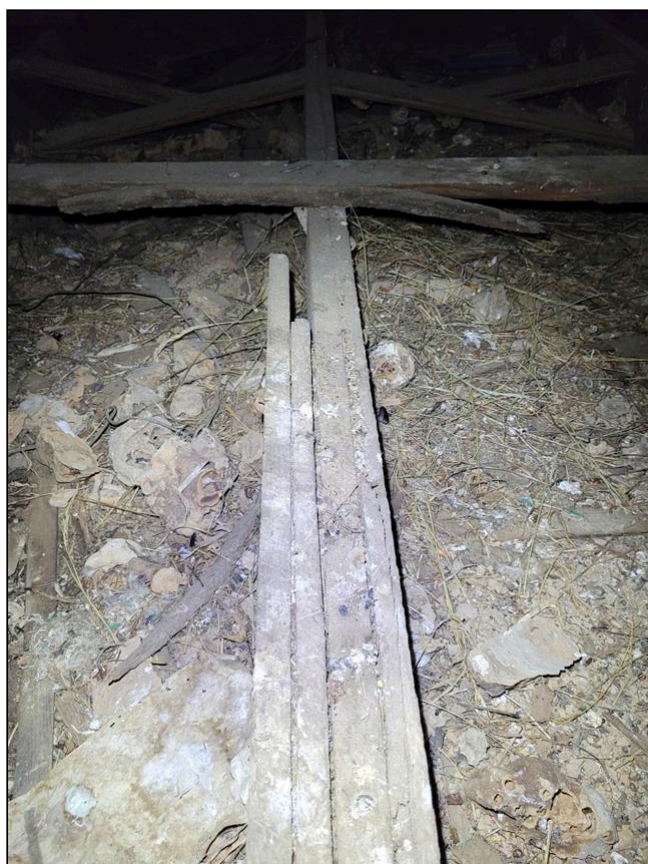
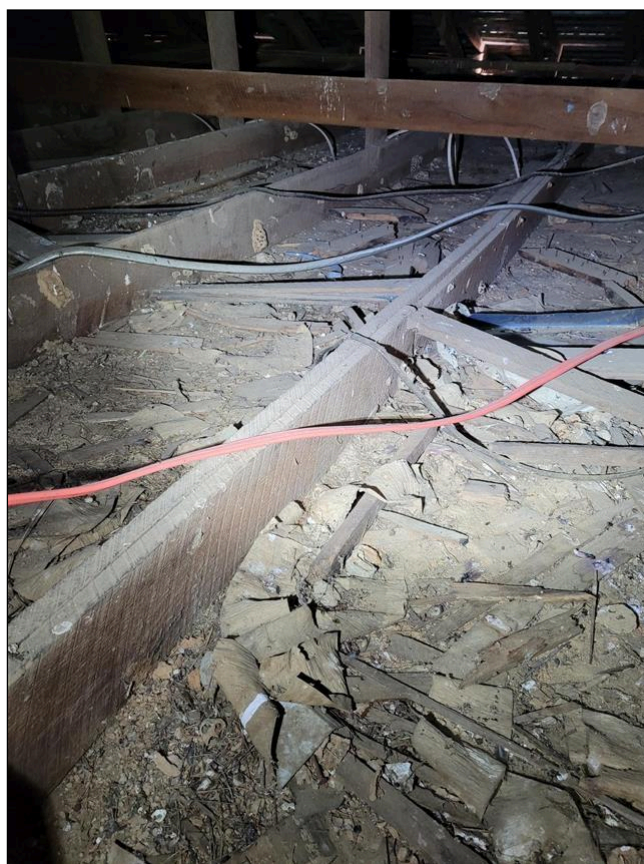
The spans on the framing components appear to be to long without supporting walls.

4.3 Item 1(Picture) 1"x6" ceiling joists

4.3 Item 2(Picture) 1"x6" ceiling joists

I recommend a qualified professional investigate all areas further and advise on all repairs that are needed.

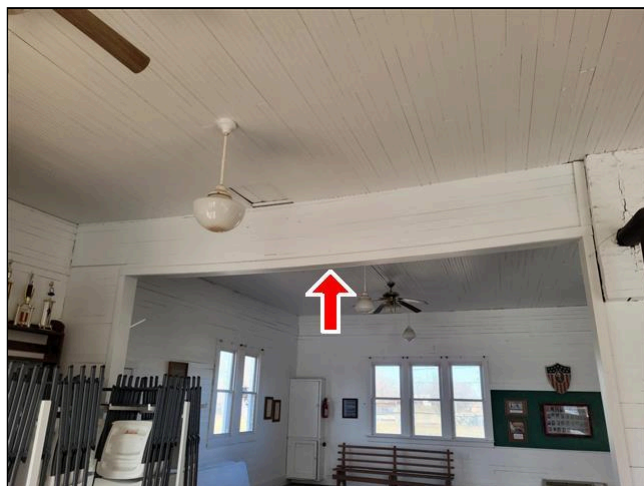
4.3 Item 3(Picture) Sagging

4.3 Item 4(Picture) Sagging

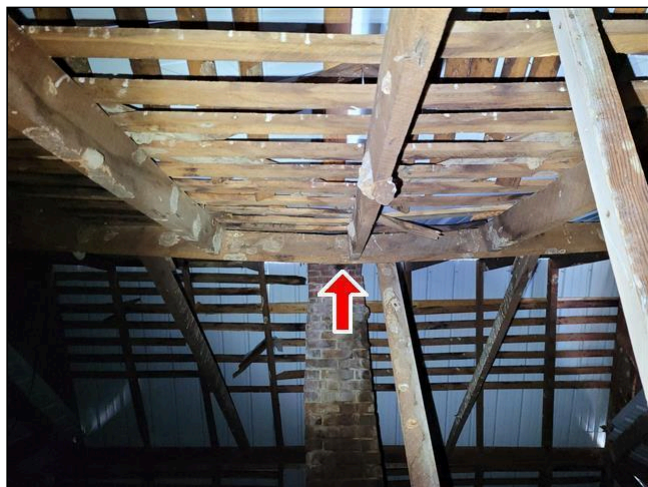
There are areas that are not supported correctly. This appears to be allowing settling to happen.

4.4 Item 1(Picture) Sagging framing area/incorrect anchoring method

(1) There are many areas of roof framing that are not to current standards. Many areas appear to need beams and supports added to prevent possible failure in the future.

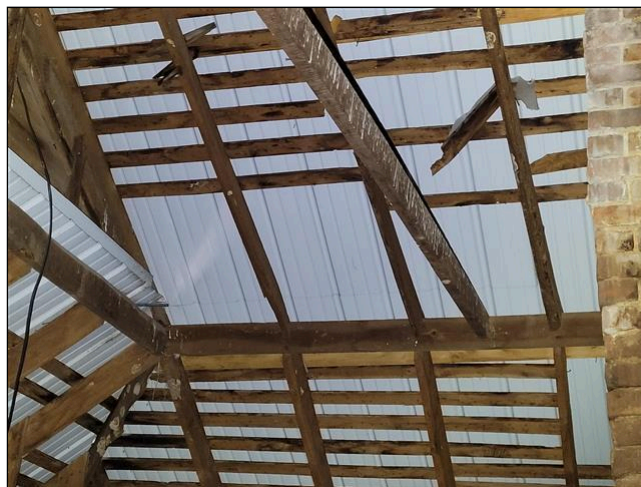
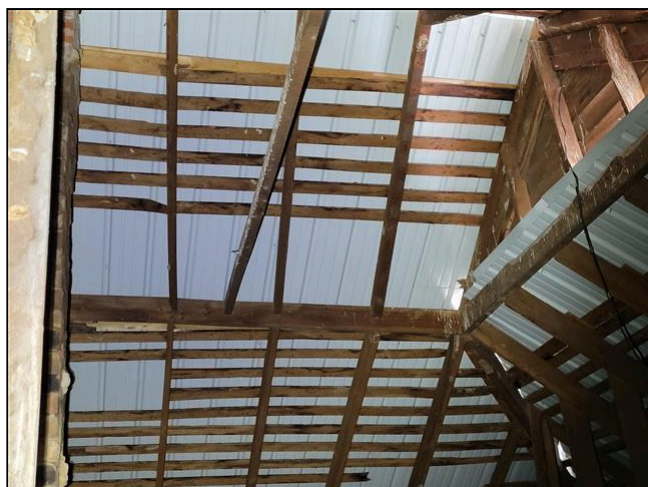
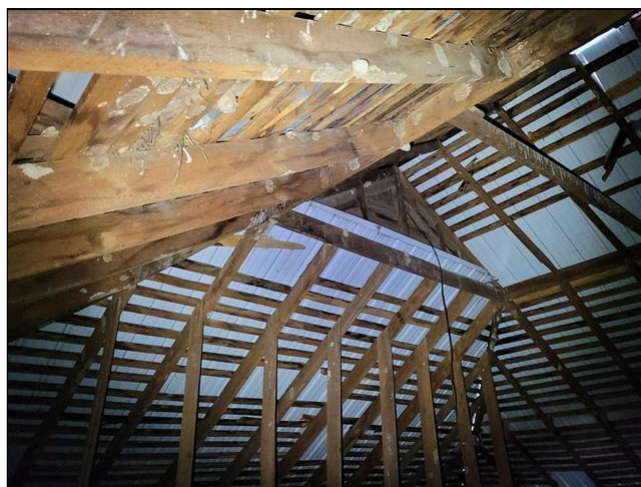
4.4 Item 2(Picture) Missing purlins

4.4 Item 3(Picture) Missing purlins

4.4 Item 4(Picture) Missing purlins

Many areas have missing roof purlins. I recommend a qualified professional investigate all areas further and advise on all repairs that are needed.

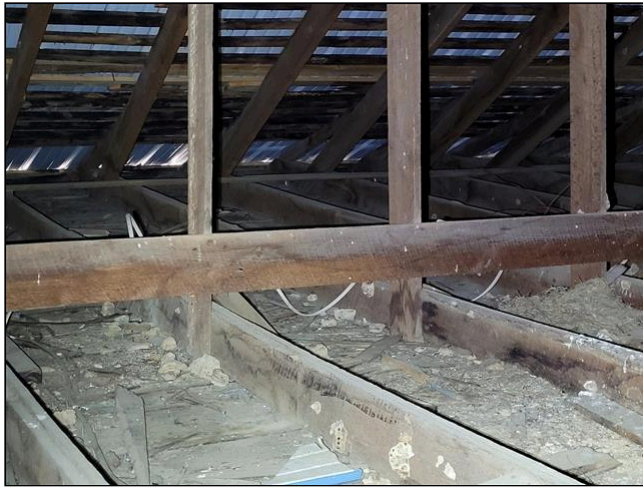
4.4 Item 5(Picture) Improper framing method

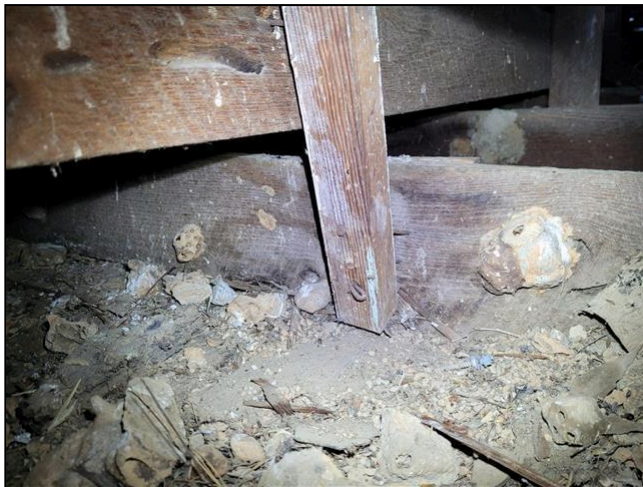
4.4 Item 7(Picture) Improper roof support anchoring method

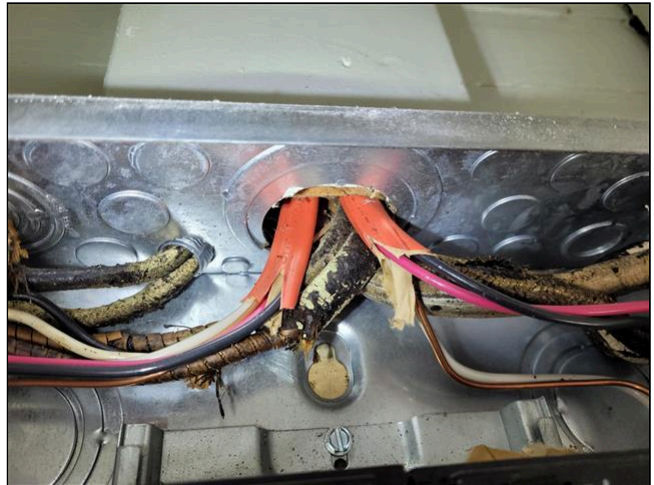
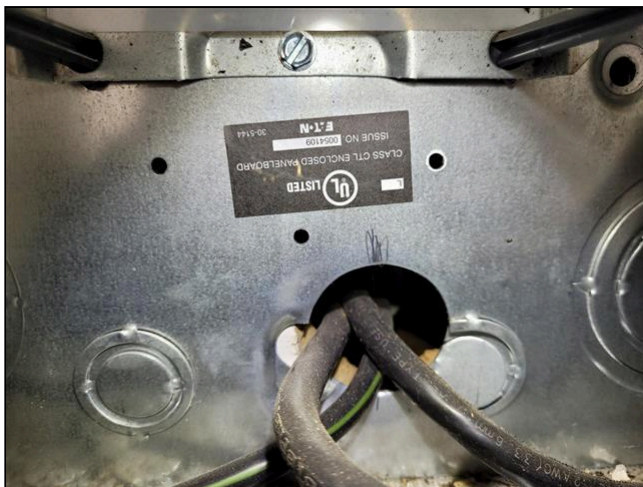
Bushings are needed in the main panel to prevent wire chafing and possibly energizing the panel.

6.1 Item 3(Picture) Bushing needed

6.1 Item 4(Picture) Bushing needed

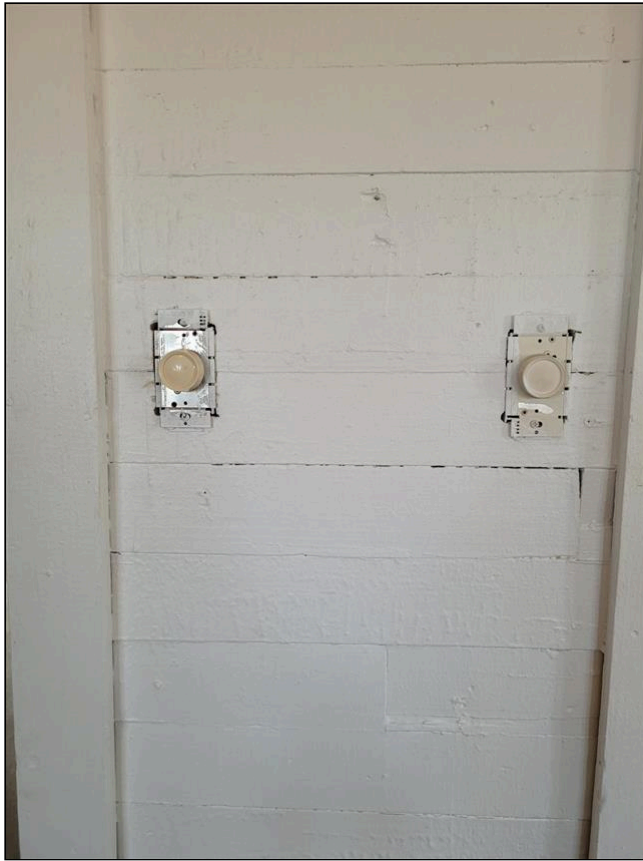
6.2 Item 1(Picture) Dimmer switches-overheating/no switch covers

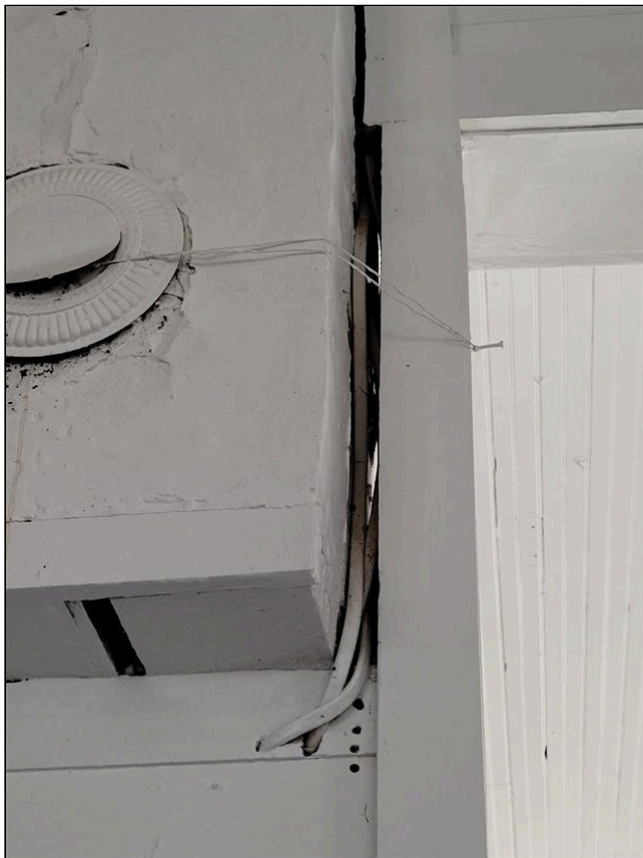
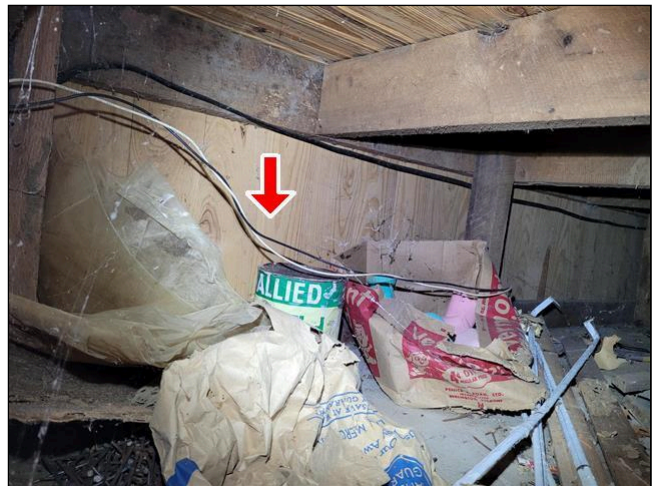
The main area had exposed wiring. Conduit is recommended to prevent accidental damage to wires.

6.2 Item 3(Picture) Exposed wiring-conduit needed

6.2 Item 4(Picture) Exposed wiring-conduit needed

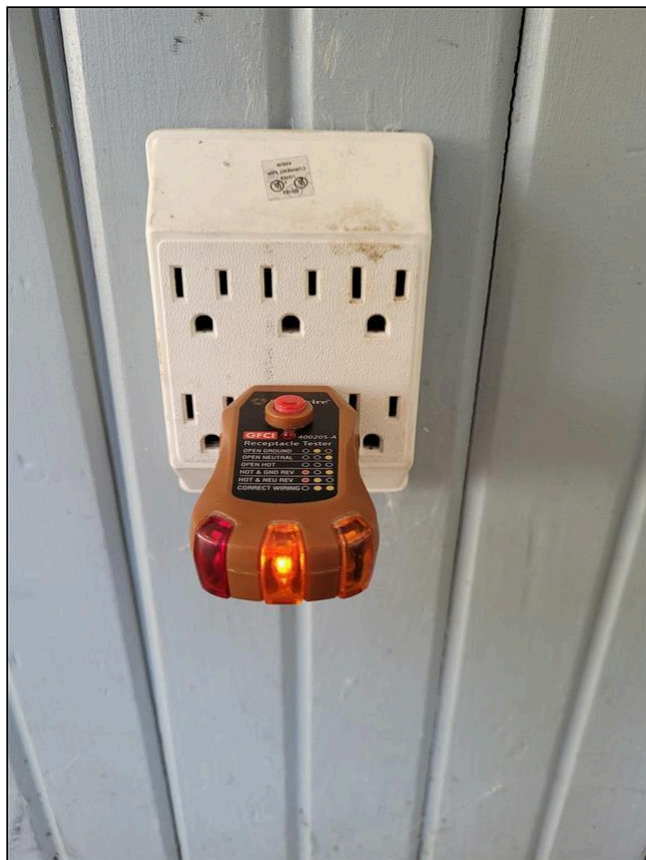
Most of the outlets were 2 prong outlets.

6.3 Item 1(Picture) Electrical outlets-open grounds

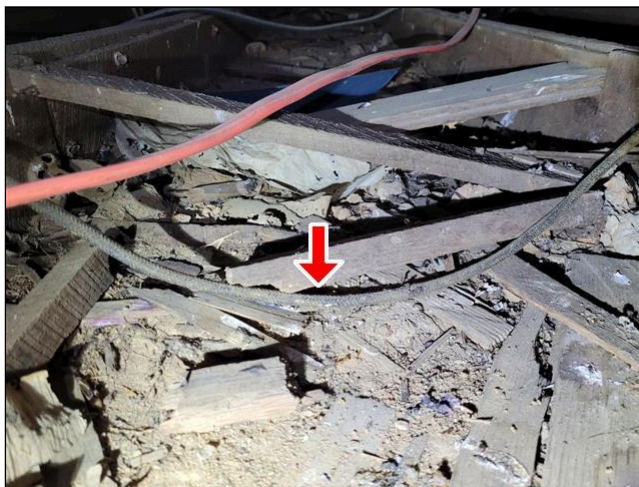
Aged fabric wiring is present.

6.3 Item 2(Picture) Aged fabric wiring

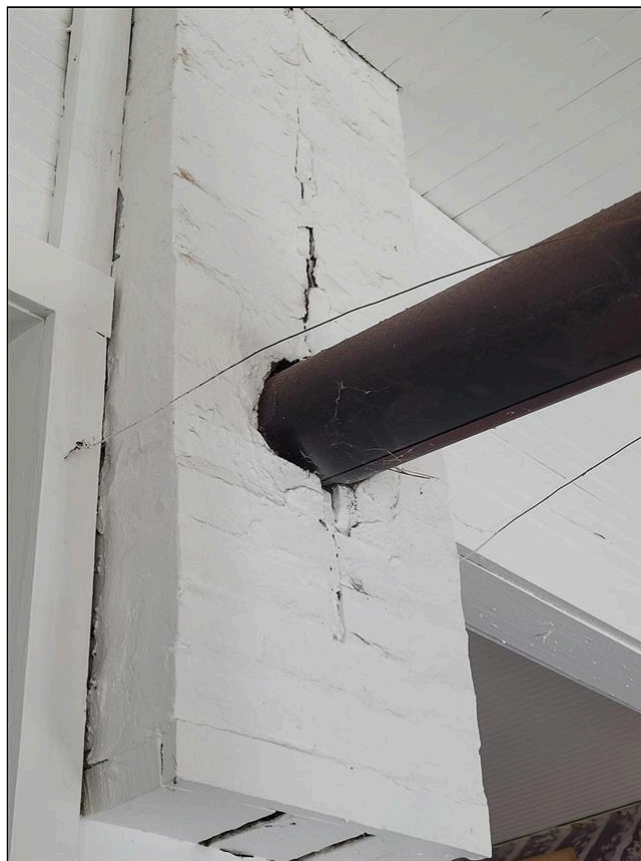
7.3 Item 2(Picture) Possible settling of bricks

(1) *The chimney liner was not inspected by our company. I recommend a qualified chimney sweep inspect for safety.*

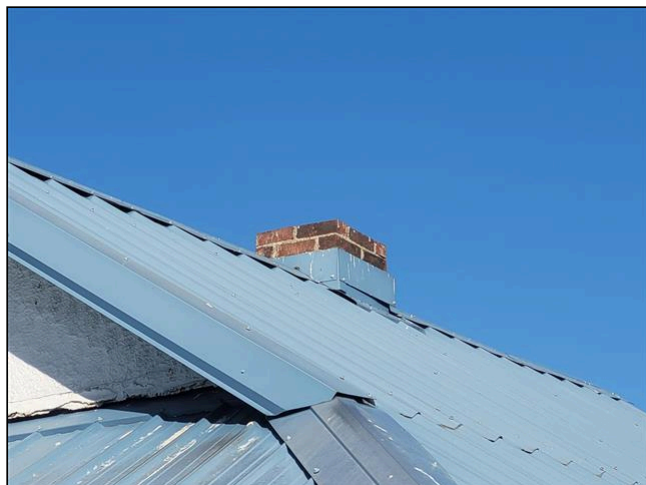
7.4 Item 1(Picture) No visible chimney cap

(1) *I recommend that a qualified chimney sweep inspect, and clean the flue pipe before using the fireplace/woodstove.*

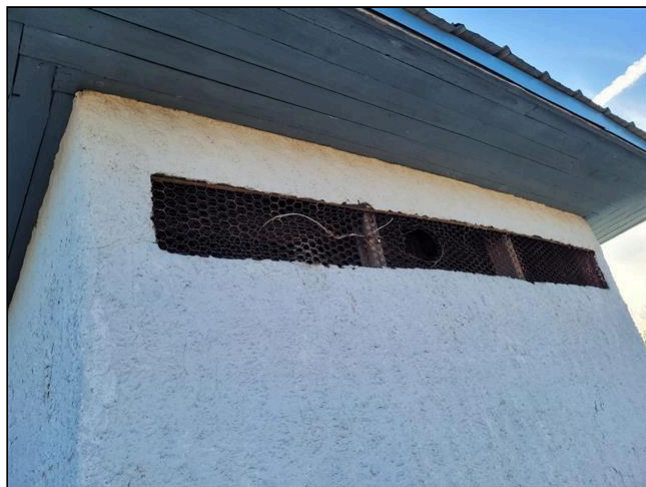
8.1 Item 1(Picture) Damaged attic vent material

The attic should be sealed to prevent access to animals.
