Inspection Report

Property Address:
74 County Road 624
Oak Grove Arkansas 72638

Abba Home Inspections, LLC

Date: 1/17/2023	Time: 08:58 AM	Report ID: F-Fairweather8425
Property: 74 County Road 624 Oak Grove Arkansas 72638	Customer: Rob Fairweather	Real Estate Professional:

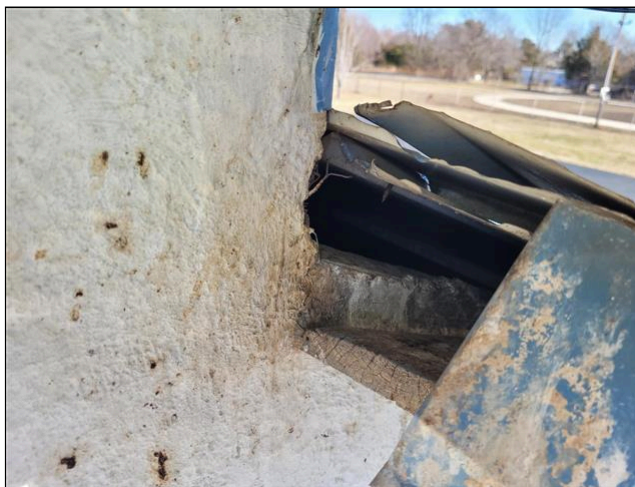
1.1 Item 2(Picture) Flash/seal all areas properly

1.1 All areas should be flashed/sealed properly to prevent water intrusion and framing damage.

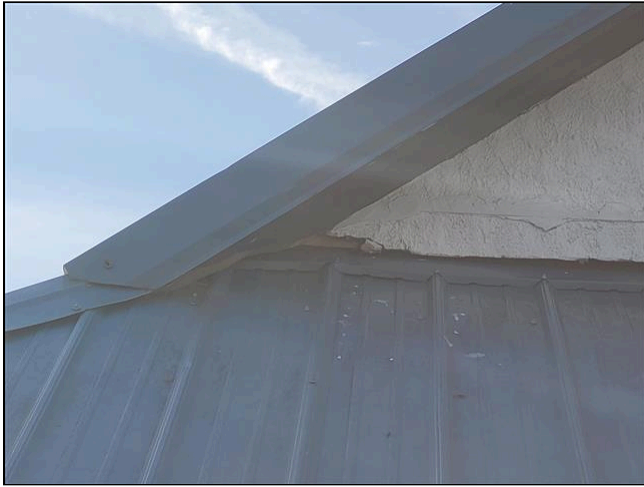
1.1 Item 3(Picture) Flash/seal all areas properly

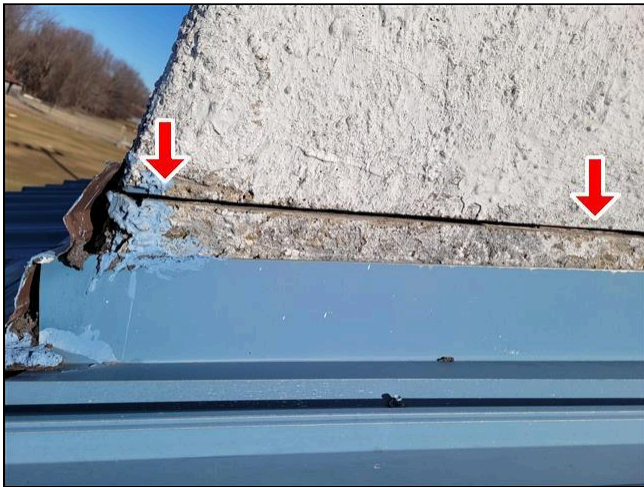
1.1 Item 5(Picture) Flash/seal all areas properly/
missing flashing

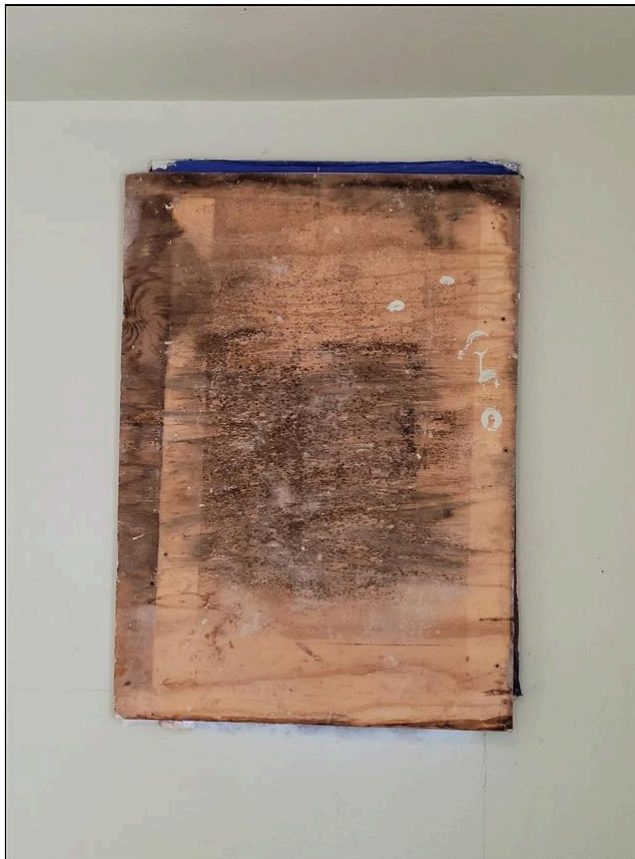
The East school room windows were fixed and one was missing the pane.

3.6 Item 2(Picture) East school room window-missing pane

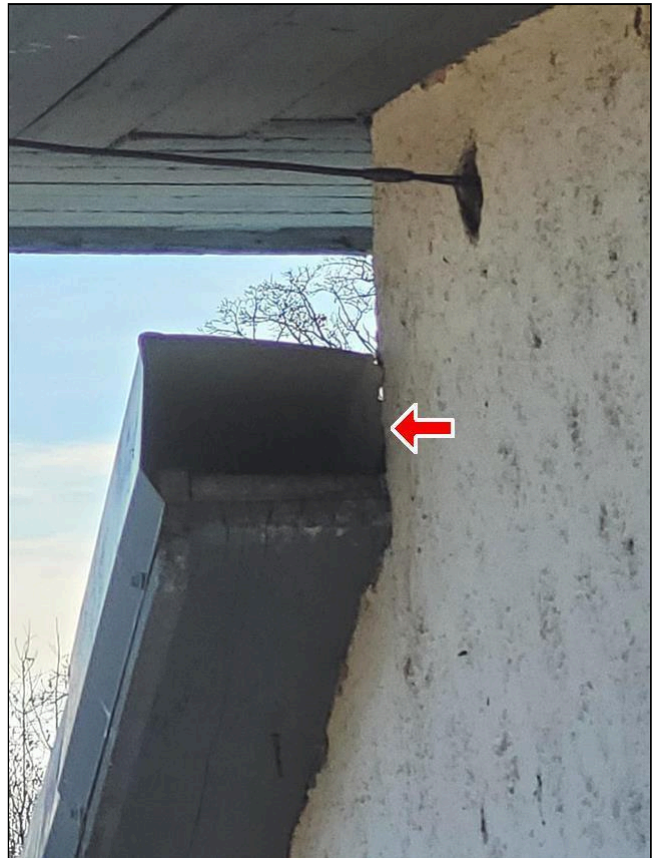
1.0 Item 3(Picture) Open area

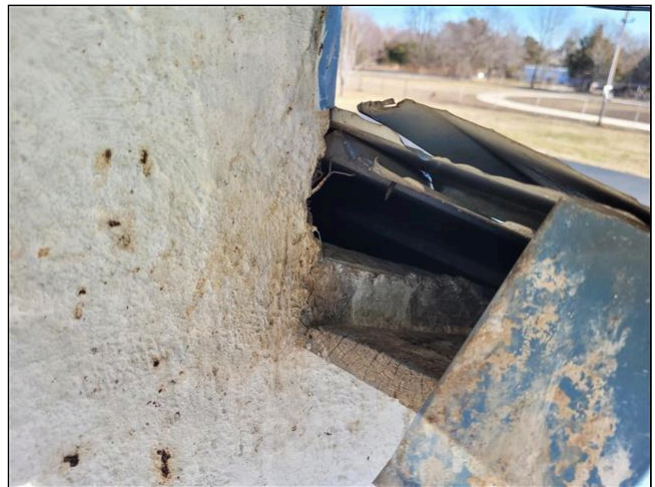
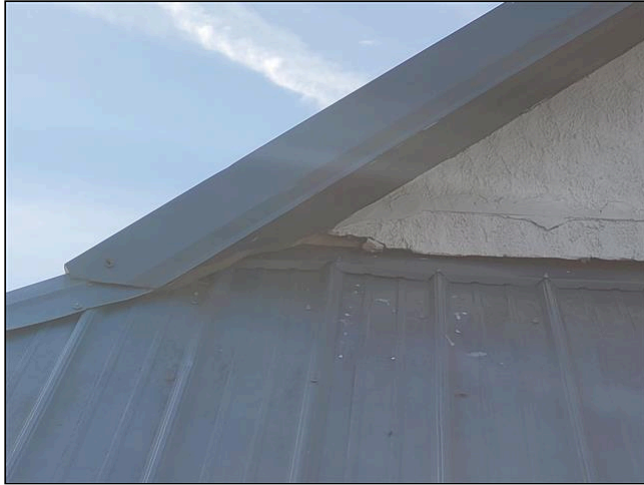
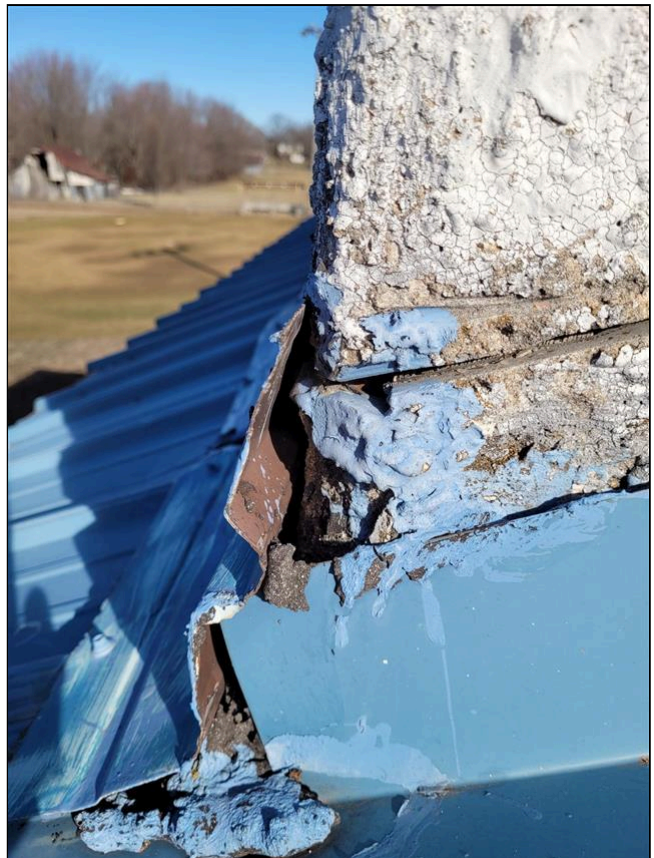
1.1 Item 2(Picture) Flash/seal all areas properly

1.1 Item 3(Picture) Flash/seal all areas properly

1.1 Item 4(Picture) Flash/seal all areas properly

1.1 Item 6(Picture) Flash/seal all areas properly

All areas should be flashed/sealed properly to prevent water intrusion and framing damage.

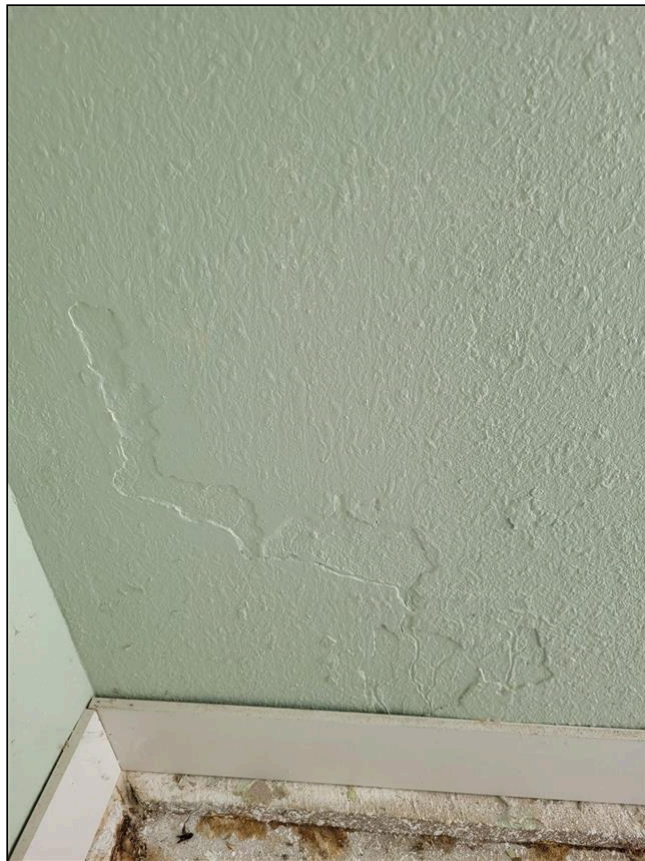
3.1 Item 3(Picture) East school room wall-possible wood destroying insect damage
